AIRWORTHINESS DIRECTIVE

GFA AD 686 Issue 5

Type Certificate Holder	Alexander Schleicher GmbH
Manufacturer(s)	Alexander Schleicher GmbH
Types/Models Affected	ASK-21Mi, ASK-21 and ASK-21B
Serial Numbers	All
Subject	Cracking of Filler at Wing Root
Implementation	MANDATORY
Background	<p>The Australian Air Force Cadets have found signs of cracking of the filler between the lower spar cap and lower wing skin at the wing root. A repair scheme from the manufacturer was implemented on one aircraft and this repair 'failed' shortly after return to service. The Australian Air Force Cadets suspended operation of their ASK-21Mi fleet on 8 Oct 2018 due to concern that the cracking at the lower spar at the wing roots was not fully understood and may jeopardise safe operation of the aircraft.</p> <p>Issue 1 of AD 686 mandated a visual inspection of the lower spar caps at the wing roots. Results found two ASK-21 aircraft in addition to the original ASK-21Mi, where the cracking had carried around the spar cap and along the spar web joint with the root rib. Several aircraft were reported with noticeable crack growth in between the spar cap and skin between annual inspections.</p> <p>Issue 2 of AD 68

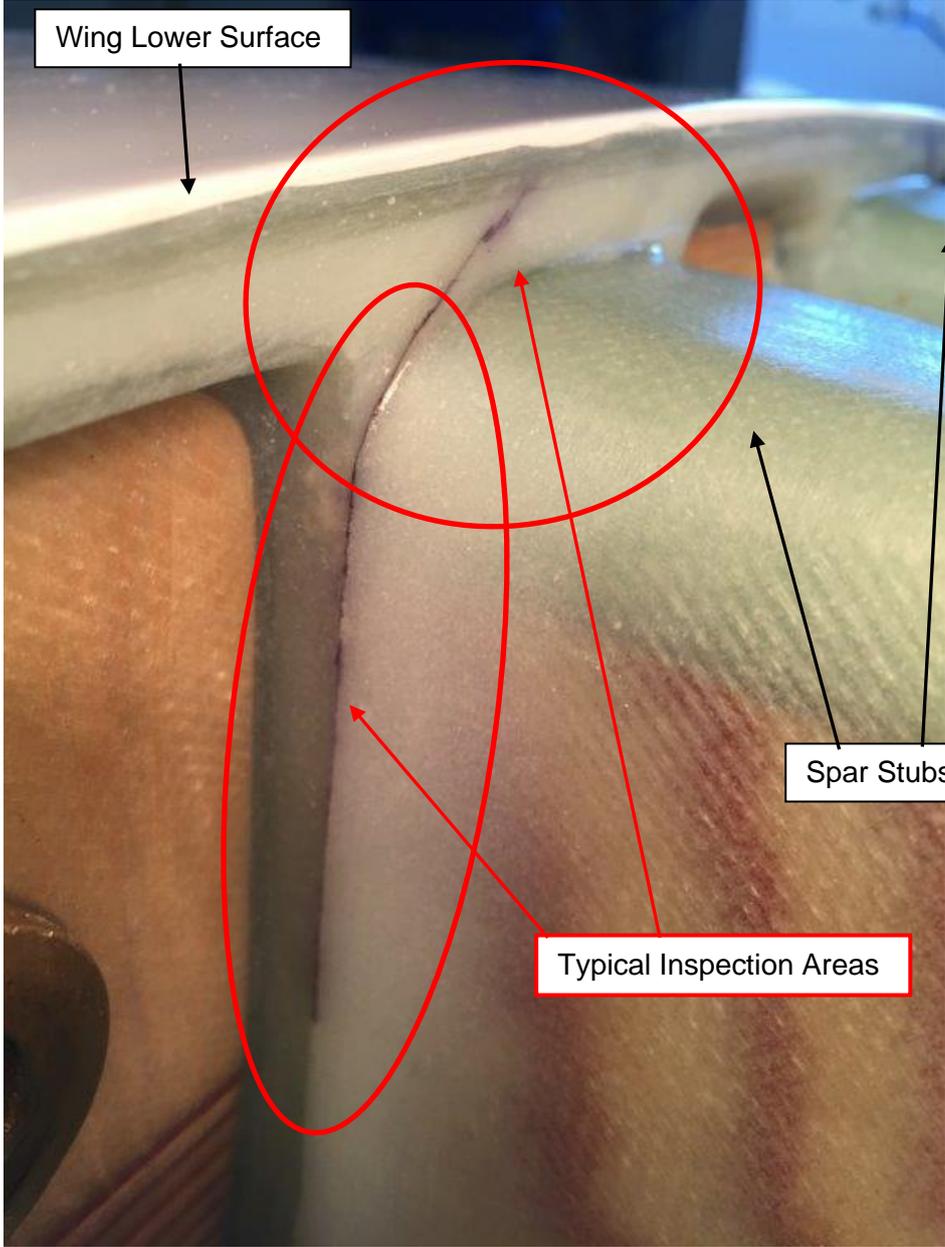
Documentation	Schleicher Technical Note TN 41 current edition
Required Action(s)	<p>1. ASK-21Mi and ASK-21: Before next flight, no later than 30 Nov 2018, an Annual Inspector FRP is to carry out the following:</p> <p>Derig the aircraft to gain access to the wing roots.</p> <p>Invert each wing on trestles or similar suitable stands.</p> <p>Using a good torch or strong sunlight, visually inspect the area around the lower spar cap and the wing skin and down the sides of the spar web and root rib as shown in Figure 1 below for signs of cracking. Particular attention should be paid at the spar web.</p>

<p style="text-align: center;">Figure 1: Wing root area requiring inspection</p>

Where cracking is found, the areas are to be measured and photographed with a ruler adjacent to the area. If no cracking is found, the aircraft can be reassembled and returned to service.

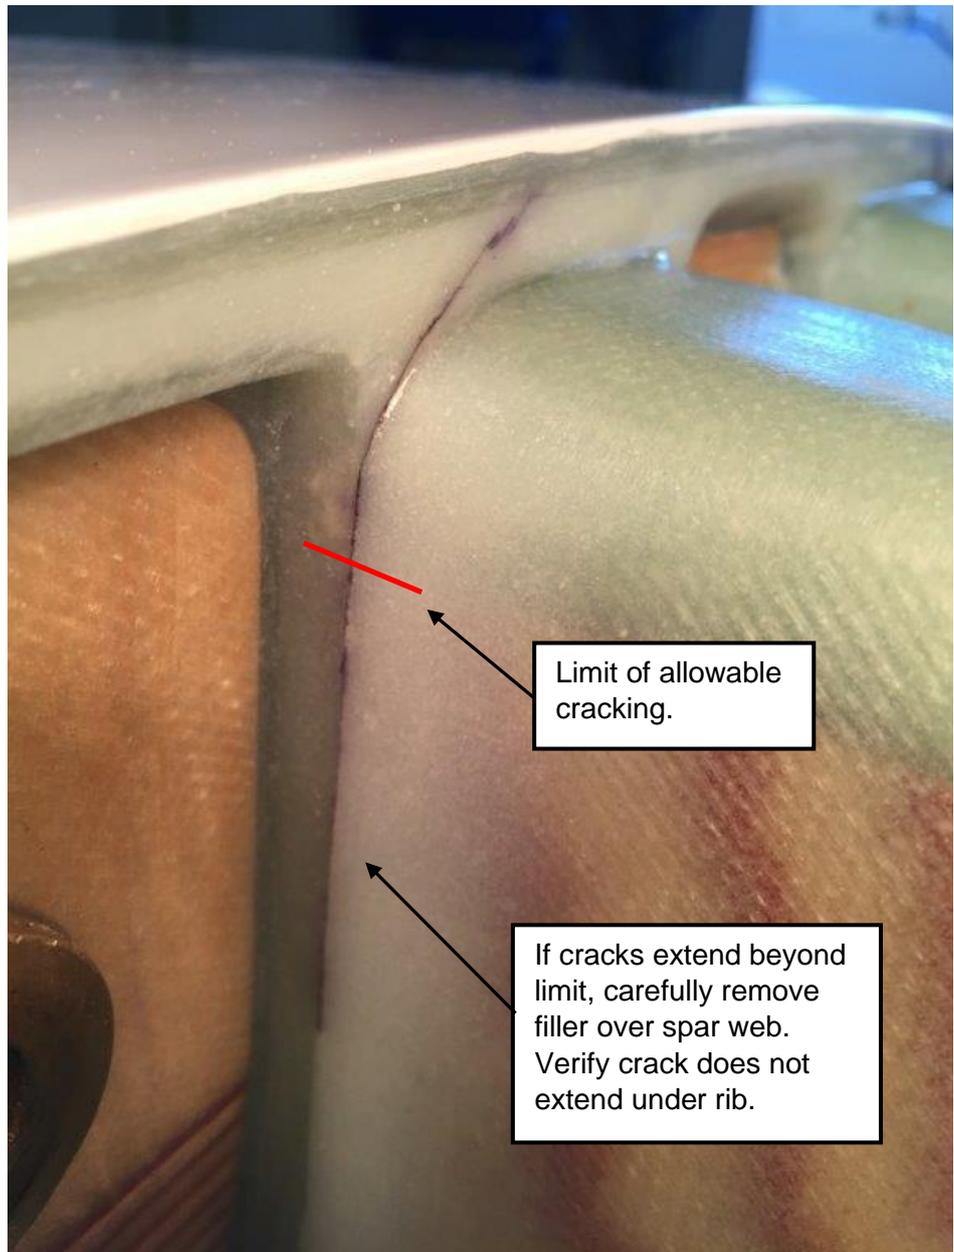
2. ASK-21Mi, ASK-21 and ASK-21B: If cracks are found at Action 1, and the cracks are confined to the area between the spar cap and the skin and has not exceeded the edge of the spar cap radius as shown in Figure 2 below, then verify that there is no audible detection of delamination of the skin to the spar cap by tap testing the region 50mm to 100mm outboard of the wing root. Mark the ends of the crack tips. Enter an inspection into the Form 1 to re-inspect every 100 landings or the next Annual Inspection whichever is first.

Figure 2: Allowable cracking limits

<p>Where cracks extend beyond the spar cap onto the spar web, carefully remove the thin wedge of filler between the spar web and the root rib. Verify that the crack has not extended under the root rib. If crack is not under the rib, do not replace the filler on the root web. The aircraft can be returned to service with the above ongoing inspections.</p> <p>Cracks extending under the rib will require repair either by Schleicher Technical Note TN41 (current edition) or by another approved repair scheme. Once repaired Actions 3 and 4 are applicable.</p> <p>3. ASK-21Mi, ASK-21 and ASK-21B: If no cracks are found in the initial inspection at Action 1, carry out Action 1 at each Annual Inspection.</p> <p>4. ASK-21Mi, ASK-21 and ASK-21B: Carry out Action 1 after every abnormally hard landing.</p> <p>5. All inspection results from the initial inspection at Action 1, including when no defects are found, are to be reported to GFA Airworthiness Chief Technical Officer CTO@glidingaustralia.org, and the Deputy Chair Airworthiness 2 dcad2@glidingaustralia.org. Crack results must include length and orientation information.</p> <p>6. All ongoing inspection results from Actions 2, 3 and 4 if crack growth is found, cracks are to be reported to GFA Airworthiness Chief Technical Officer CTO@glidingaustralia.org, and the Deputy Chair Airworthiness 2 dcad2@glidingaustralia.org. Crack results must include length, orientation information and aircraft hours and landings.</p>
