GFA AIRWORTHINESS DIRECTIVE

TYPE AFFECTED: SZD-32A Foka 5

SUBJECT: Possible jamming of aileron controls

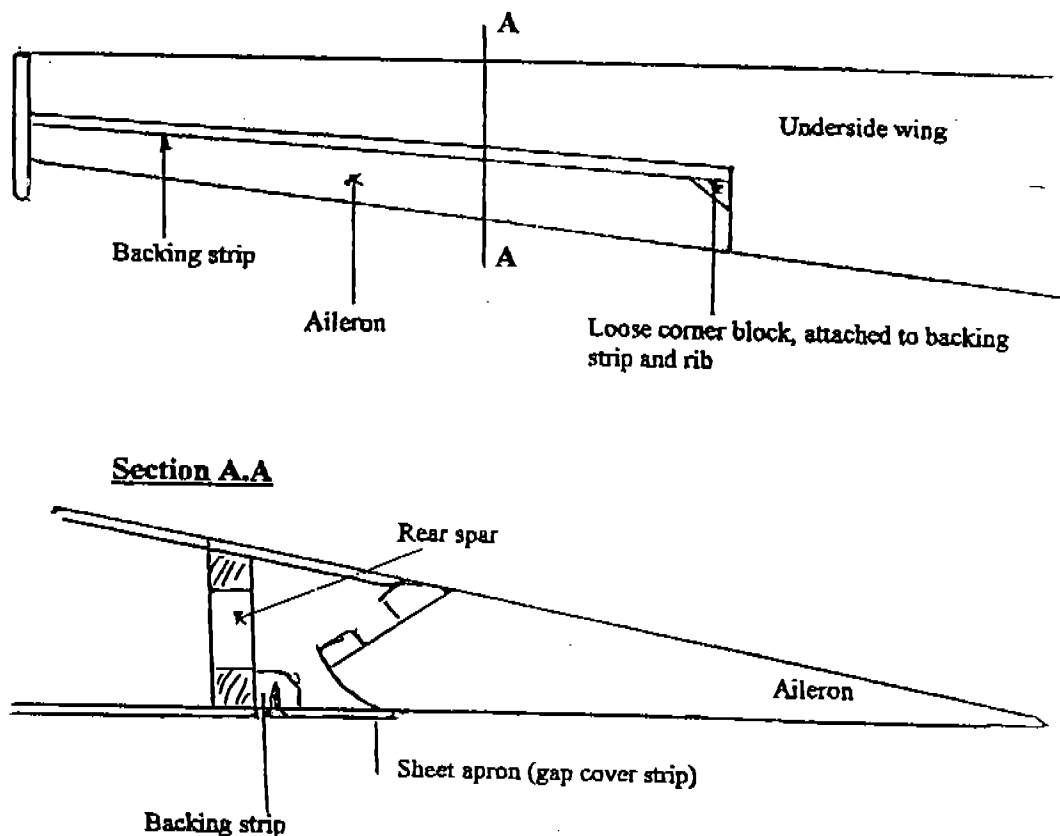
More recently (July 2001), a further problem has been found. There is a strip of timber attached to the lower part of the rear spar of the wing, to which the metal sealing strip is attached with woodscrews. It was discovered by the owner of Foka 5R GQN that, on one wing, this backing strip was not properly attached and it fell off when subjected to a light tap with a small hammer. When it fell off, it took the corner block with it. Should such a thing occur in flight, it is not known whether it would simply fall off and disappear or whether it would flail around and either cause damage or possibly jam the aileron. Neither case is acceptable.

If deterioration is found, it will be necessary to remove the backing strip in order to clean off all traces of glue residue from both the strip and the spar. Note that the corner block is glued between the strip and the rib, not between the spar itself and the rib. Therefore, if the strip is insecure, the corner block may also be insecure. In fact, on one wing of VH-GQN, the opposite situation existed - the strip itself had suffered complete glue failure and the whole assembly was held in place only by the glue attaching the corner block to the rib. Little wonder it fell off with hardly any persuasion.

ACTION REQUIRED: Remove the metal sealing strip on the underside of both wings. Check for deterioration of the glue attaching the backing strip to the rear spar of the wing. If no glue deterioration is found, the sealing strips may be re-attached and the glider returned to service.

Note also that it may be necessary to remove the aileron to gain access to the whole area for cleaning off old glue residue and re-gluing the backing strip. Epoxy glue, such as Epiglu, is recommended for the repair.

Refer to the diagram below.
