## AIRWORTHINESS ADVICE NOTICE

TYPE AFFECTED: DG-500 all variants

SUBJECT: Miscellaneous airworthiness information.

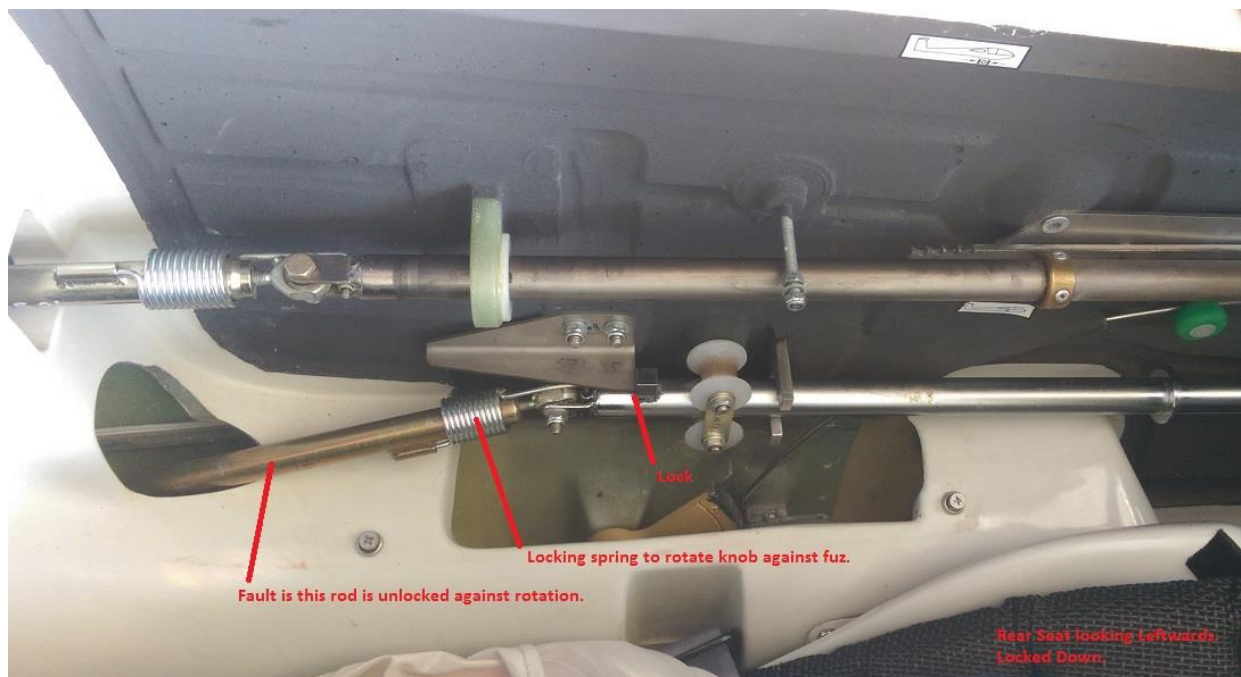
4. UNDERCARRIAGE CONTROL KNOB NOT REMAINING IN LOCKED POSITION: (Previously AWA 2018-3) The DG-500 and DG-1000 are subject to the undercarriage control knob not remaining rotationally locked. The control push rod is subject to spring forces which 'breaks' the torque on the jam nut / lock washer combination permitting the rod to rotate on the end fitting threads.

Figure 1: Undercarriage push rod in left rear cockpit

Access is gained through the left rear seat control cover. Loctite stud locker high strength is recommended to supplement the lock washer and hold the fitting in correct orientation.

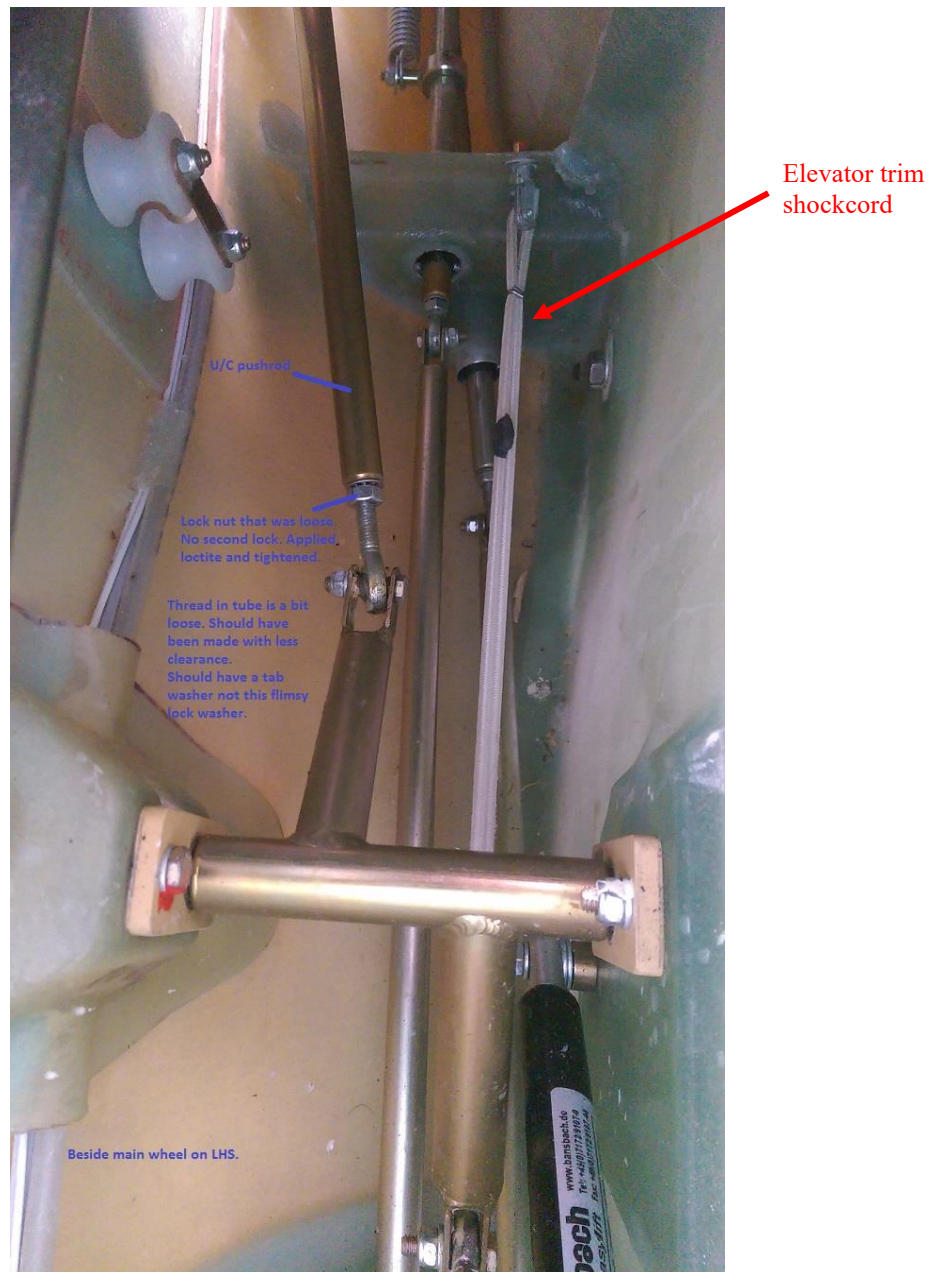
Figure 2: Undercarriage push rod in centre fuselage. Elevator trim shockcords are on right hand side

5. SHOCKCORDS: The DG-500 and DG-1000 variants use shock cords to apply added trim tension and apply tension to tow release cables when not under load. See example in Figure 2 above. The trim control will lose effectiveness if tension is lost, or the release cable could snag or foul if not kept under tension. The release knob hanging down is an indicator that the shock cord is losing effectiveness.

All shock cords used on these types will need replacement with time. They should be checked for effectiveness at each annual inspection. The trim mechanism is located beside the main wheel well. The release cables under the rear seat instrument binnacle.
