THE GLIDING FEDERATION OF AUSTRALIA

AIRWORTHINESS ADVICE NOTICE NO. AWAN 6-71-1

L-13 Blanik

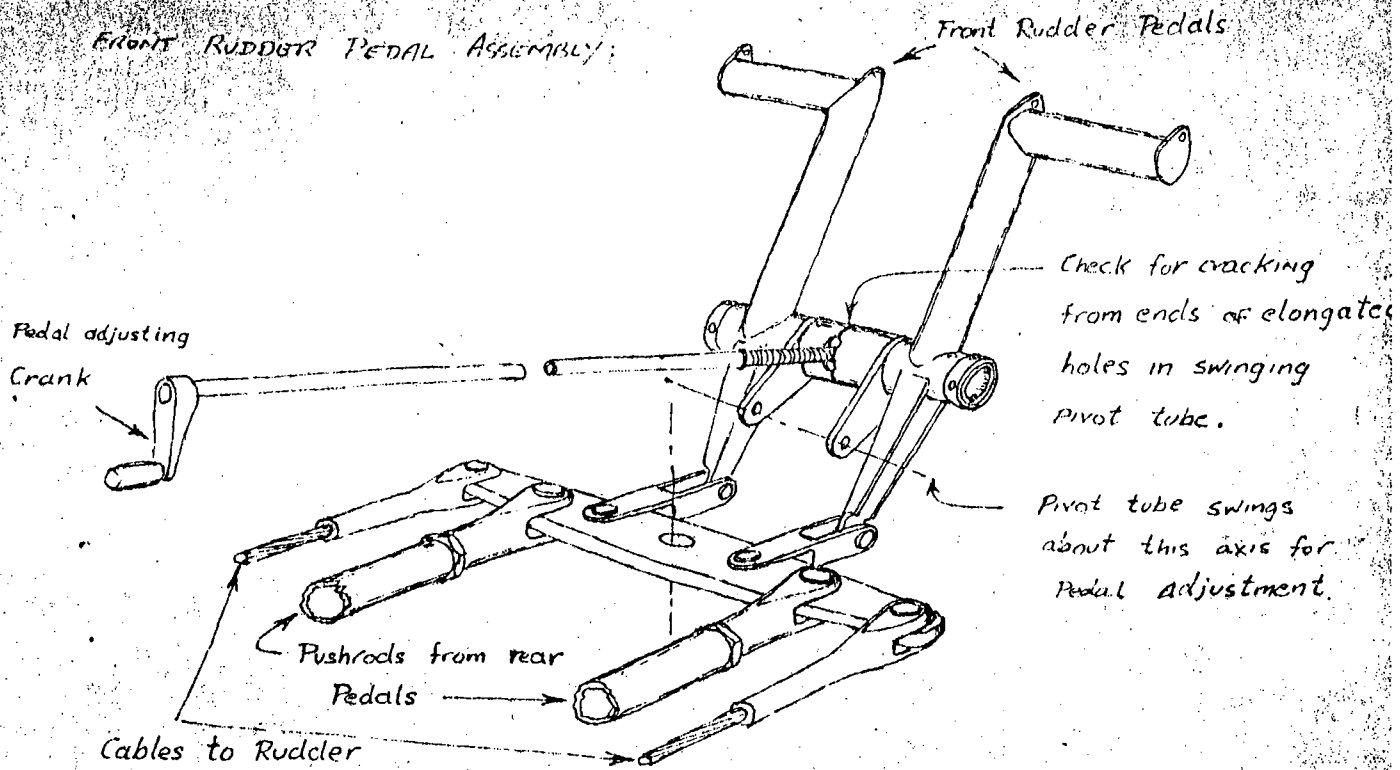
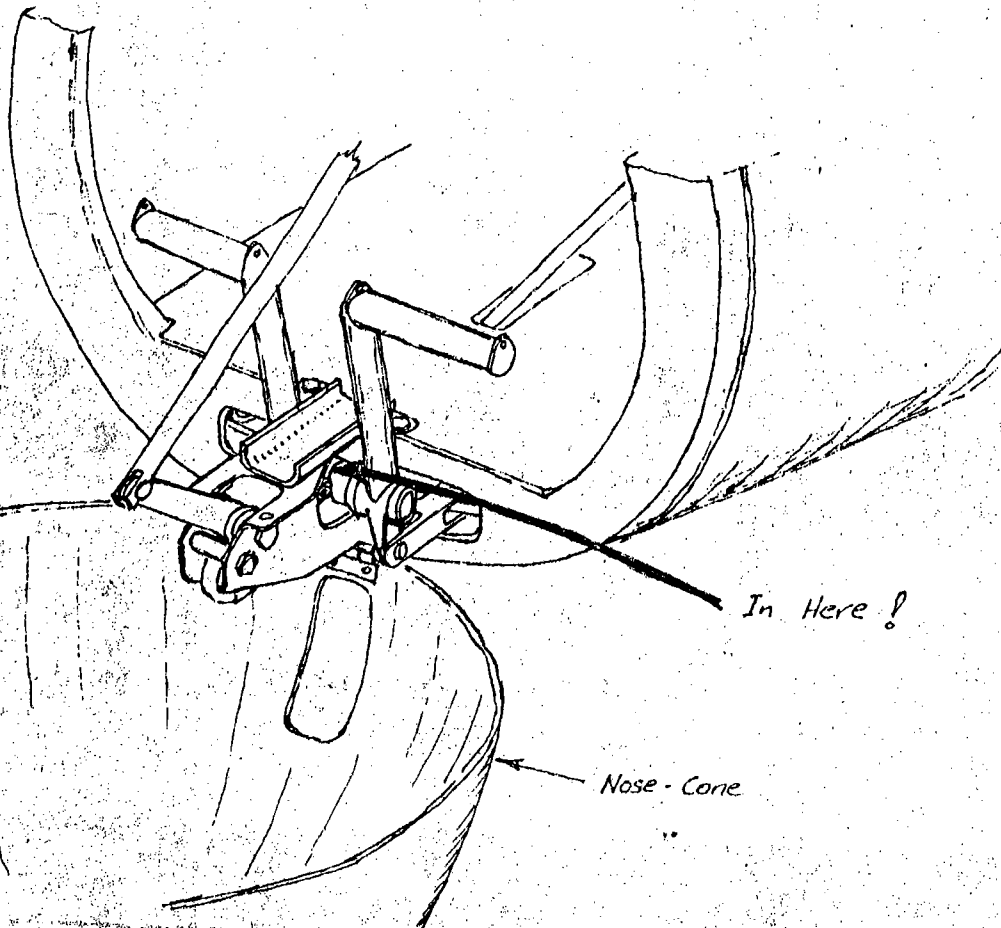
FRONT RUDDER PEDAL ASSEMBLY:

During a recent inspection of an L.13 Blanik a fracture in the carrier for the front rudder pedals was detected. The subject aircraft had amassed 1,210 hours operations and 157 hours since the last major inspection.

The rudder pedal carrier bracket has a tubular centre member which has an elongated transverse hole through which the pedal adjustment screw passes. Cracking occurred through the remaining metal on one side of the tube hole. The tube is loaded in torsion during operation of the rudder pedals and cracking once started could be expected to progress rapidly.

It appears that the weakness is known to the makers as this member on late models is made heavier, however, it is not known when the change was made as no notification has been received.

Open nose cone and inspect component (refer illustration) use magnifying glass and if cracking is suspected use a dye penetrant method to confirm or remove the fitting for checking by magnaflux or other non destructive crack detection process. Replace component if any evidence of cracking is detected and report the fact to C.T.O.A.

At intervals not exceeding 25 hours operation and preferably at each daily inspection inspect for evidence of cracking.

Result of this inspection to be entered in the maintenance section of the glider log.
