AIRWORTHINESS ADVICE NOTICE

All Schweizer sailplanes

SERVICE BULLETIN SA-002

SUBJECT: DAILY INSPECTION OF AIRCRAFT STRUCTURES; DETAILED VISUAL INSPECTION OF TAIL RUDDER, ELEVATORS, VERTICAL TAIL SURFACE (TAIL FIN), AND FUSELAGE.

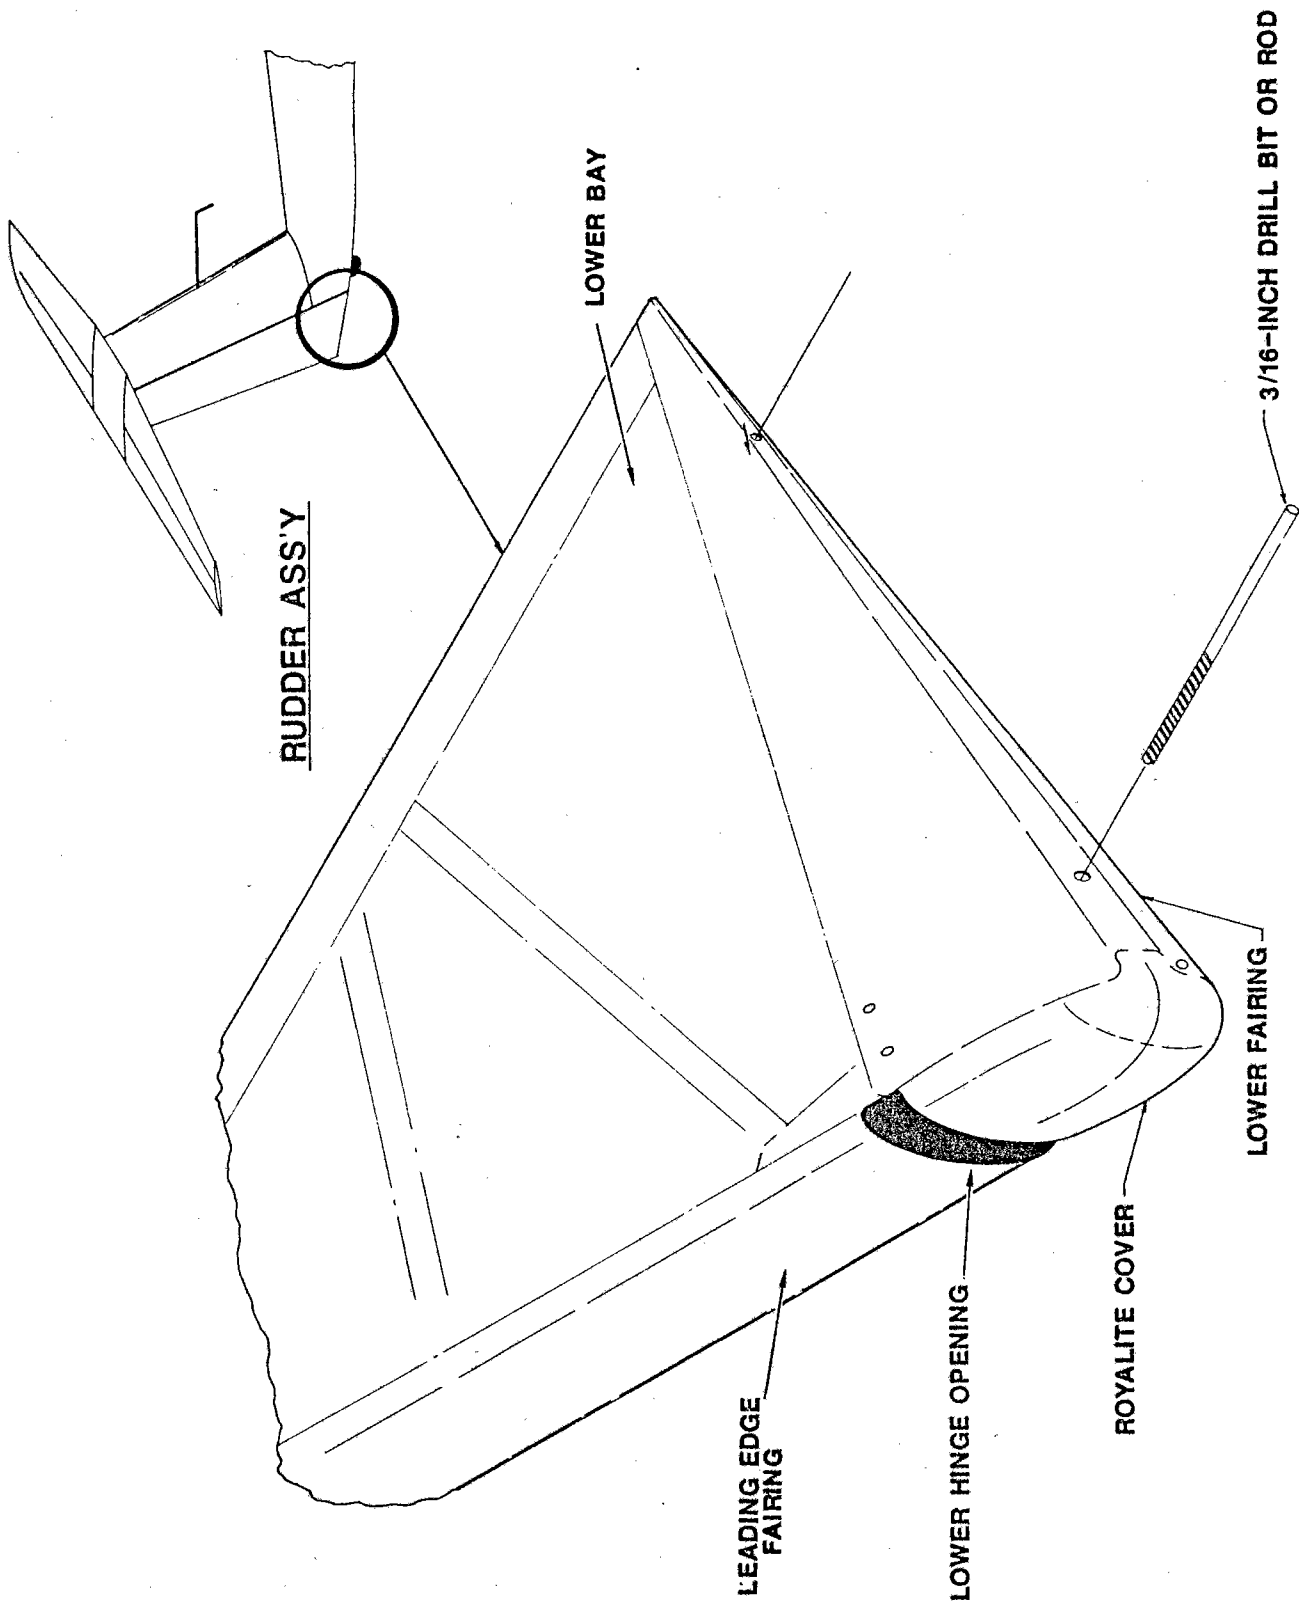
FIGURE 1

Rodents may gain access and deposit debris at four different locations within the tail rudder. Debris may be present between the leading edge fairing and the spar, inside the lower fairing, inside of the lower bay or inside the upper bay. (Refer to Figure 1.) Each of these areas should be thoroughly inspected with flashlight and inspection mirror.

- (1) Carefully adjust rudder position to extreme left or right.
 - (2) Using a flashlight, inspect for debris inside lower fairing (Figure 1) by looking through lower hinge opening.
 - (3) If debris is found, use a vacuum cleaner with flexible extension hose to remove debris.
 - (4) Check two drain holes (Figure 1) at bottom of fairing for obstruction. Clear obstructions with 3/16-inch drill bit.
- d. Open access door on horizontal stabilizer stub (Figure 2) and use a flashlight to inspect upper fin and stabilizer stub area for debris. Use vacuum cleaner to remove debris.
 - e. Inspect brake/wheel area for obstructions. Remove obstructions as required.

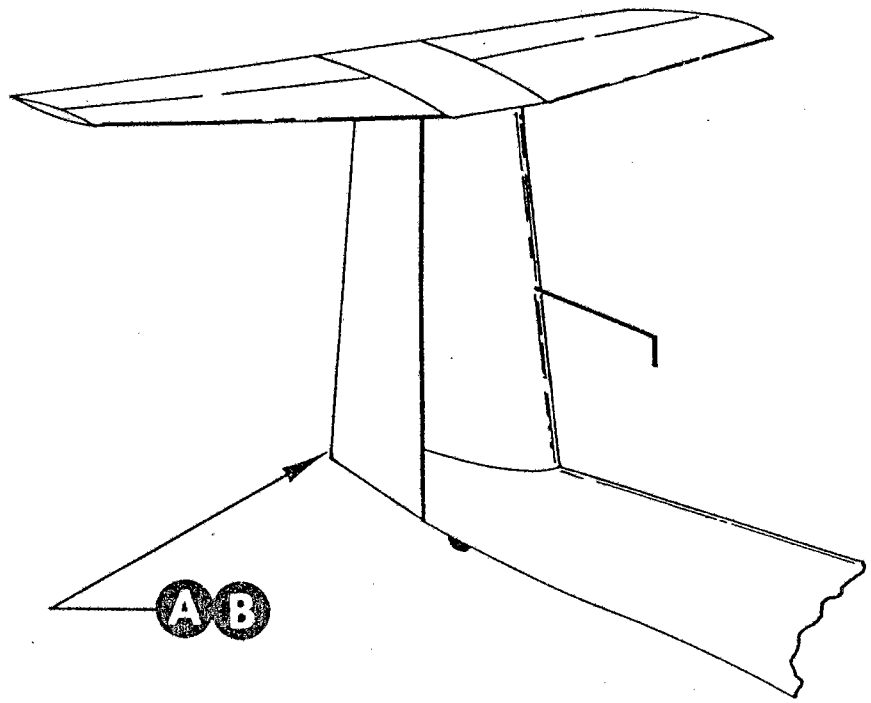
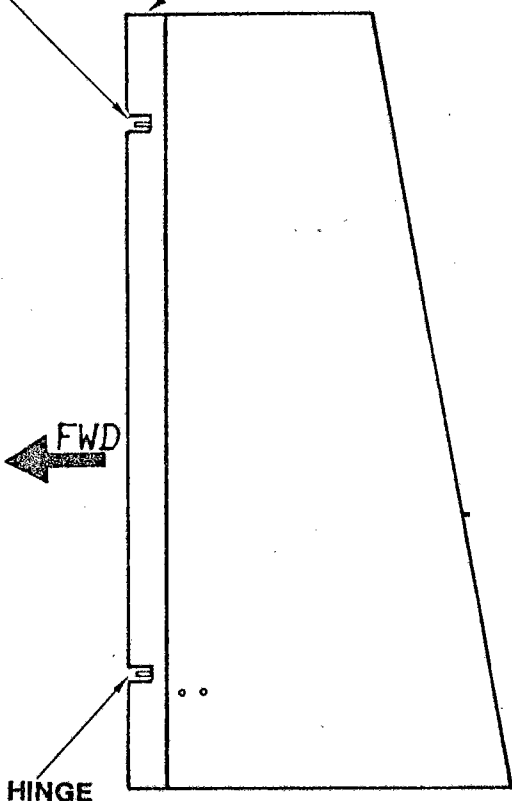
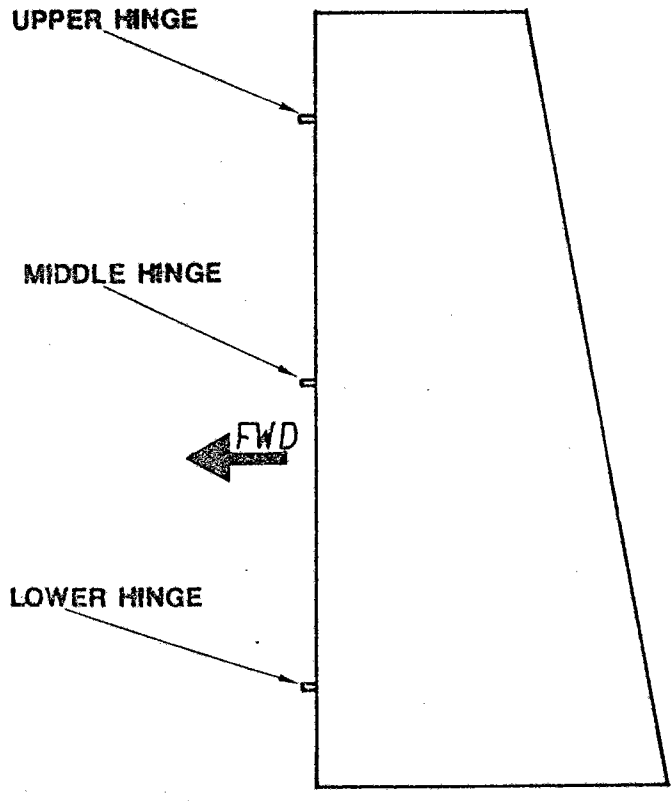
FIGURE 3

One of two types of tail rudders may be installed on the affected aircraft. The earlier type is an unsealed unit without a leading edge fairing (Figure 3, Detail B). The later type is sealed at the leading edge by a fairing (Detail A). Removal of an unsealed rudder is accomplished by performing step a(1) through a(3). A sealed rudder is removed by performing steps b(1) through b(3).

- c. Using a flashlight and inspection mirror, inspect for debris inside of rudder by looking through hinge openings (Figure 3, Detail A or Detail B, as applicable).
- d. If debris is noted between leading edge fairing and spar, remove debris through upper hinge opening, using vacuum cleaner and flexible extension hose.

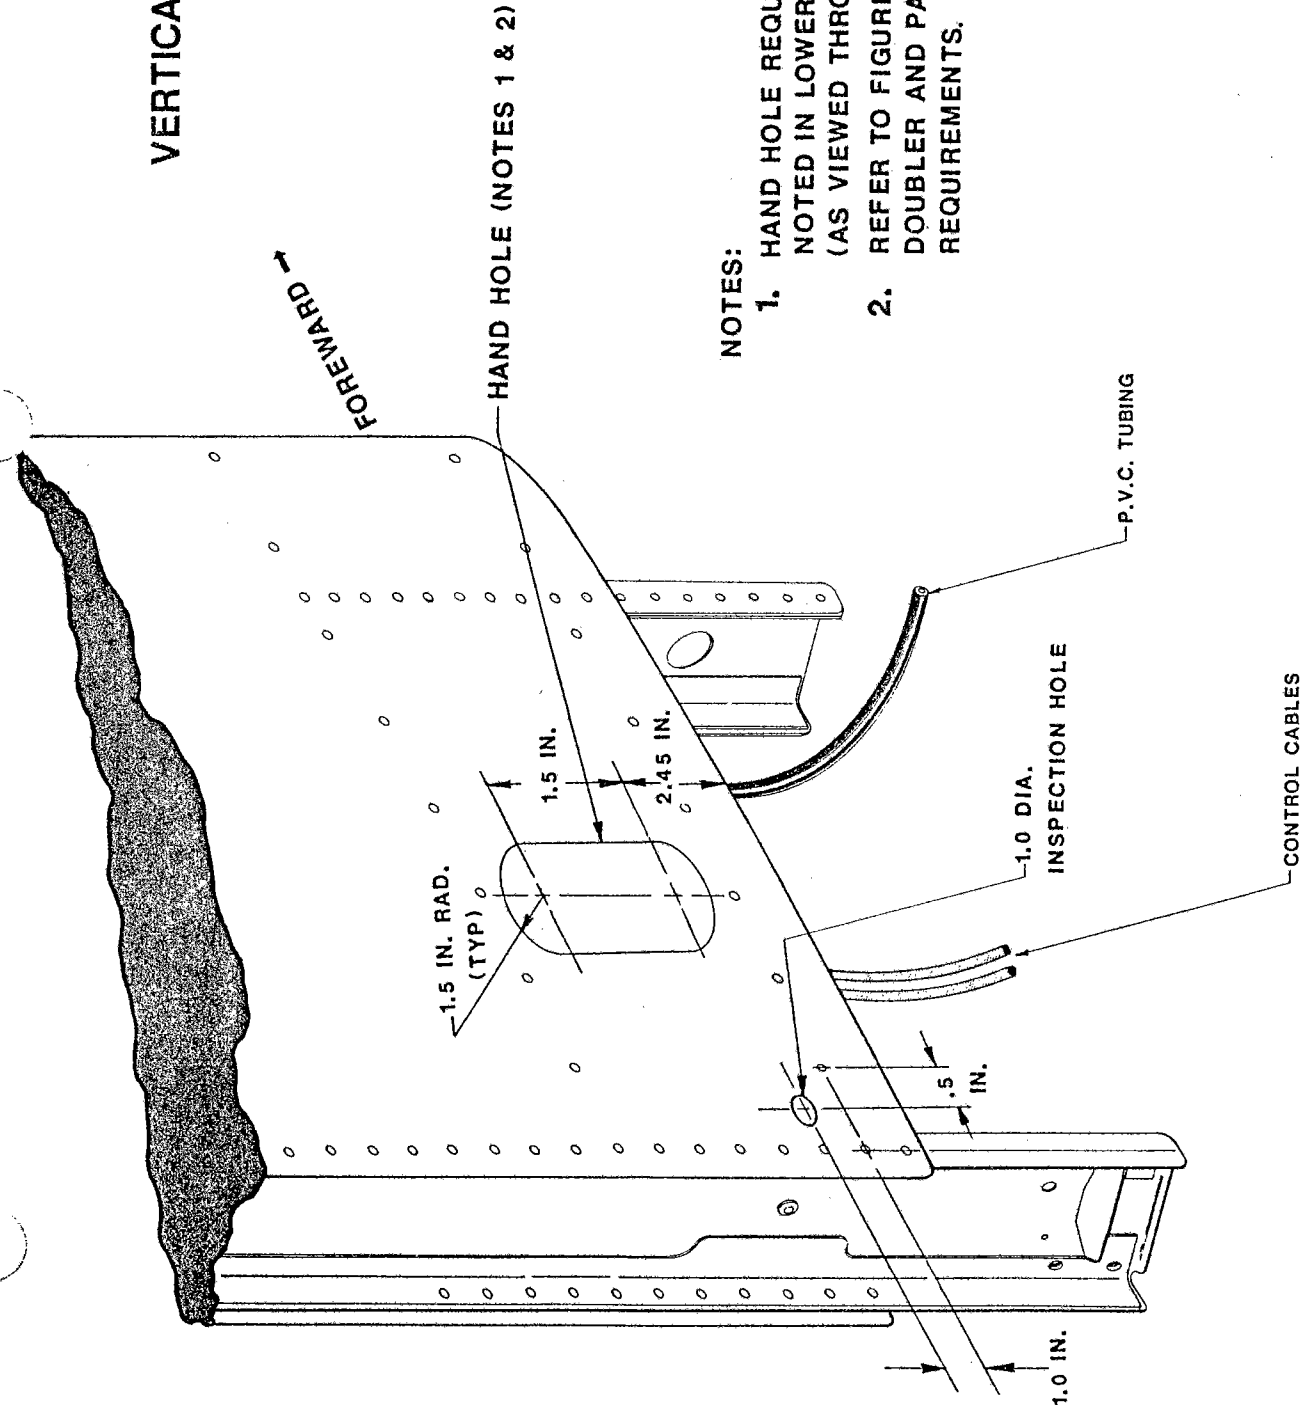
FIGURE 4.

1. HAND HOLE REQUIRED ONLY IF DEBRIS IS NOTED IN LOWER PORTION OF TAIL FIN (AS VIEWED THROUGH INSPECTION HOLE).
2. REFER TO FIGURE 5 FOR STRUCTURAL DOUBLER AND PATCH INSTALLATION REQUIREMENTS.

- j. Remove oval shaped inspection holes at aft end of fuselage and inspect fuselage interior for debris. Remove debris as required.
- k. Using 1-inch drill bit and drill, install a 1-inch inspection hole in one side of tail fin at location shown in Figure 4.

- (1) Use drill to puncture skin (of tail fin) and saber saw (or equivalent) to cut access hole at location shown (and size shown) in Figure 4. Deburr edges of access hole.

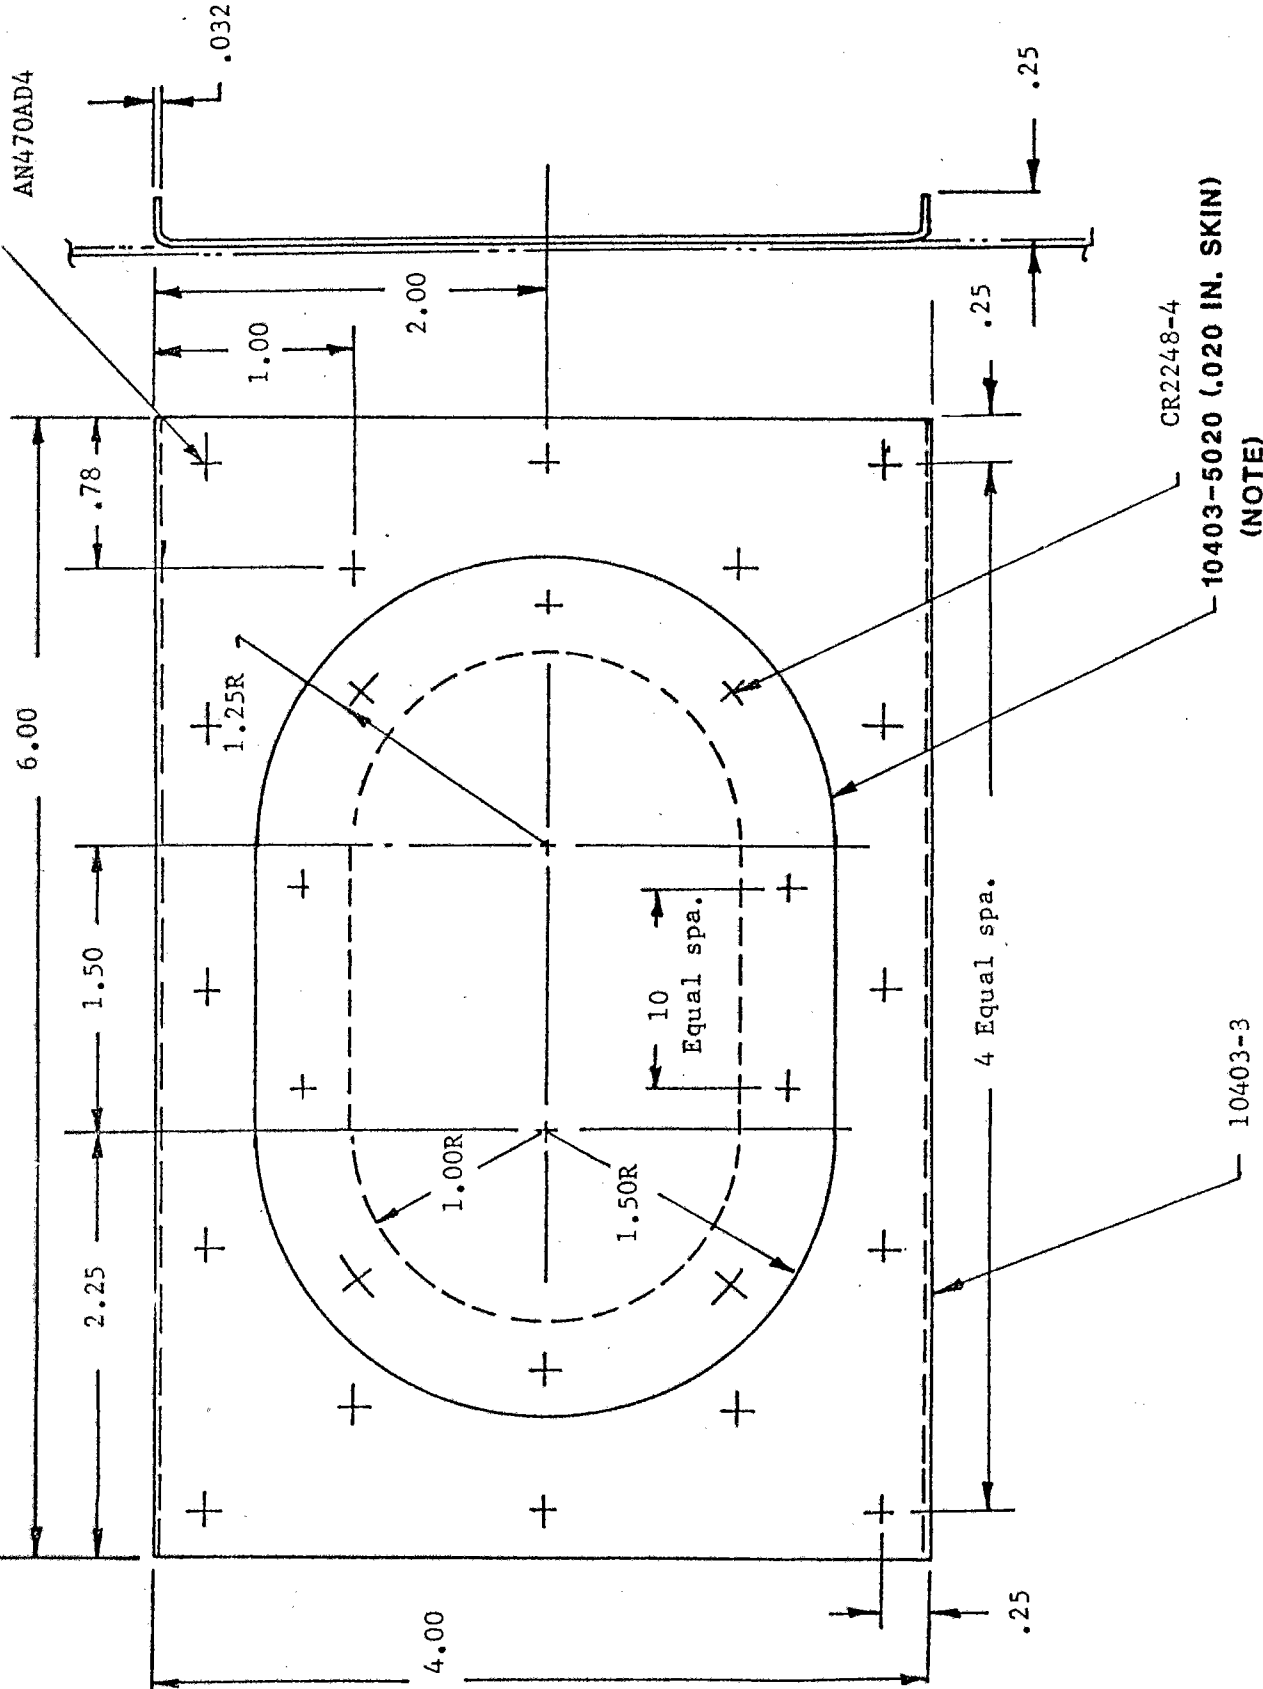
FIGURE 5. STRUCTURAL DOUBLER HOLE PATCH

Doubler
.032 2024-T3 Alc.
NOTE: EARLY SGS 1-35 SAIL PLANES WHICH INCORPORATE
A .016 IN. SKIN REQUIRE A 10403-5016 PATCH.
10403-3
CR2248-4
10403-5020 (.020 IN. SKIN)
(NOTE)

- (2) Use vacuum cleaner with flexible extension hose to remove debris from lower portion of tail fin.
 - (3) Using doubler as a template, install appropriate number of rivet holes (of proper size) in tail fin skin at locations shown in Figure 5.

- (4) Slide doubler through access hole, rotate it 90 degrees, and use appropriate rivets (Figure 5) to fasten doubler to fin skin.
 - (5) Secure patch to doubler with rivets. (Refer to Figure 5.)
