AIRWORTHINESS ADVICE NOTICE

TYPE AFFECTED: LS 1 series.

SUBJECT: Miscellaneous airworthiness information.

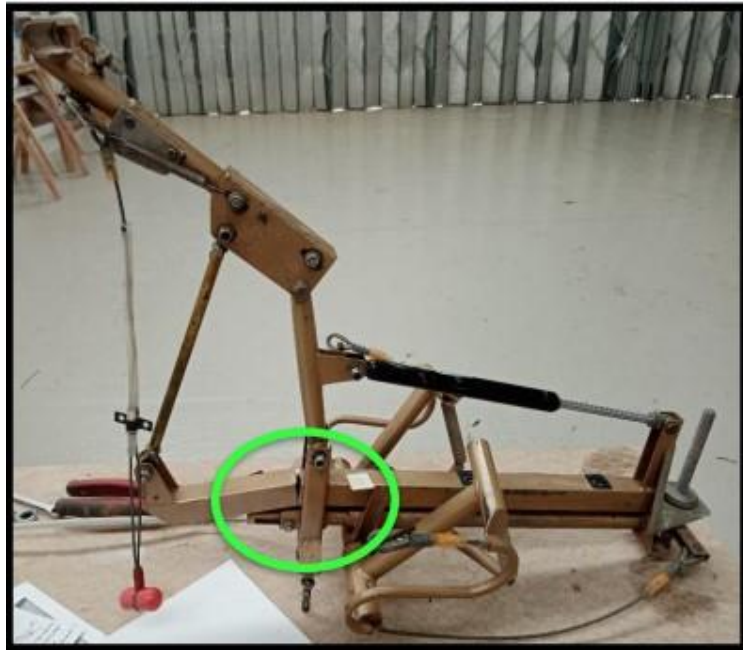
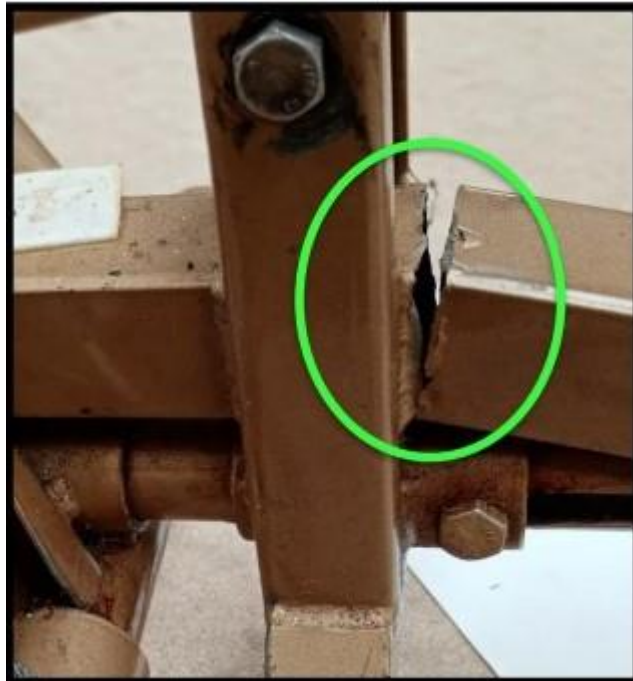
1. There have been defect reports received both here and overseas relating to canopy support structure failures in LS1, LS3 and LS4 type sailplanes.

The canopy when extended is supported on a structure which is subjected to in service fatigue loads caused by opening in windy conditions and tow-out with canopy unlocked (causing bouncing on the strut).

The fatigue accumulates and can result in failure of the lower 25 x 25 mm square (fore and aft) structure anchored to the floor. This tube is thin walled (<1 mm) and generally fails towards the rear end of the central tube. Refer photos.

In the case of LS1, the canopy attachment does not latch with pins along the front of the canopy frame. In the event of an inflight failure of the frame, the canopy could suddenly separate from airframe.

Repair welding work requires the four floor mounting points to be jugged to ensure the geometry is maintained and the part fits back in place. The repair should be carried out in accordance with an engineering order or approved data equivalent.

It is highly recommended that the affected area be inspected for defects or cracking at every Daily Inspection.
