AIRWORTHINESS ADVICE NOTICE

TYPE AFFECTED: Twin Astir, G103 Twin II & Acro, G103 Twin III & Acro, G103Twin III SL

SUBJECT: Miscellaneous airworthiness information.

**THE GLIDING FEDERATION
OF AUSTRALIA INC**

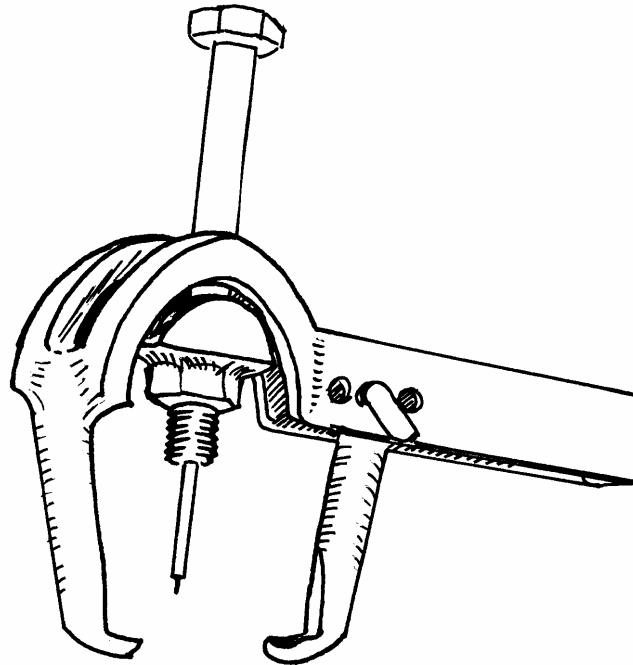
FIGURE 1 HINGE PIN REMOVER

2. Hinge roll pin removal. The most common method of removing the ailerons and elevators is by use of a hammer and pin punch. This type of impact can be quite damaging to the hinge and its attachment to the main structure. The following sketches have been offered by one of our inspectors as an alternative tool for roll pin removal, which does the job quite well and may prevent delamination of hinge attachments. (See GFA AD 213.)

The main problem is that the holes in the pins are individually drilled and are at all sorts of angles, hence the curved arch of the tool and the bolt in the trunnion so that the individual roll pin angle can be duplicated by the tool.

A secondary problem is that not all the hinge pins are the same length so that the tool-must cater for differing spans of hinge. The feet of the tool must slip and hold under the different sized ends of the pins. One foot of the tool (the foot in the handle) has to be loose so that it can be inserted below the end of the hinge pin first and then the main body of the tool presented to it, the foot then being secured to the body by a pin (a bent nail in the prototype). It

is fiddly as the aileron/elevator also has to be held at the correct angle so that the roll pin being removed does not pierce the control surface shell. Once the roll pin is moving it slides out very easily.

The tool has to span differing hinge lengths of 30 mm, 35 mm and 42 mm. The holes in the main body assembly are drilled to suit these spans.

The feet are chiselled out at the 'instep' to suit the diameters of the hinge pin ends otherwise they will slip off when the bolt is being wound down and damage the aircraft finish. For Roll Pin insertion use another bolt in the tool with a flat ground end.

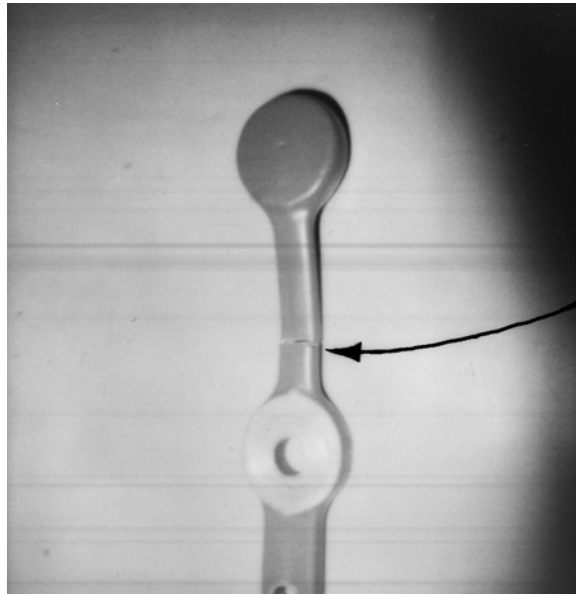
FIGURE 4 FAILED TRIM LEVER

4. Twin Astir Trim Lever Failure. The Twin Astir trim lever is cast aluminium with a plastic covering.

In one case a pin hole in the plastic allowed sweat to contact the aluminium which caused a corrosion spot which then propagated as a crack and the lever failed.

Crack and failure
from pin hole in
plastic

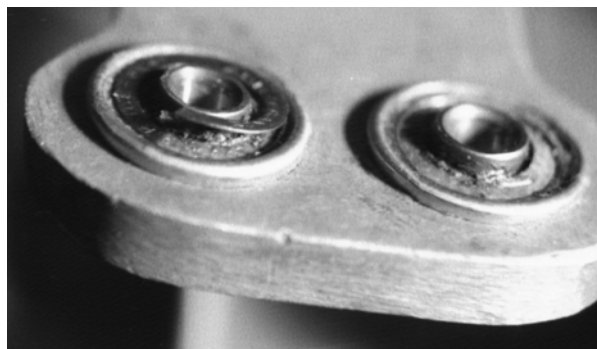
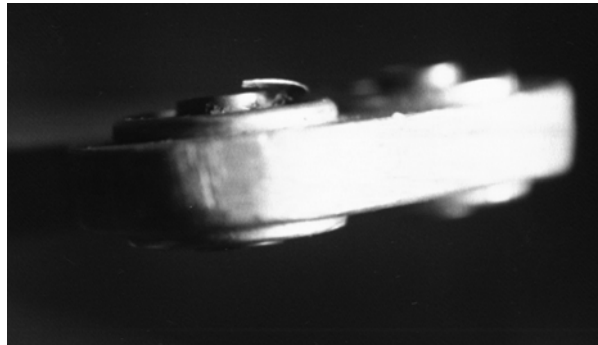
FIGURE 5 THE DISPLACED BEARING SEAL

5. Restriction of aileron control. During an Annual Inspection the metal seals on a number of control system bearings were prised out, apparently for the purposes of lubrication. These bearings are lubricated for life and require no routine lubrication. If a bearing seems to require lubrication it is faulty and should be replaced.

In the particular case someone tried to reinstall the seals and the end of the seal popped up and jammed the aileron circuit.

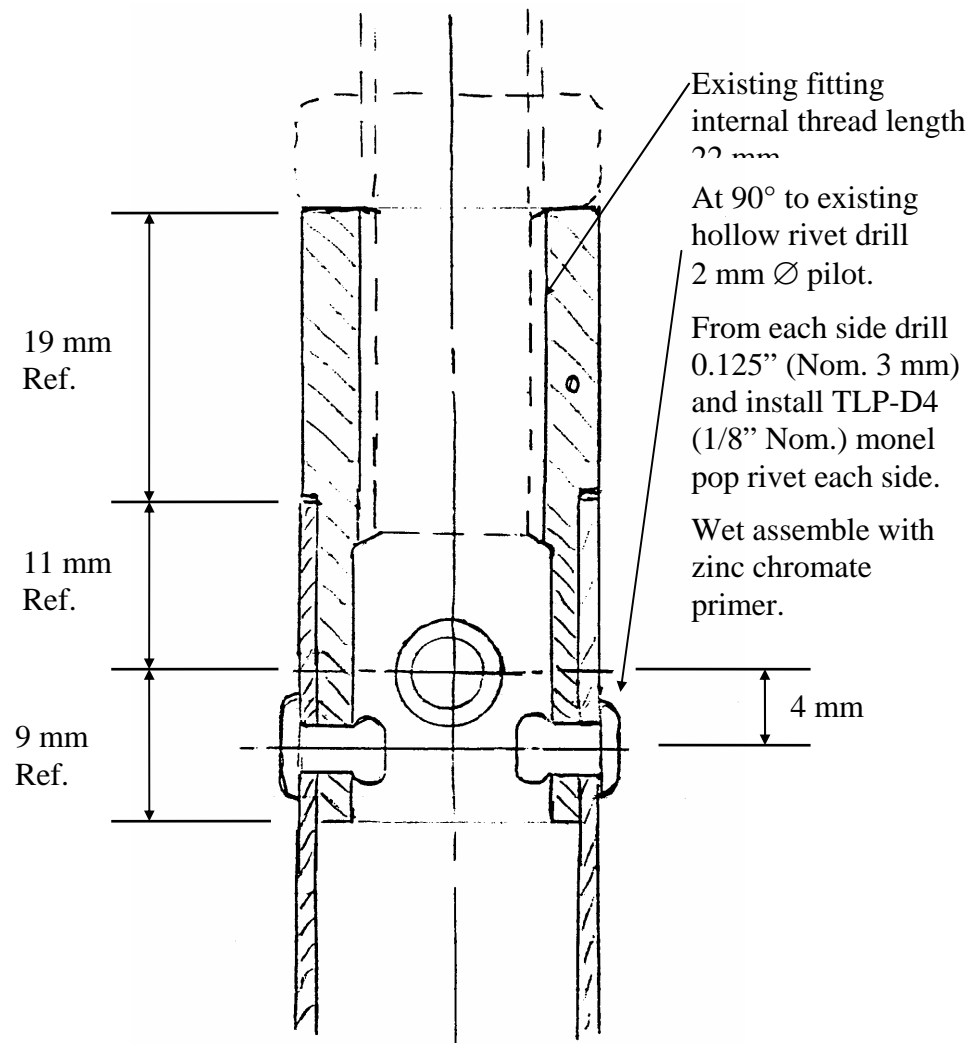
**FIGURE 6 LOOSE ROD END REPAIR SCHEME****APPROVED MODIFICATIONS:**

8. Loose elevator pushrod ends. A number of cases have been reported of loose elevator pushrod ends. The original design only used one tubular rivet to secure this part and so to remove slop a design involving the installation of two monel pop rivets has been developed by G. Sunderland.

Note: This repair scheme was developed for an Astir CS and if any difficulties are encountered then the CTOA should be contacted so that any necessary variations which may be required are recorded in this AN.
