GFA AN 71
(ISSUE 2)**AIRWORTHINESS ADVICE NOTICE**

TYPE AFFECTED: Mosquito, Mosquito B, Glasflugel 304

SUBJECT: Miscellaneous airworthiness information.

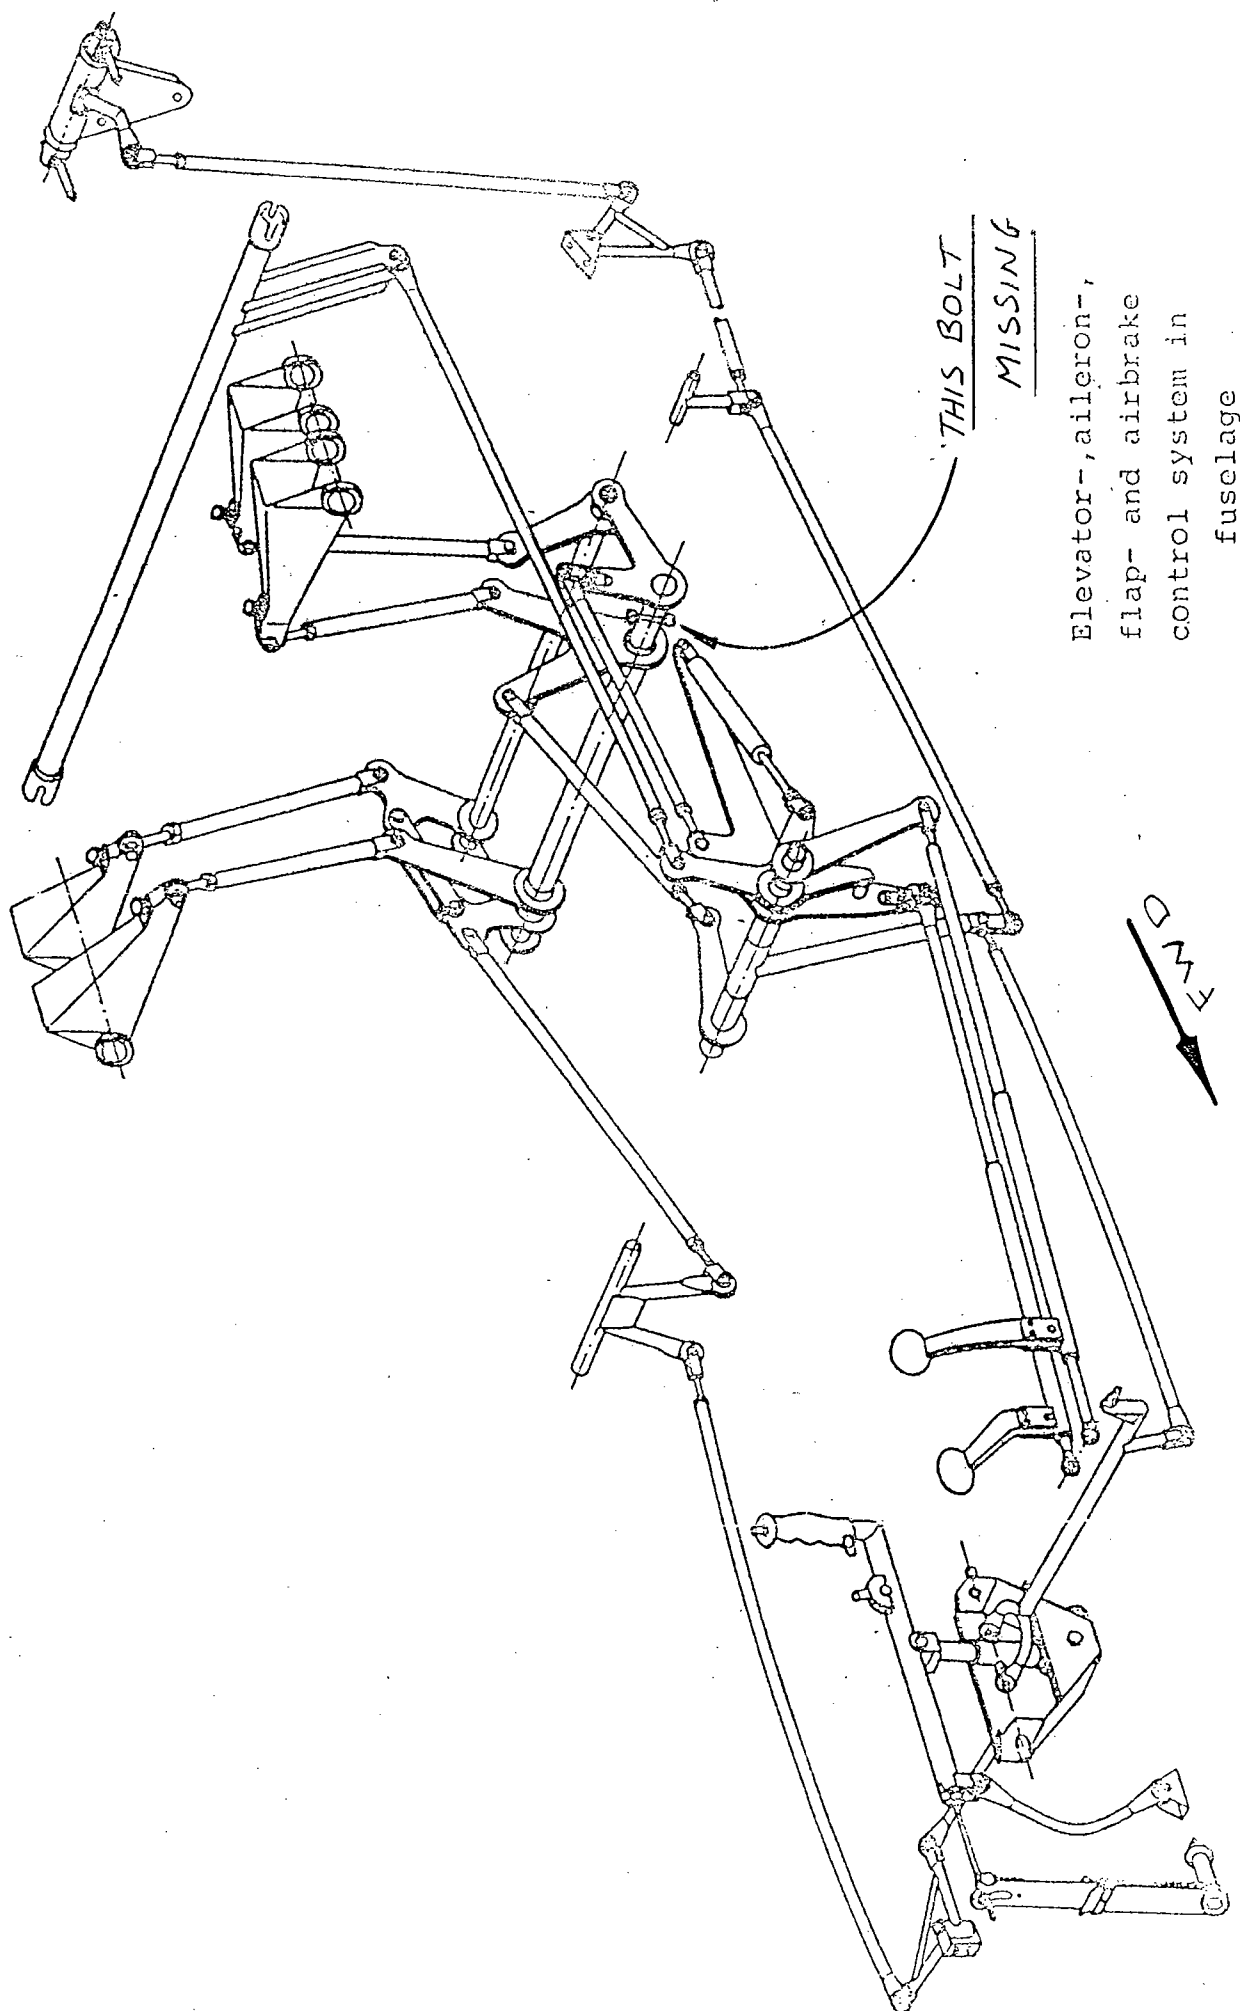
1. Aileron system. A Mosquito was flown for some time with aileron control response sufficiently sluggish to raise pilot comment but not such as to warrant investigation.

Eventually it was found that a bolt had been left out of the aileron circuit, as shown in the diagram overleaf, which effectively let one aileron hang free, except for friction through the torque tube. How the bolt came to be left out is not known, but the problem could have been detected if a proper DI control hook-up check had been carried out (one person operating stick, one person holding control surfaces).
