AIRWORTHINESS ADVICE NOTICE

TYPE AFFECTED: PIK-20 Series including PIK-20 E/EII.
SUBJECT: Miscellaneous airworthiness information.
BACKGROUND: This AN records airworthiness information which is useful to know.

For and on behalf of:		
CHIEF TECHNICAL OFFICER AIRWORTHINESS	THE GLIDING FEDERATION OF AUSTRALIA		
GFA AN 81	ISSUE: 4	12 November 2021	Page 1 of 7

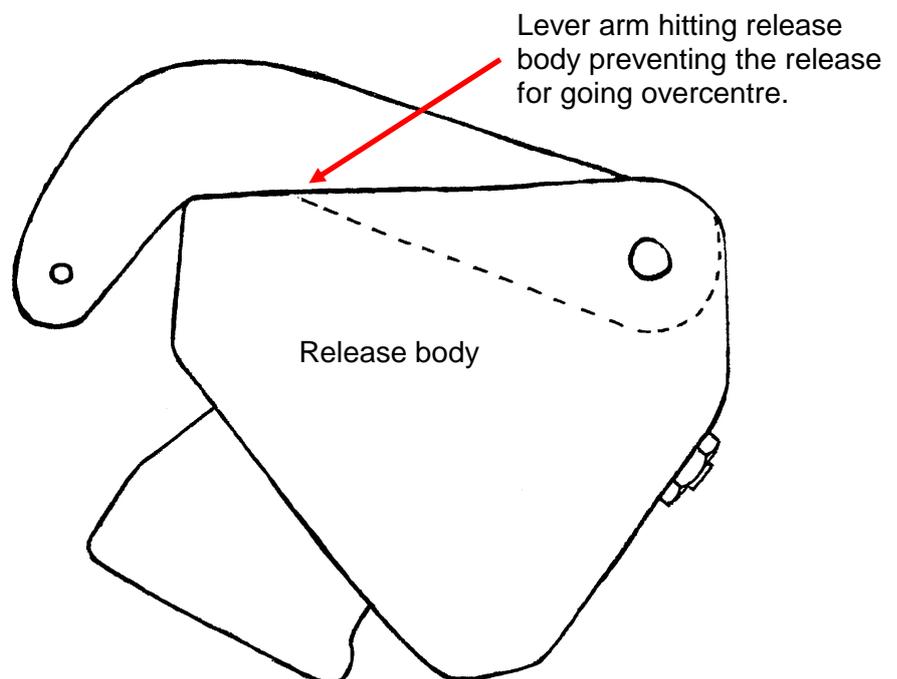
2. After adjusting the Tost release mechanism from a PIK-20D an inspector found that when the Pik lever arm was refitted to the release, it touched the back of the release body and prevented the mechanism from going overcentre.

Figure 1: Lever Arm Preventing Overcenter

The problem was rectified by careful removal of metal from the lever arm so that a small clearance was obtained between the arm and the release body.

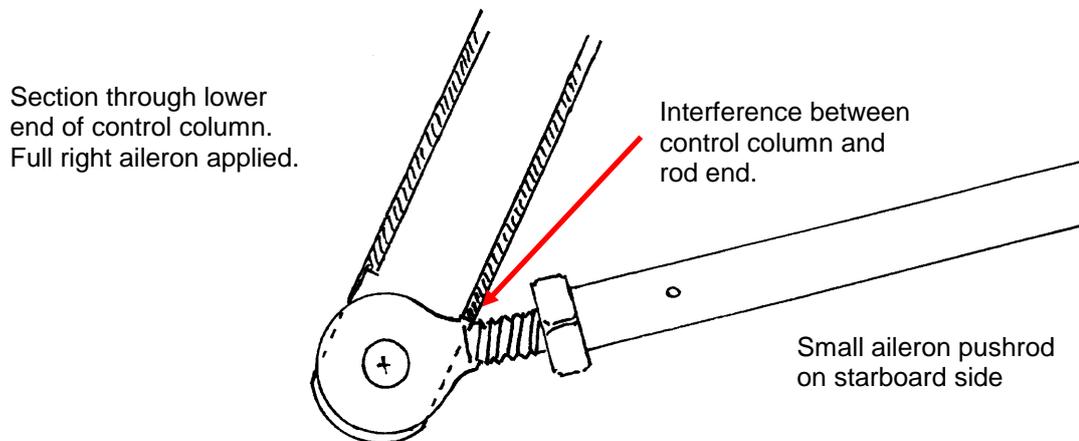
3. During the annual inspection of a PIK-20D, the lower part of the control column was found to be fouling the thread of a rod-end when full right aileron was applied.

Figure 2: Lower Control Column Demonstrating Interference at Cut Out

To remedy the situation the cut-out in the control column was enlarged.

NOTE: If a rod end is found bent, it must not be straightened but replaced with a new one.

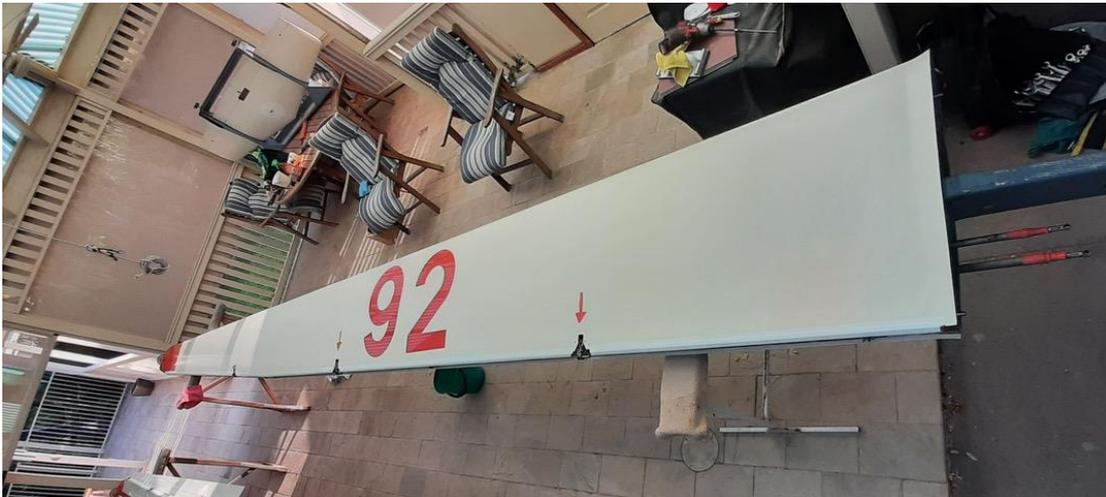
5. A Service Difficulty Report was received detailing circumferential cracking of two chrome plated flaperon pivot pin spigots on the right wing of a PIK-20E. The PIK-20 flaperon has three actuating pushrods with a corresponding spigot that forms part of the hinge. Two of these spigots on the right hand wing adjacent to the flaperon push rods had circumferential cracking (see red arrows on wing below). The cracks were only in the chrome and had not extended into the chrome molybdenum tubing. Despite this, all cracks are cause of concern and must be repaired or replaced as it is exceedingly difficult to determine the crack depth.

Figure 3: Inverted Stbd Wing Showing Location of Cracked Spigots

If a survey or deeper inspection has not been recently carried out, it is recommended a detailed inspection be performed at the next annual inspection.

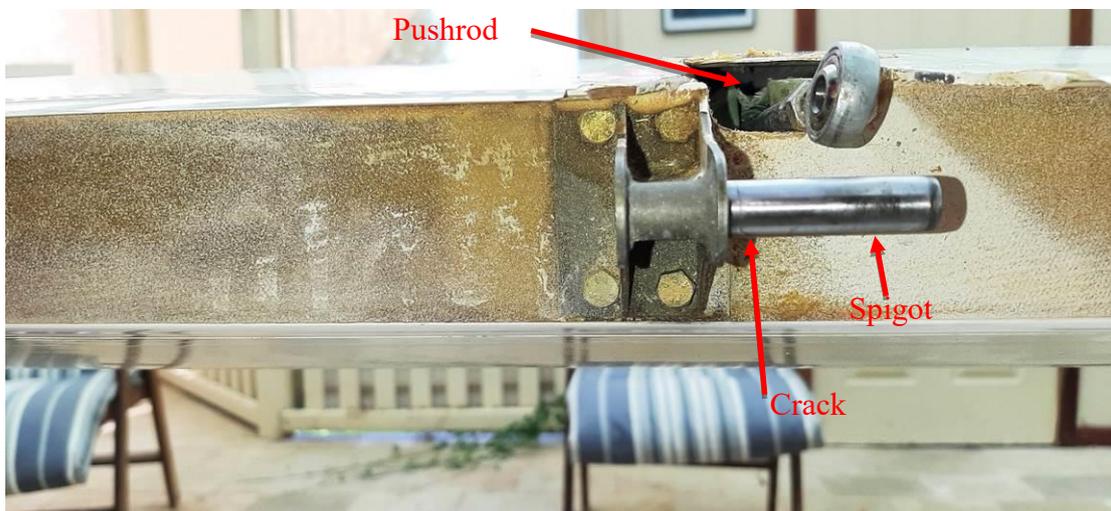
Figure 4: Detail of Cracked Spigot

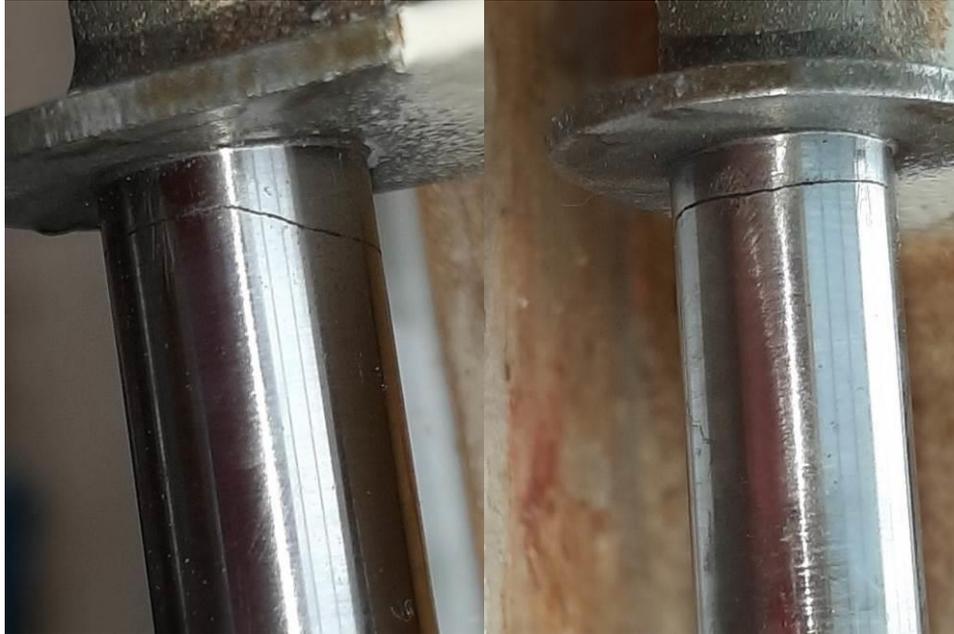
It appears there are three types of spigots fitted to PIK-20 variants. Some have bare chrome molybdenum spigots, others have chrome plated spigots and later PIK-20 E II variants have completely different design of chrome plated spigots. The design drawings make no mention of chrome plating. The GFA is aware of one PIK in England with similar cracking. .

Figure 5: Circumferential Cracking Of The Chrome Plating Near Base Of Spigot

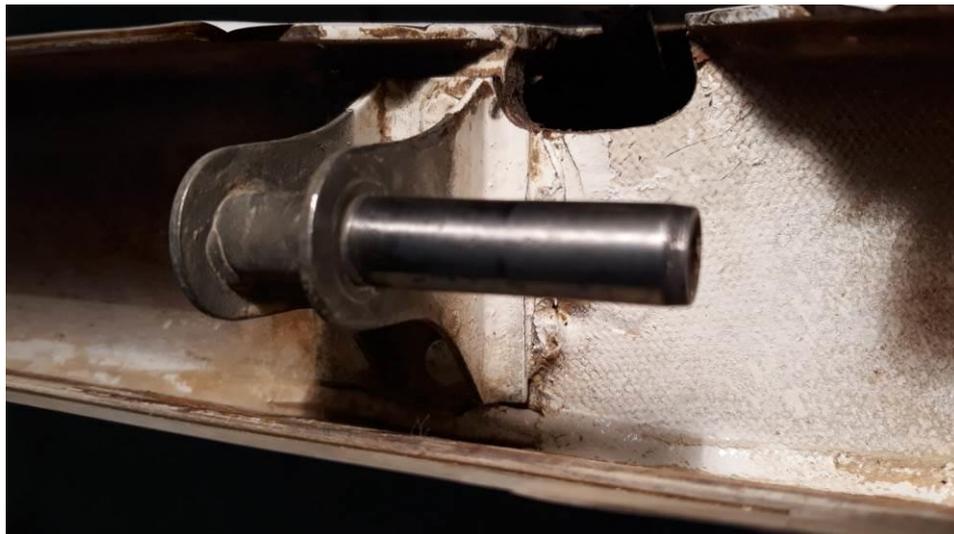
Figure 6: Spigot Without Chrome Plating

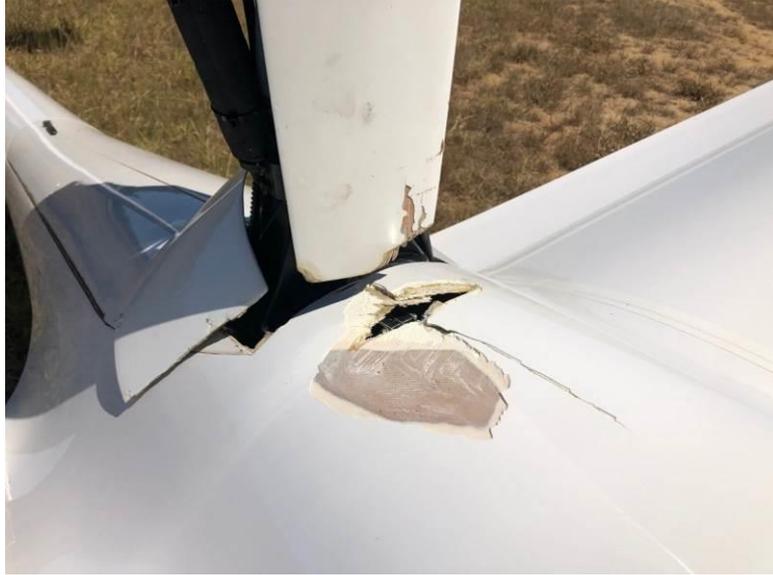
6. A PIK-20EII suffered a failure of the engine thrust stay cable resulting in the pylon and propeller moving forward and contacting the fuselage. The upper turnbuckle assembly failed due to fatigue, possibly after being bent and then straightened.

Figure 7: Damage to Upper Fuselage After Prop Strike From Broken Thrust Cable

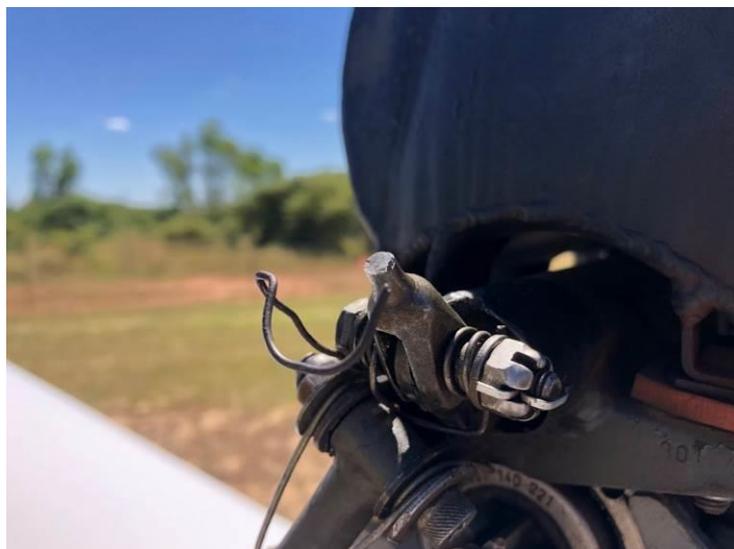
The cable when under full thrust load is taught, but when idling can be seen to oscillate. The cable tension figure is stated to be less than 200N (45 lbs) when retracted but no figure is given for rigging when the engine is fully extended. It is very possible that the tension will vary greatly between PIK-20E variants and therefore some cable assemblies may be subject to an increase in fatigue. Turnbuckles that have been bent must be replaced rather than straightened and reused.

Figure 8: Broken Turnbuckle Near Head of Engine Pylon

Some operators place a safety cable around the turnbuckle to mitigate any damage experienced with such a failure.

The cable assembly should be visually inspected at daily inspections and a deeper inspection using magnifying glass or other NDT methods at the annual. It is further recommended that the turnbuckle assembly is replaced any time the stay cable is replaced and the complete stay cable assembly be replaced at each life extension survey inspection.
