AIRWORTHINESS ADVICE NOTICE

TYPE AFFECTED: SZD-50-3 Puchacz.

SUBJECT: Miscellaneous airworthiness information.

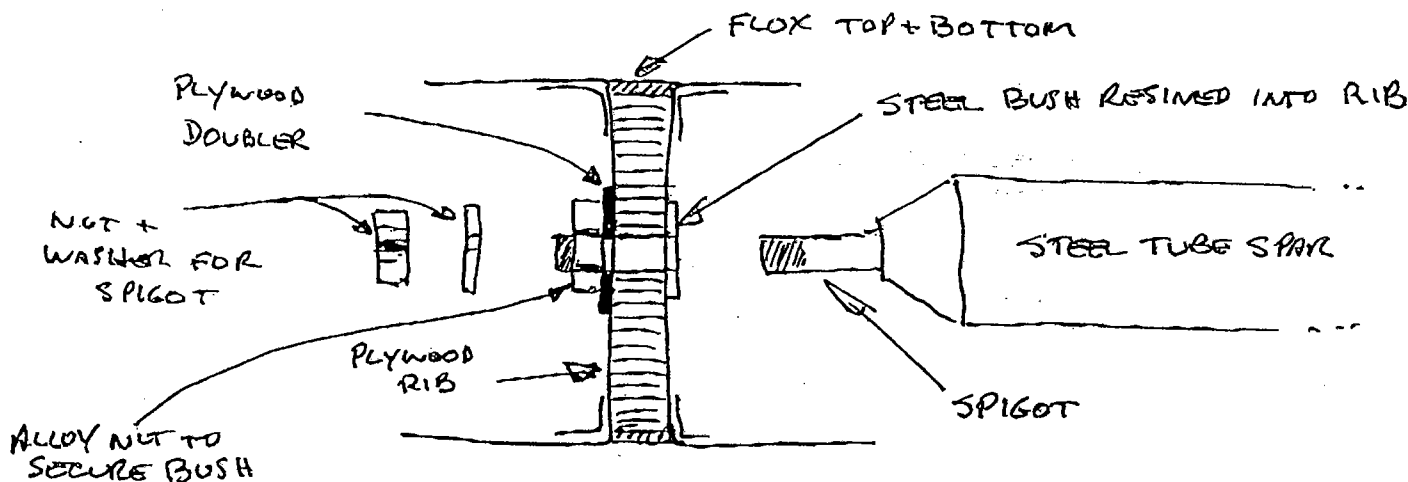
A defect has been discovered in the tailplane of one example of the Puchacz. Details and a sketch of the defect, provided by Tom Gilbert of T and J Sailplanes, are as follows:

The right tailplane half carries the tubular steel main spar, which is captive in the tailplane. A threaded spigot with nut is attached to a plywood rib 310 mm outboard of the root rib. This plywood rib is 8 mm thick and has a plywood circular doubler around the spigot attachment point. A steel bush is permanently fixed (with resin and a nut) in the rib. This is the attachment point for the spigot of the steel tube spar.

During an inspection it was noted that the steel spar in the subject glider could rotate within the tailplane. An inspection hole was cut in the rear shear-web for a boroscope. This showed that the rib was cracked chordwise, but not totally fractured, and the steel bush could rotate in the plywood (resin bond failed). During removal of the rib, broken "flox" was found between the rib and the outer skin.

It appeared that the steel spar had excess load applied span-wise. This may have occurred in a trailering accident some two years previously. The load cracked the rib and caused the resin bond with the bush to fail. This in turn allowed the main spar to rotate. The spar has to be in its correct rotational position for the locking pin to locate.

The rib was replaced, which required large access holes to be cut in top and bottom skins, together with some simple jiggling.

Recommendation. It is recommended that the tailplane be removed from the aircraft as soon as practicable and a check made that the tubular spar is secure in the RH half, i.e. that it cannot rotate. **Caution:** do not use excessive force when checking for rotation, or a problem could be caused which did not exist before. If a genuine problem does exist, it will be detected by applying a relatively light rotational force.

If a problem is found, the aircraft must not be flown and the GFA Secretariat should be notified as soon as possible.
