THE GLIDING FEDERATION OF AUSTRALIA

GFA AN 121
(ISSUE 1)

AIRWORTHINESS ADVICE NOTICE

TYPE AFFECTED: ES 59 Arrow.

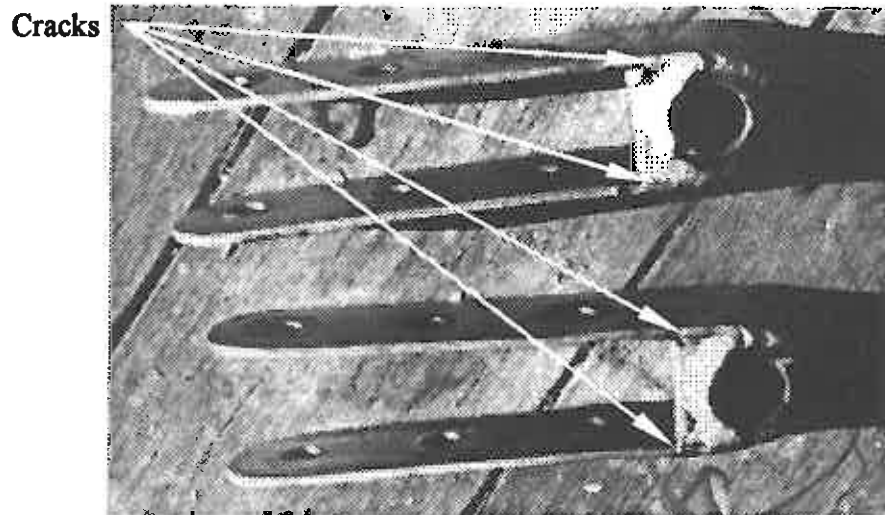
FIGURE 1 MAIN FITTINGS FROM FUSELAGE

2. **Main wing fitting cracks.** A number of cases have been reported of cracking of the main wing attachment fittings on both the fuselage and the wing at the places shown in Figures 1 and 2.

If these cracks are found then the cracks should be ground out and rewelded.

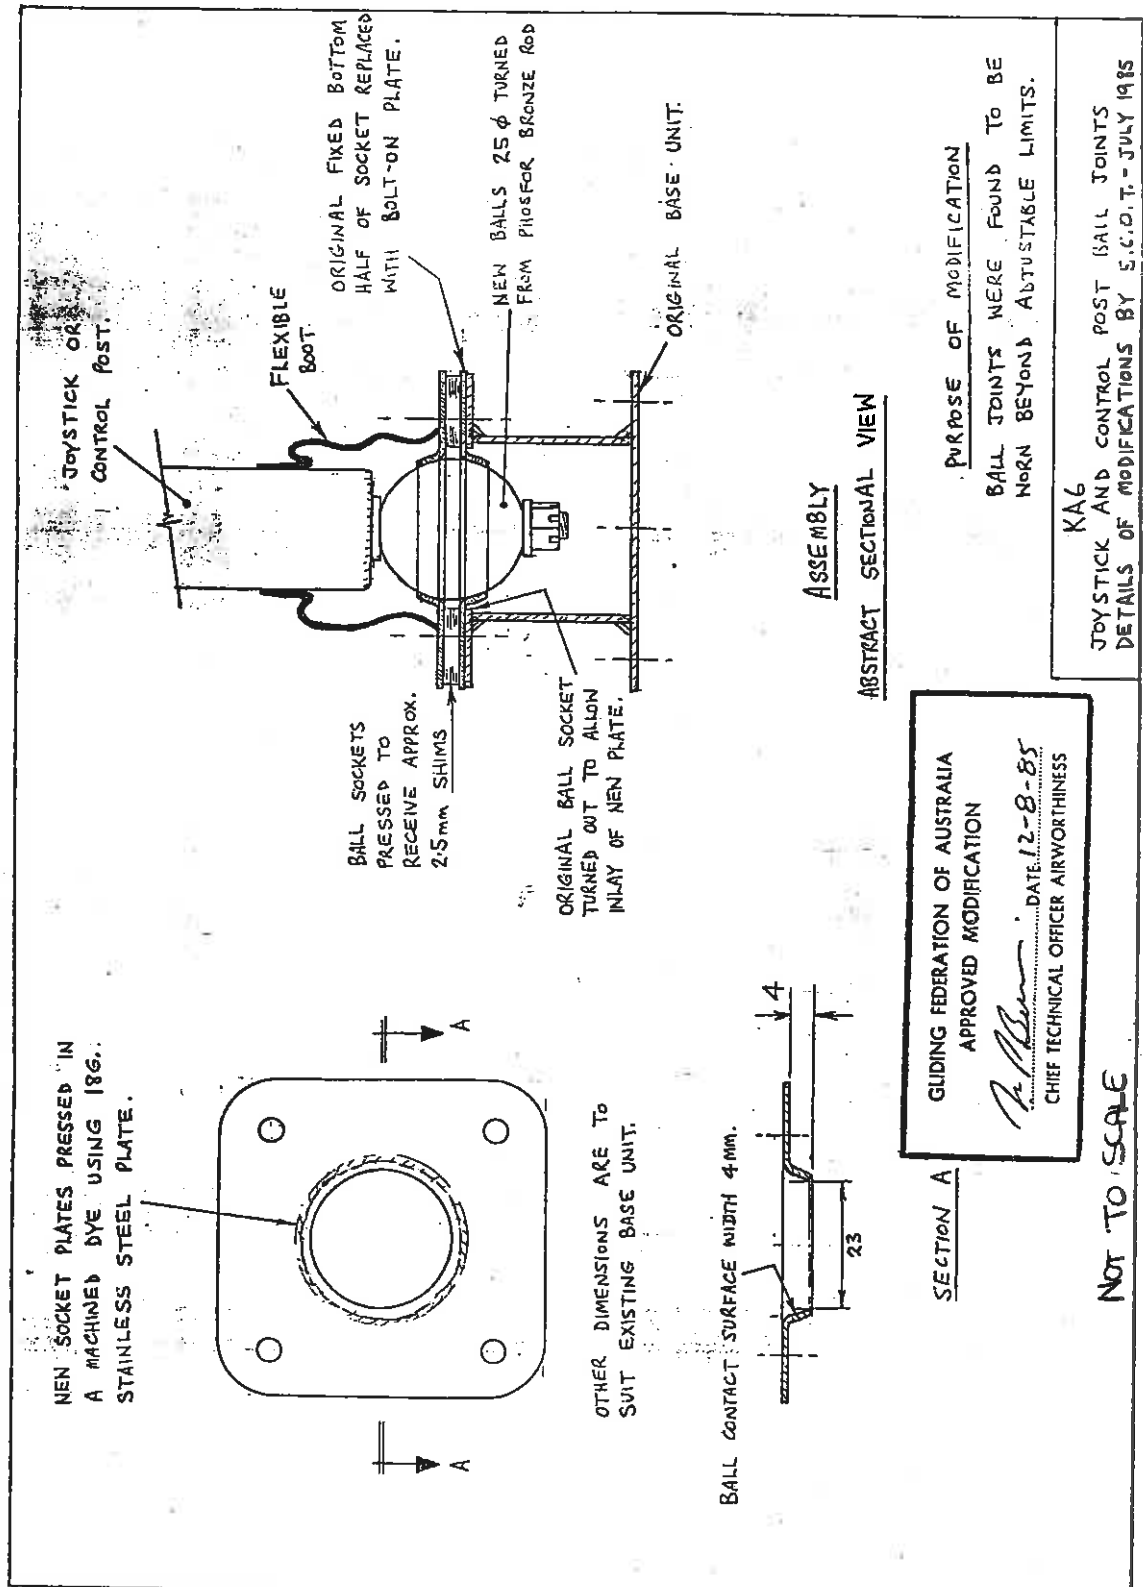
DRAWING 1

1. **Control Column Ball Joint.** The Ball joint at the base of the stick is prone to wear and if the wear is excessive the stick may pull out of the pivot or push through the lower plate which reduces available control travel.

One possible solution is to remanufacture the ball joint in accordance with Drawing 1. The GFA in conjunction with the owners of a ES 60 Boomerang is developing a new junction similar to that which is fitted to the K7/K13 sailplanes. When this Mod is completed this AN will be updated to provide drawings of the Mod.
