AIRWORTHINESS ADVICE NOTICE

TYPE AFFECTED: DG 500 / DG 1000 series gliders.

SUBJECT: Serious deterioration of airbrake arm ball bearings due to water ingress as a result of water collecting in the dive brake box.

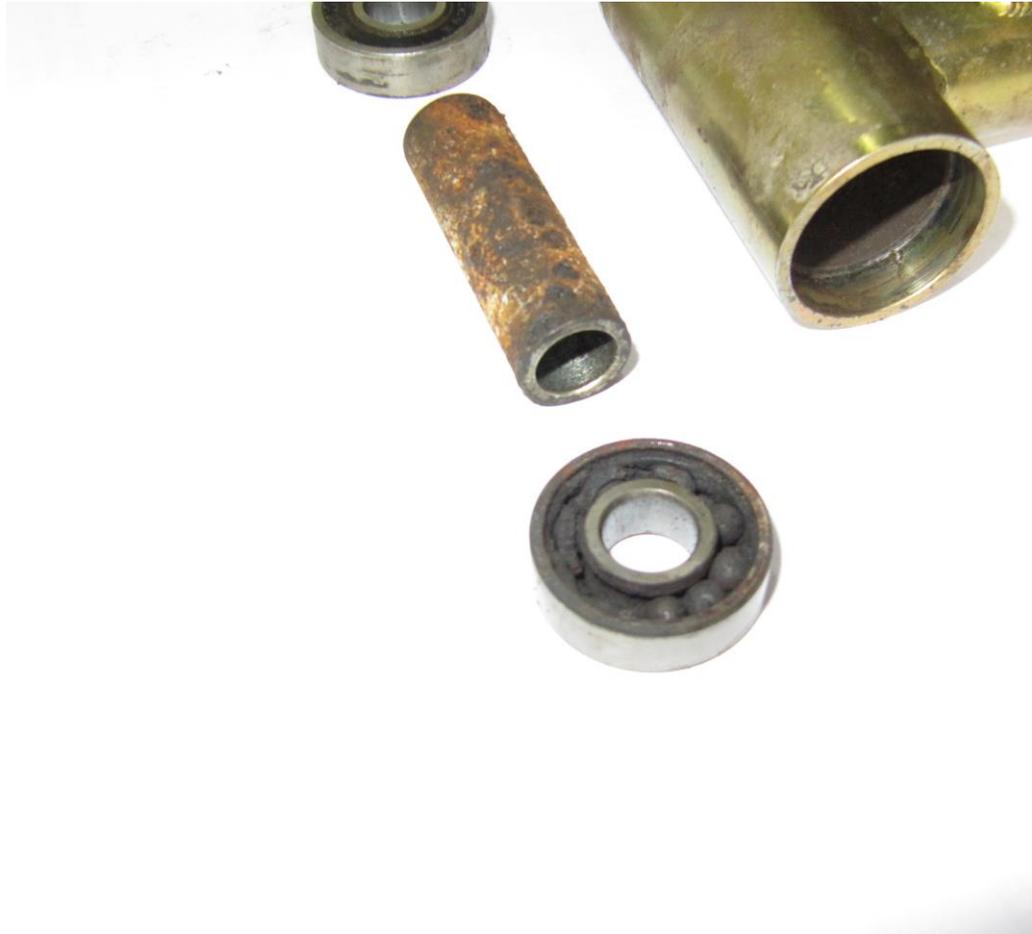
BACKGROUND: DG 500 glider VH-VMF serial number 5E251X80 was exhibiting increasing freeplay in the chordwise direction at the inner airbrake arms where the swinging arm attaches to the airbrake paddle. The problem was evident on both wings; freeplay with the airbrakes fully extended was of the order of 3 to 4 millimeters. The problem had become steadily worse over the period of a year. Removal of the swinging arm assembly revealed the problem as shown in the attached photograph. There was severe corrosion in the pivot arm ball bearings due to water ingress past the plastic face seal to the point where in places the bearing cage was nonexistent. The inner surface of the tubes which form the tunnels into which the bearings are pressed also showed corrosion.

A second report has been submitted detailing the same defect on another DG500 sailplane. The bearings reportedly also being submerged in water. Operators of DG500 and DG1000 need to be very aware of this potential for damage. The design of the airbrake box is such that any water entering the airbrake box will pool in the inboard end and submerge the bearings. There is no water drain located on the inboard end.

Damaged Dive Brake Pivot Arm Bearing and Corroded Spacer Tube Removed from DG 500 Glider VH-VMF

Warning, if the pivot assembly is severely corroded then it may prove difficult to remove the bolt intact. The bearings can be readily removed from the lever arm assembly. Replace any corroded bearings, remove any corrosion evident on the spacer sleeve and bearing tunnel tube and paint with Stits epoxy chromate primer. Re assemble the airbrake actuating arms into the glider. Repair the inspection openings made in the wing lower surface observing the repair procedures and materials specified in the manufacturer's manuals.
