AIRWORTHINESS ADVICE NOTICE

TYPE AFFECTED: SZD-50-3 Puchacz

SUBJECT: Miscellaneous airworthiness information.

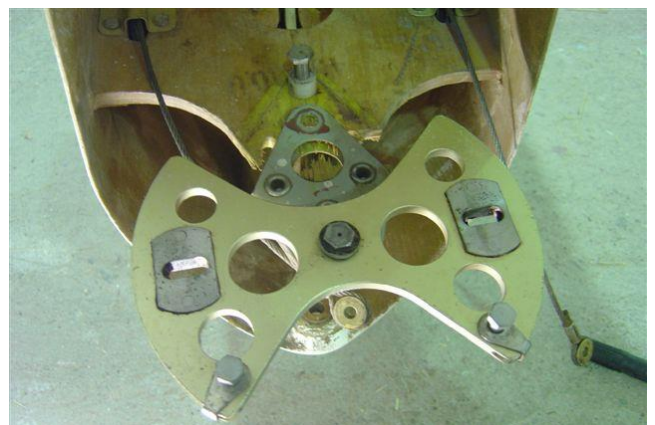
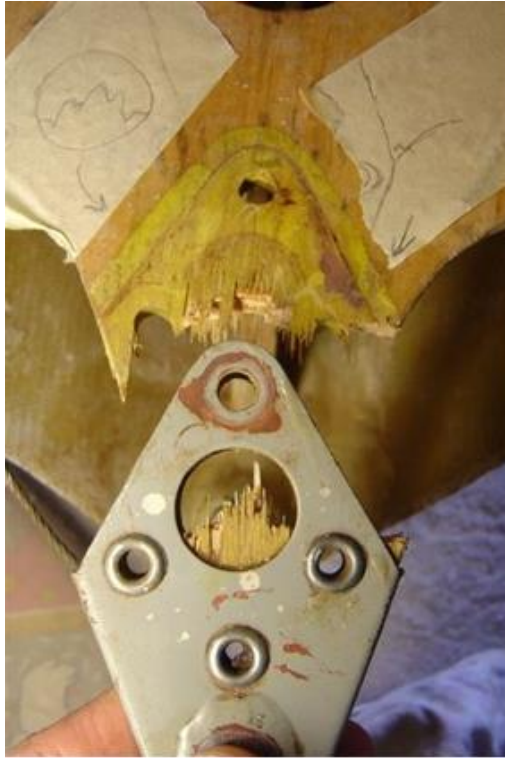
2. Damage to rudder support ply plate caused by incorrect rudder rigging.

During an annual inspection the ply plate at the base of the fin which supports the rudder drive quadrant mounting bracket was found broken. Inspection of a second aircraft revealed similar damage. AWA 2009-2 now cancelled was issued at the time.

The drive quadrant pivots on the steel brackets fabricated from two diamond shaped plates with side gussets & is attached to the plywood by three tubular rivets and an 8 mm bolt at the forward end. A nylon bush attached by this bolt serves as a rudder overtravel stop by limiting rotation of the drive quadrant. There are lightening holes in the upper & lower metal plates, through which the plywood is visible.

The failure occurred span wise between the tubular rivets on the left and right side of the bracket and may be visible in the lightening holes. It could be difficult to detect during an annual Form 2 inspection and would be virtually impossible to detect during a normal DI.

When the rudder cable circuit & pedal stops are correctly adjusted, the quadrant does not contact the rear stop, but incorrectly rigged rudder pedal stops could permit significant foot loads to be applied to the rear stop. This would be exacerbated by loose rear cables.

It is essential that the rudder system is correctly rigged, the primary rudder stops on the rudder pedals must positively contact at full rudder deflection. The Puchacz inspector must additionally be aware of the potential for hidden structural damage when performing inspection on this type.
