## ACCIDENT

| <b>Aircraft Type and Registration:</b> | Schempp-Hirth Nimbus-3 glider, G-EENN | |
| <b>Date &amp; Time (UTC):</b> | 4 September 2012 at 1233 hrs | |
| <b>Location:</b> | Portmoak Airfield, Scotlandwell, Kinross | |

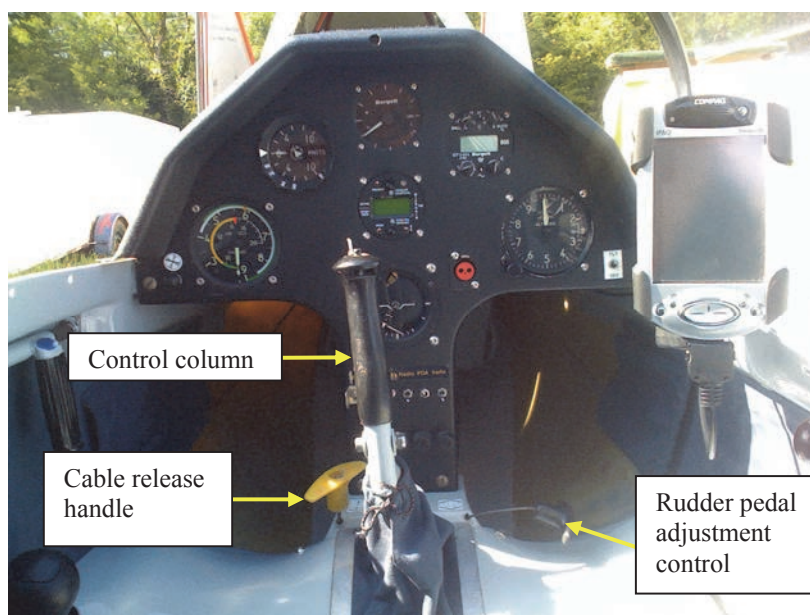
**Figure 1**

Photograph of the cockpit in G-EENN taken several years prior to the accident

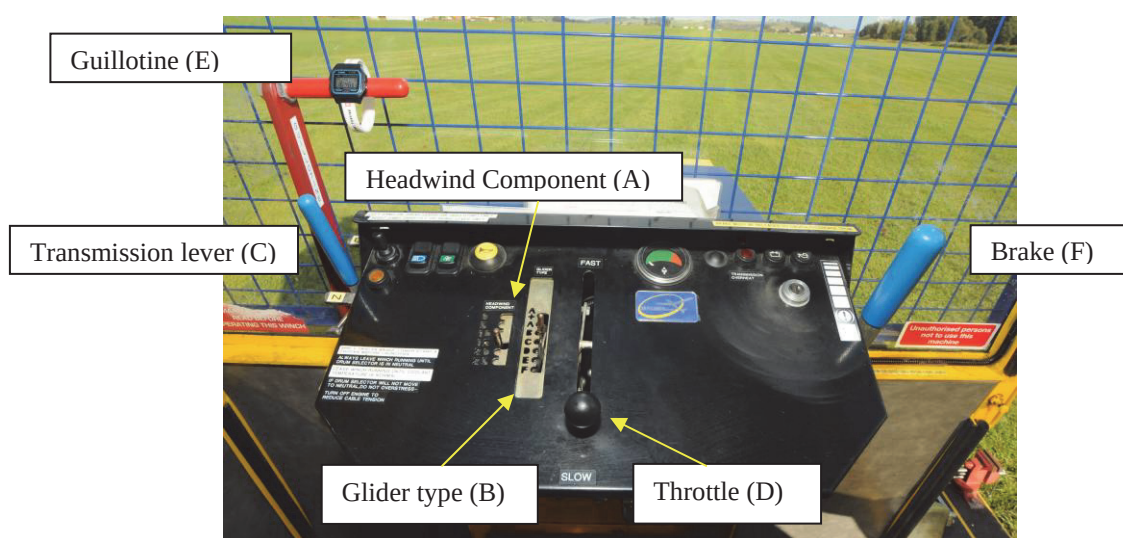
**Figure 2**

Following the accident, the preset for the headwind component was found to be set at 15 kt and the 'glider type' was set at 'B'. The weak link fitted to the launch

Winch controls

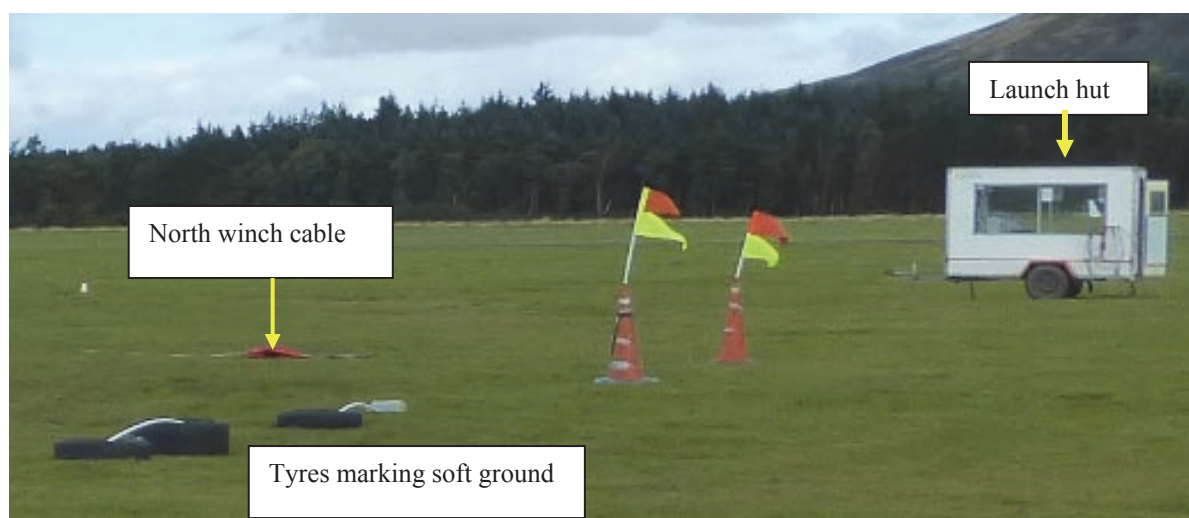
**Figure 3**

The winch cables were pulled to a position marked by two cones and flags with sufficient space for a glider to be launched from either side of the cones. An area of soft ground adjacent to the cones was marked by two tyres. G-EENN was launched from the southern position using the ‘south’ cable and from the ground marks it was established that at the start of the launch it was approximately 60 m from the launch hut. After the accident the ‘north’ cable, which was still in the position where both cables had been delivered, was found to be approximately 30 m north of the position from where G-EENN was launched (Figure 3).

Launch area at time of the accident, looking north-west

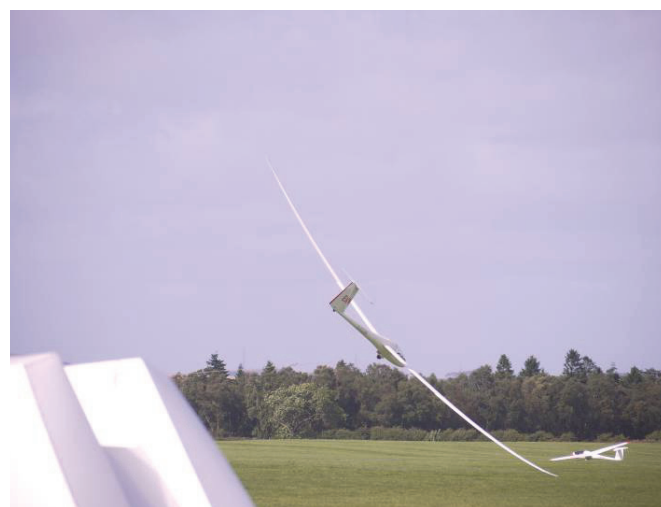
**Figure 4**

G-EENN, cable just released

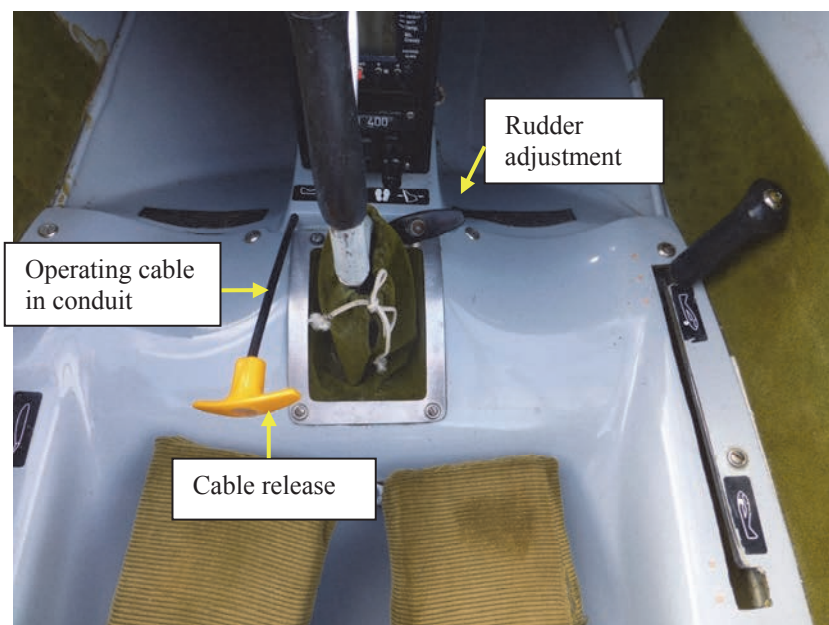
**Figure 5**

The winch cable release handle fitted to the test glider had a much longer operating cable, which was contained in a black conduit, than the handle fitted on G-EENN (Figure 5). Therefore the tests were carried out using the black rudder pedal adjustment handle, which although situated on the opposite side of the control column, was more representative of the winch cable release handle fitted on G-EENN. The pilot who operated the controls during the tests was approximately six foot tall and of average build.

Cockpit layout in glider used in test

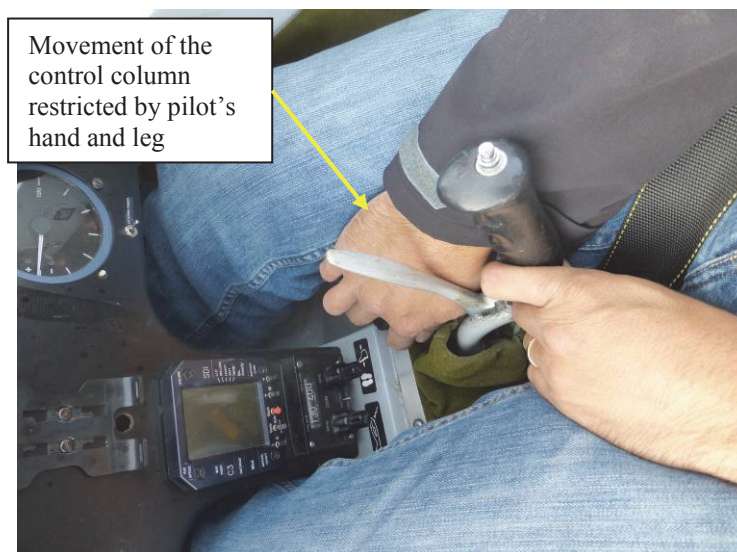
**Figure 6**

The tests showed that when the pilot kept his hand on the rudder adjustment handle, movement of the control column to the right was restricted by the control column making contact with his right hand, which was constrained by his leg (Figure 6). The maximum distance

that the control column could move corresponded to the aileron surfaces moving approximately 55% of their full range. When the test was repeated using the winch cable release handle equipped with the longer operating cable contained in the black conduit, the control column and ailerons could be moved through their full range of travel.

Movement of control column restricted by pilot's hand

It is recommended that the European Aviation Safety Agency amend the certification standard for Sailplanes and Powered Sailplanes (CS 22) to include the requirement that the cable release mechanisms can be operated at any stage of the launch without restricting the range of movement of any flying control.

It is recommended that the European Aviation Safety Agency require that Type Certificate holders of EASA Type Certificated gliders ensure, where practicable, that the cable release control can be operated at any stage of the launch without restricting the range of movement of any flying control.

It is recommended that the British Gliding Association ensure that, where practicable, the cable release control on EASA Annex II gliders can be operated during any stage of the launch without restricting the range of movement of any flying control.

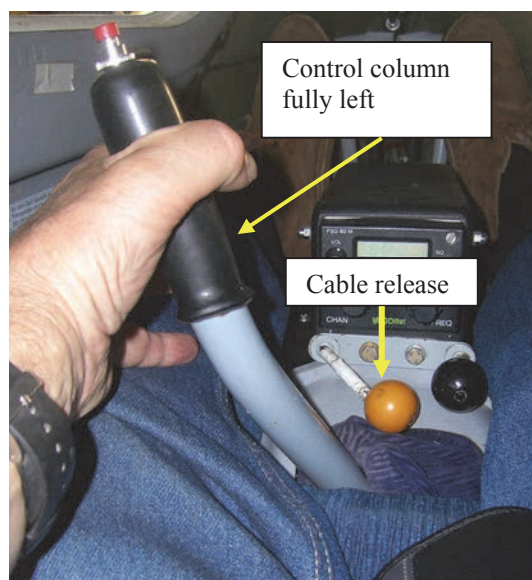
**Figure 7**

Figure 7 shows the location of the cable release on a Schleicher ASW 19 glider, which has a similar arrangement to the ASW 20L. The photograph was taken with the control column in the full left position.

Location of cable release on ASW 19 glider

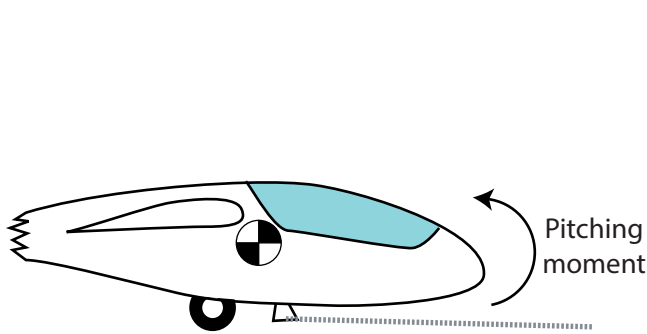
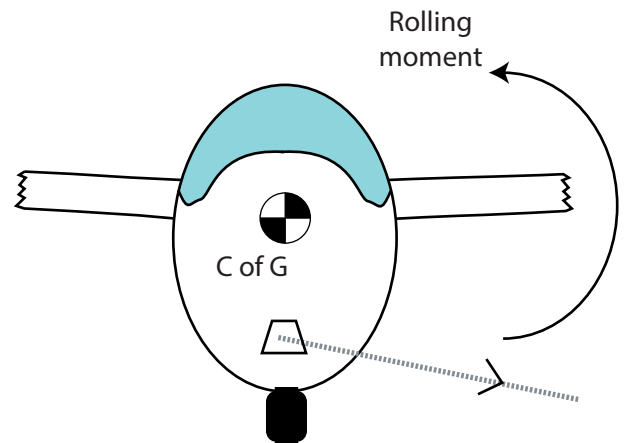
### Figure 8a and 8b

The hook used for winch launching is normally located below and forward of the glider Centre of Gravity (C of G) (Figure 8a). If the hook is located along the centre of the lower fuselage, then during the launch the force on the cable will initially attempt to rotate the glider nose upwards about the C of G. If the hook is off-set from the centre line, or the winch cable is set at an angle to the glider's heading, then there will be an additional rolling moment during the launch once airborne (Figure 8b). In general, the greater the misalignment between the glider and the winch cable the greater the rolling moment.

Location of winch hook

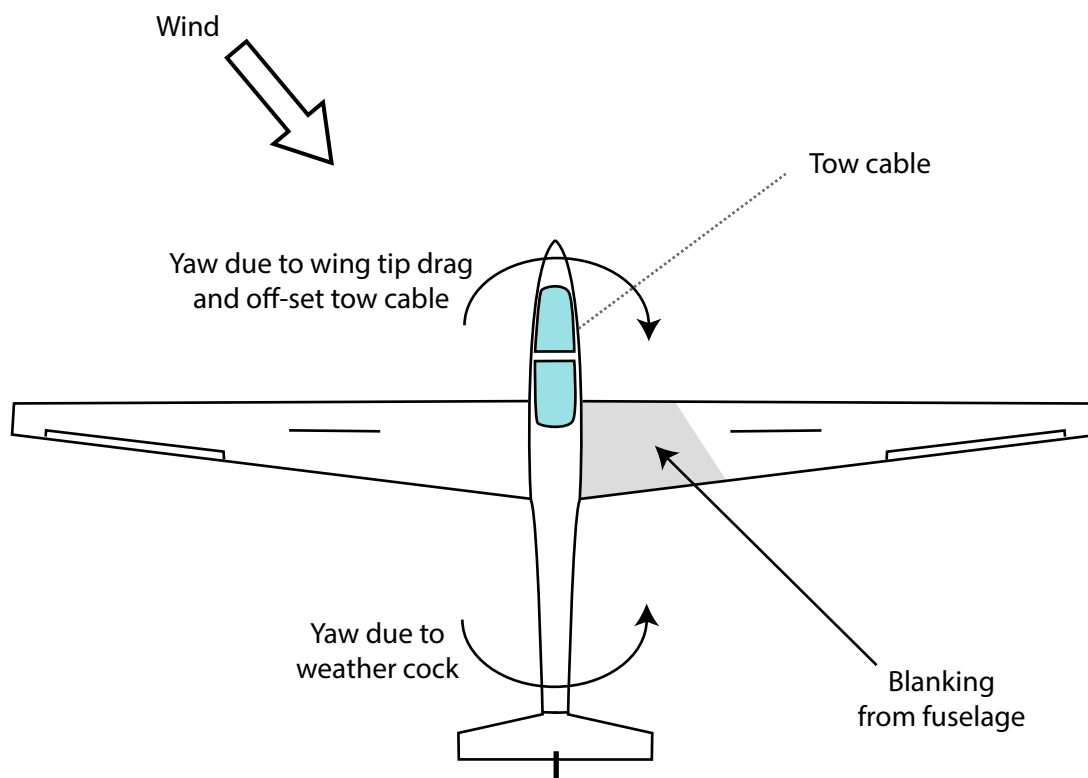
**Figure 9**

A wing drop accident can be considered in two phases; start of launch and weight-off the main wheel. In this example the release hook is mounted along the longitudinal axis, there is a crosswind from the left, the winch cable is offset to the right and the right wing tip is on the ground (Figure 9).

Example of winch launch dynamics

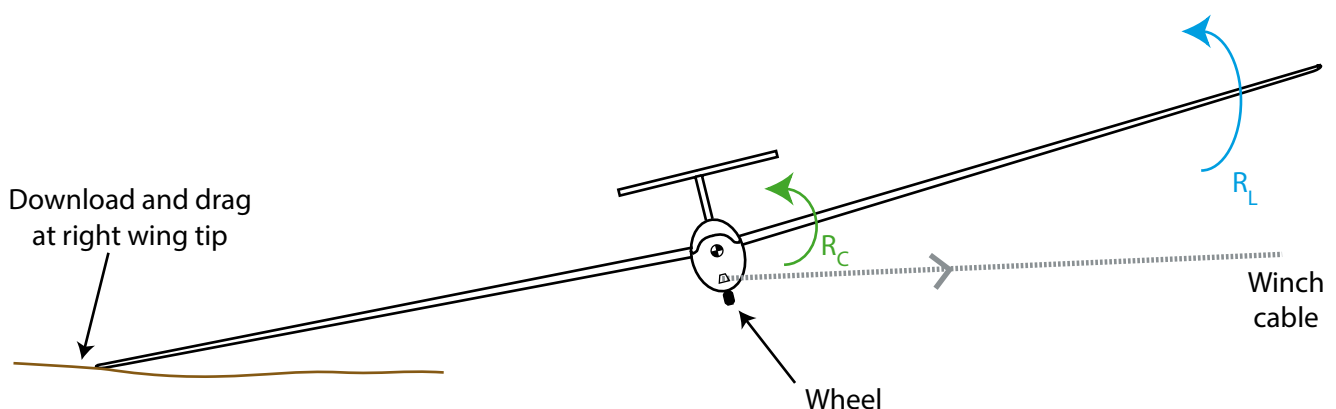
**Figure 10**

With a modern winch the weight will come off the main wheel approximately three to four seconds after the start of the launch sequence. With the main wheel off the ground, and the winch cable offset from the glider's heading, the force from the winch cable will introduce a rolling moment ( $R_c$ ) about the glider's C of G (Figure 10).

This rolling moment acts in addition to the aerodynamic effects ( $R_L$ ), and further increases the down load and drag on the right wing tip. The risk of an accident and injury to the occupants will have substantially increased.

Rolling moment due to offset winch cable
