# AIRWORTHINESS DIRECTIVE

## THE GLIDING FEDERATION OF AUSTRALIA

### GFA AD 678 Issue 1

| <b>Subject</b> | Increased risk of flutter of the tailplane and degraded security of tailplane attachment caused by loose bolts in the tailplane attachment bracket assembly and the tailplane control horn. |

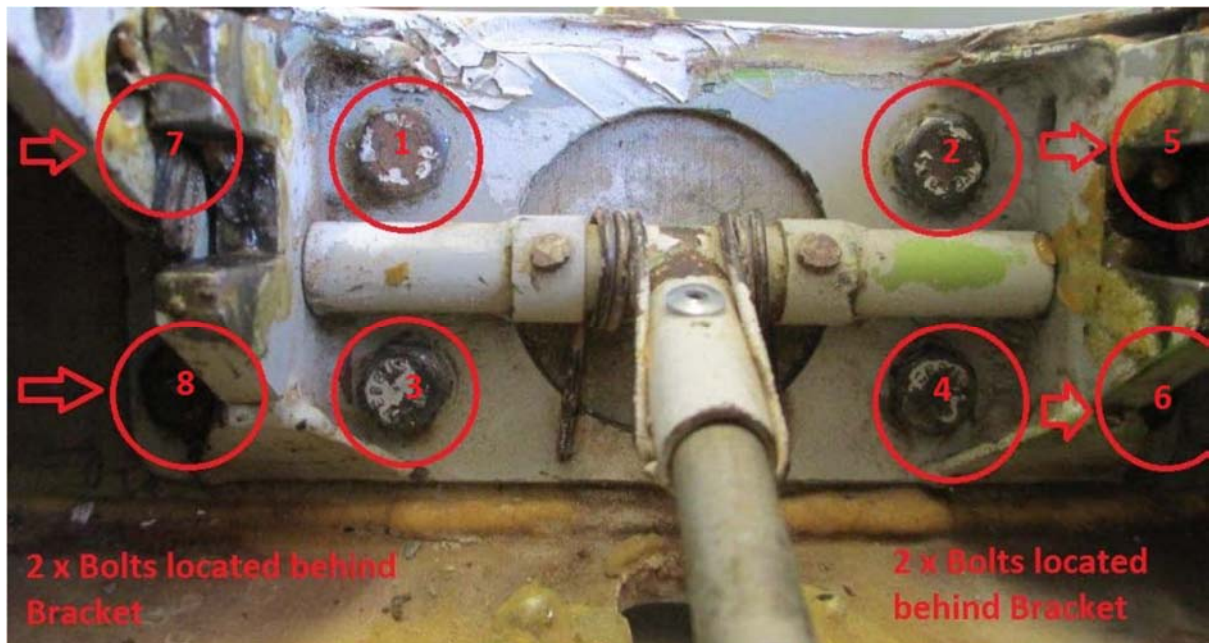
Figure 2. Locations of bolts to be inspected for "Style A" attachment bracket to all-flying tailplane.

"Style A" consists of a tailplane attachment bracket fitted into the tailplane recess and attached to the tailplane by 8 Bolts passing through the tailplane spar. These are the bolts referred to in this Airworthiness Directive for "Style A" and their locations are shown in figure 2.

"Style A" is NOT affected by loose bolts at the control horn. For "Style A", the bolts to be inspected are the bolts fitted to the tailplane attachment bracket only, **NOT** the bolts fitted to the control horn. There are 8 bolts to be inspected for "Style A".

When testing for looseness of the 8 bolts, only a minimum torque is to be applied in a clockwise direction to determine looseness. **DO NOT** apply excessive torque to the bolt heads during the testing process. Loose bolts previously found have turned easily. Applying excessive torque may damage the spar by compressing the wood fibres.

If a bolt resists turning, as described above, the bolted attachment is considered serviceable.

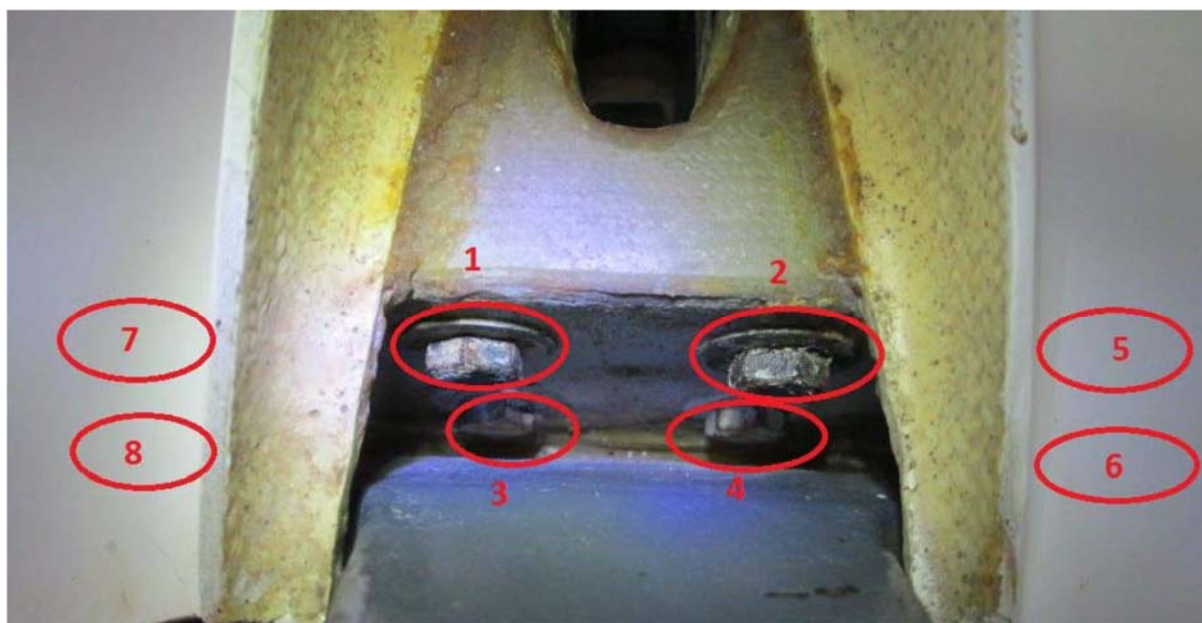
*Figure 3. Locations of 8 of the 12 bolts to be inspected for "Style B"*

"Style B" consists an attachment bracket fitted into the tailplane recess and attached to the tailplane by 8 bolts that pass through the tailplane spar. These bolts are 8 of the 12 bolts to be inspected for "Style B" as referred to in this Airworthiness Directive. The locations of these 8 bolts are shown in figure 3.

For “Style B”, the bolts to be inspected are the 8 bolts fitted to the tailplane attachment bracket **AND** the 4 bolts fitted to the control horn. There are 12 bolts to be inspected for “Style B”.

When testing for looseness of the 8 bolts, only a minimum torque is to be applied in a clockwise direction to determine looseness. **DO NOT** apply excessive torque to the bolt

heads during the testing process. Loose bolts previously found have turned easily. Applying excessive torque may damage the spar by compressing the wood fibres.

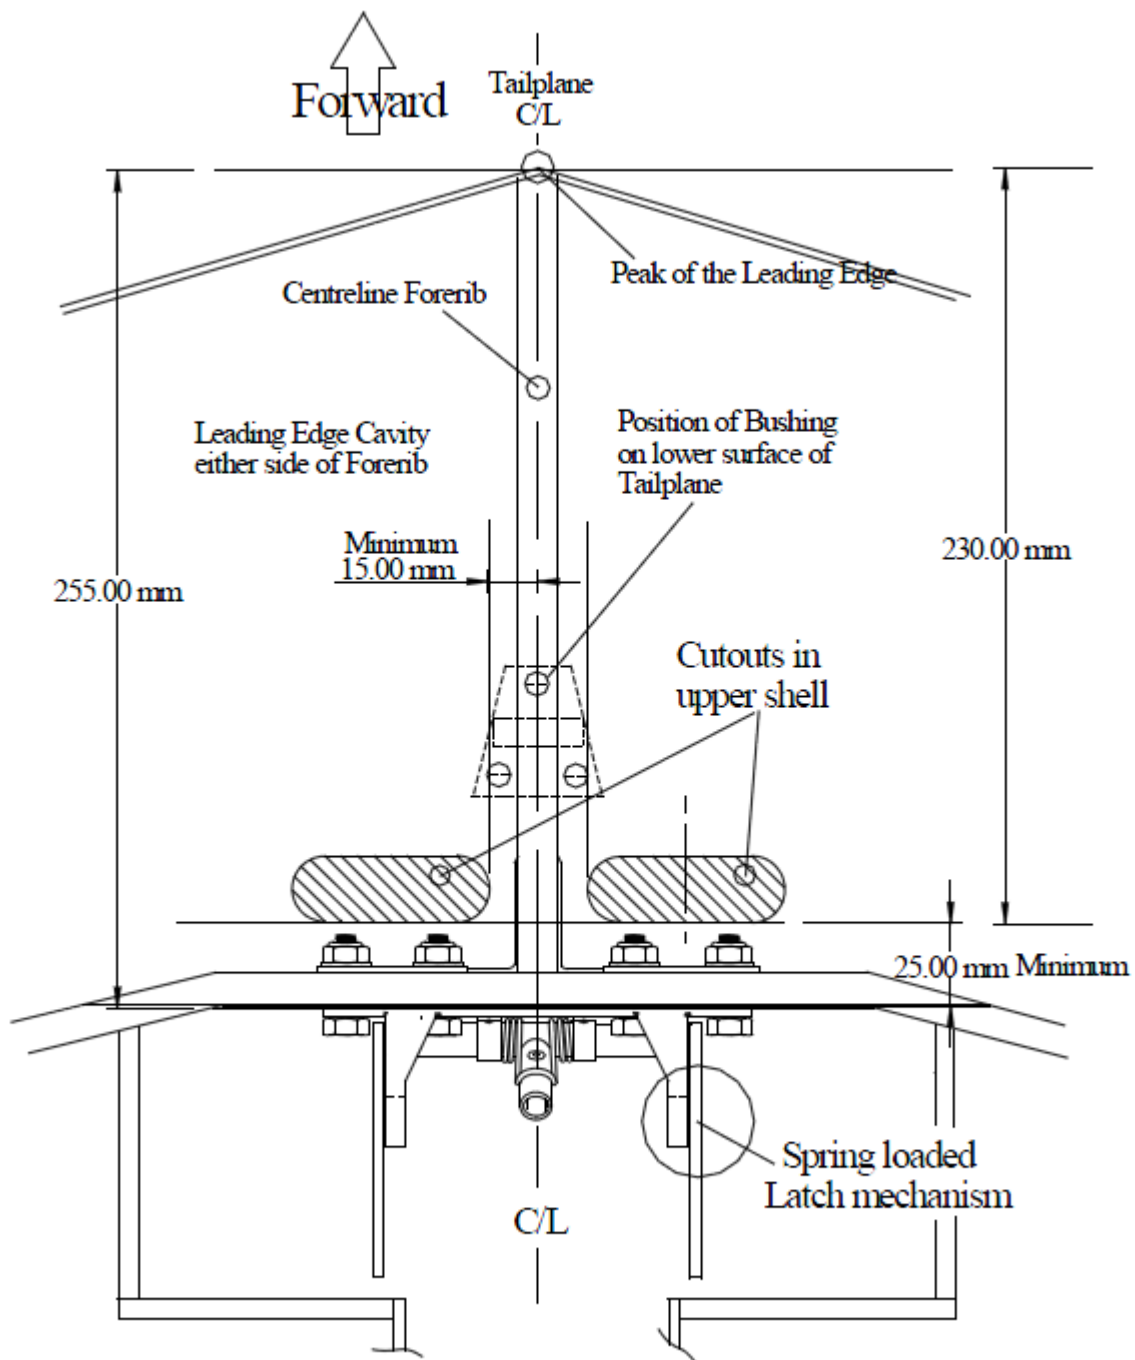
1. Style "A" - Tailplane Attachment Bracket with spring-loaded latch - 8 Bolts:

Plan View looking down onto the top surface of the Tailplane, guidance dimensions, structure and hardware shown.

Choose the dimension of the cut-outs so that a suitable tool can be used for securing the nuts.

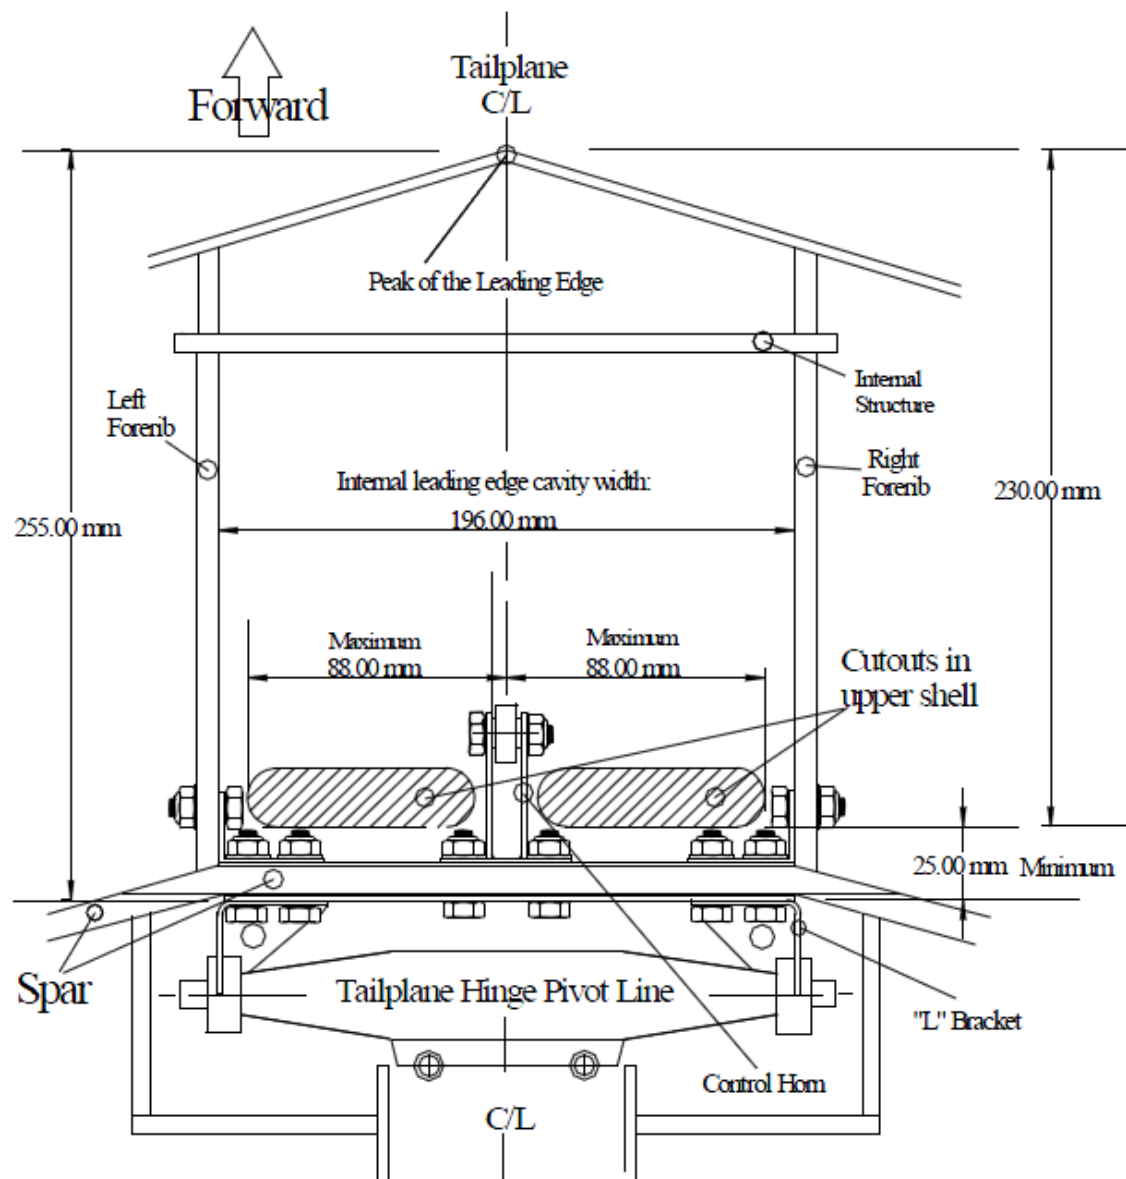
2. Style "B" - Tailplane Attachment Bracket with Bushed Arm and Control Horn - 12 Bolts:

Plan View looking down onto the top surface of the Tailplane, guidance dimensions, structure and hardware shown.

As can be seen from the structure drawing above, the outer pairs of bolt heads on Style "B" will be difficult to reach, especially as some aircraft may have "T" Brackets at the ends of the installation instead of "L" brackets. If bolts are positioned behind the upright of a "T" bracket, they will be difficult to reach and cutouts in the shell will be required.

Choose the dimension of the cut-outs so that a suitable tool can be used for securing the nuts.
