*The Gliding
Federation of
Australia Inc.*

AIRWORTHINESS SAFETY ALERT
ASA No. 01/13
8th OCTOBER 13

Increased risk of flutter and poor security of tailplane

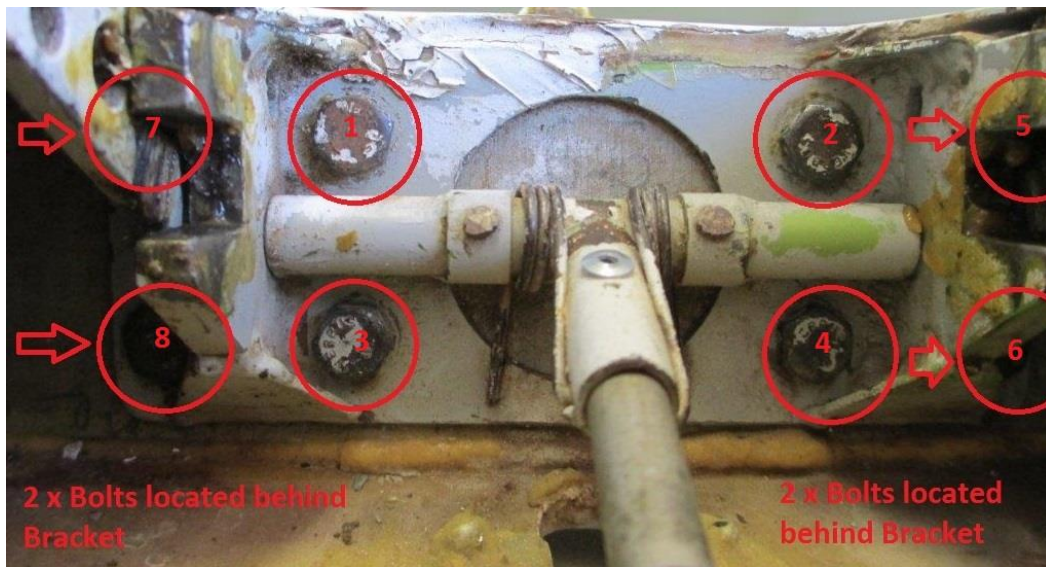
Figure 1 – Tailplane attaching style A

Investigations into loose tailplane attaching bolts on the 5th and 6th of October have discovered that due to very dry conditions experienced in Australia recently, the wooden tailplane spars have shrunk slightly allowing the attaching bolts that mount the tailplane to the fuselage to become loose. The bolts are retained by nuts at the rear of the spar however these are not captivated and spin freely. Access to these nuts is not possible without cutting holes in the fibreglass. This prevents the bolts from being torqued to the correct specifications.

Schempp – Hirth have two different methods of attaching tailplanes in this generation of sailplane, and both methods have been found to exhibit the same problem. Of 6 aircraft inspected (Both Cirrus and Nimbus 2) 5 were found to have this issue, with varying numbers of loose bolts. One aircraft was found to have all 8 bolts loose.

There are 8 x bolt/nut combinations that affix the tailplane to the fuselage. Both methods are shown below in Figures 1 and 2 on page 2 of this alert.

1. A GFA 'Form 2' authorised FRP Annual Inspector is to remove the tailplane and inspect the attaching bolts for security. If more than two bolts are found to be loose the aircraft is rendered un-airworthy and a Major Defect is to be placed in the Maintenance Release of the aircraft. If two adjacent bolts (in any combination of 1-4 in the photos) are loose the aircraft is also rendered un-airworthy.
2. If no loose bolts are discovered, an entry in the Minor Defects section is required to alert pilots that this inspection has been conducted and that a Safety Alert has been raised for the aircraft. Subsequent inspections are required in accordance with item 1 every month until the Airworthiness Directive has been promulgated and actioned accordingly.
