## GFA AIRWORTHINESS DIRECTIVE

SUBJECT: Extension of service life to 6000 Flight Hours.

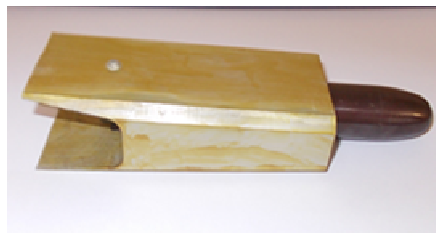
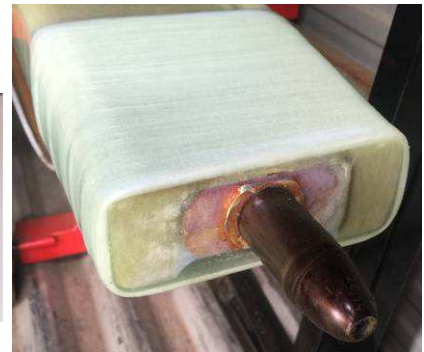
Recently GFA has found a Jantar where the pins were replaced prior to 1989 with old style pins, and signed off on this AD. It was therefore not safe from pin failure and required the new pins. The Registered Operator must check all Jantars for date of pin replacement and that pins from pre-1989 are the new style. Visible on derig, no destruction.

1. Before next flight; For gliders listed in 1,2 and 3 above that have had their spar spigot pins replaced prior to October 1988, irrespective if AD 304 has been acquitted in the glider logbook, carry out the following inspection. With the glider de-rigged perform a detailed inspection of the end face of the wing spars. If the new style of spigot pin is fitted the front face of the aluminum block should be visible. Picture below shows the new style spigot pin installed per PZL Bielsko Service Bulletin BE-037/89. If it can be determined that the new style pins are fitted then reference this inspection in the glider's logbook and no further action is required. If the original style spigot pins are installed carry out the requirements of step 3 below.

3. Prior to reaching 3000 flight hours the gliders listed in 1, 2 and 3 above must have their spar spigot pins replaced in accordance with PZL Bielsko Service Bulletin BE-037/89.
