The Gliding Federation of Australia Inc

Occurrence Summaries

01/01/2016 to 31/12/2016

The Gliding Federation of Australia Inc
SOAR Accident and Incident Occurrences

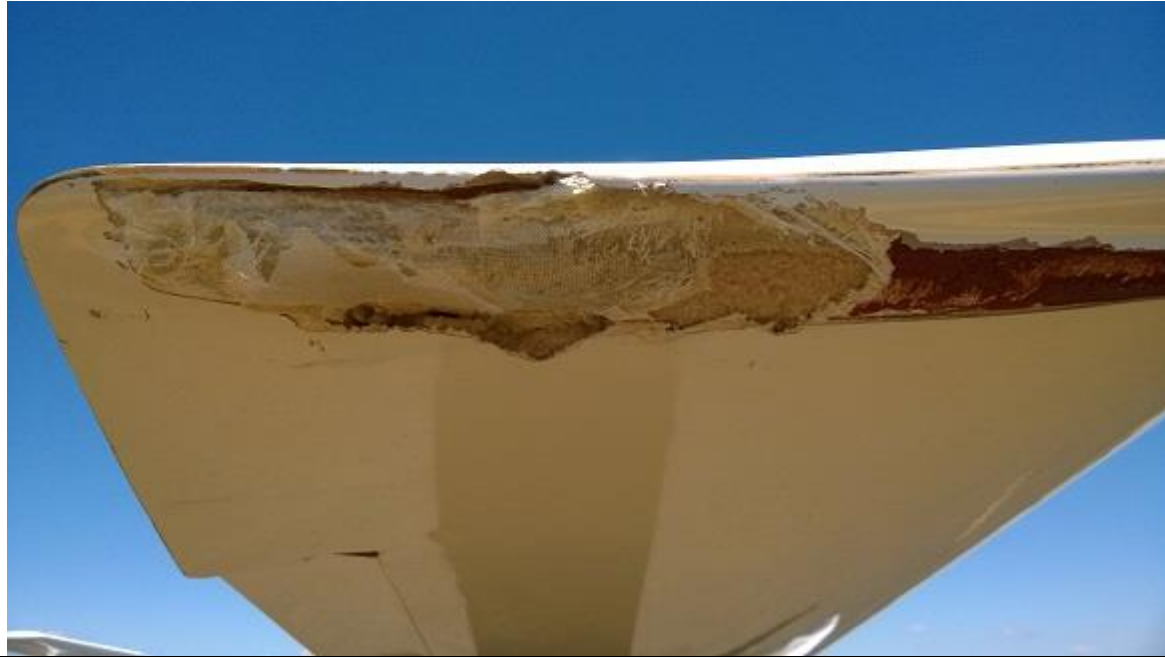
After preparing his glider for flight, the pilot untied the 'tie-down' ropes but failed to remove the rope from the hole in the starboard wing tip skid. The glider was attached to the vehicle and as it was moved from the tie-down area the rope tore the tip skid from the wing tip. The glider was de-rigged and sent for repair. This is not an uncommon incident and highlights the importance of ensuring tie-down ropes are completely removed from the glider before towing out.

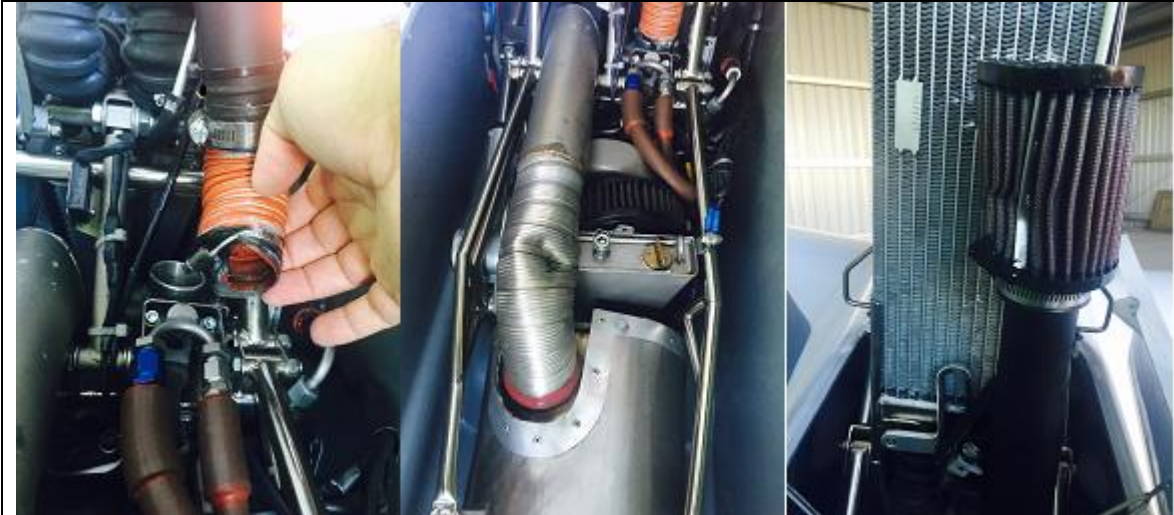
Investigation found the lower air intake tube securing clamp failed causing the air intake tube to become detached from the throttle body, which caused engine power fluctuations after take-off. Secondary damage to the muffler and radiator occurred when the propeller tower was subsequently retracted. The reason for clamp failure was not identified but may have been due to: (a) Over tightening; (b) Not being tight enough due to this type of clamp binding while being tighten giving a false sense of tightness; or (c) Manufacturing fault of the clamp. A contributing factor may have been 2- stroke oil on the inside of the tube. Once the clip failed this lubrication would have eased the progress of the tube off of the throttle body. To prevent recurrence, both the upper and lower air intake tube securing clamps were tightened, torqued to 0.9NM and then lock wired in place, after which a bead of "Torque Seal" was applied to the clamp. In late August 2016 the AAFC issued 'Special Technical Instructions (STI) 01603 detailing rectification and ongoing maintenance procedures, upon completion of which saw the aircraft returned to service.

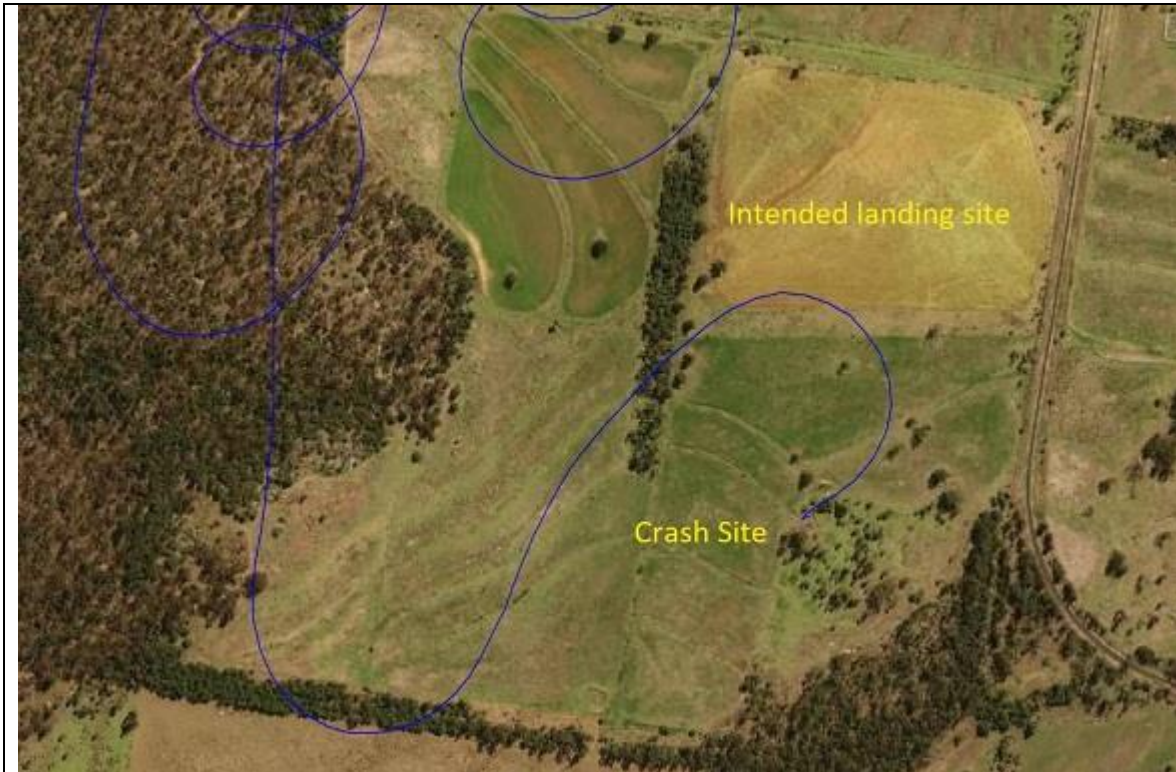
The paddock in which the pilot intended to land and where the aircraft crashed.

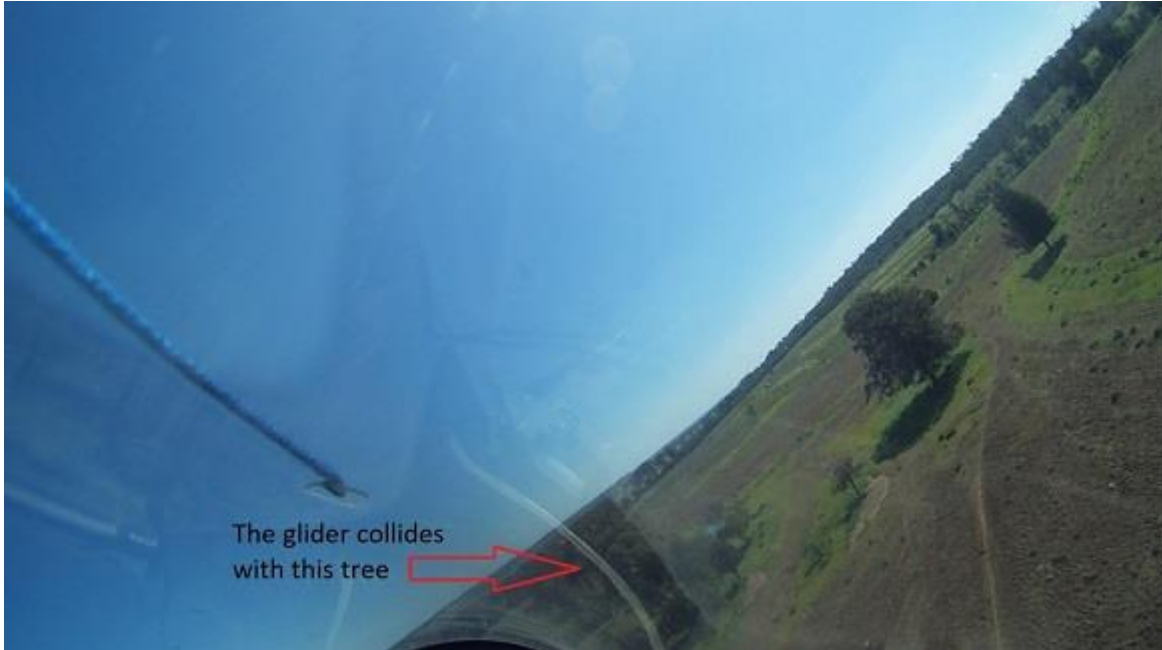
Video footage from the cockpit showing the bank angle at time of impact with the marked tree.

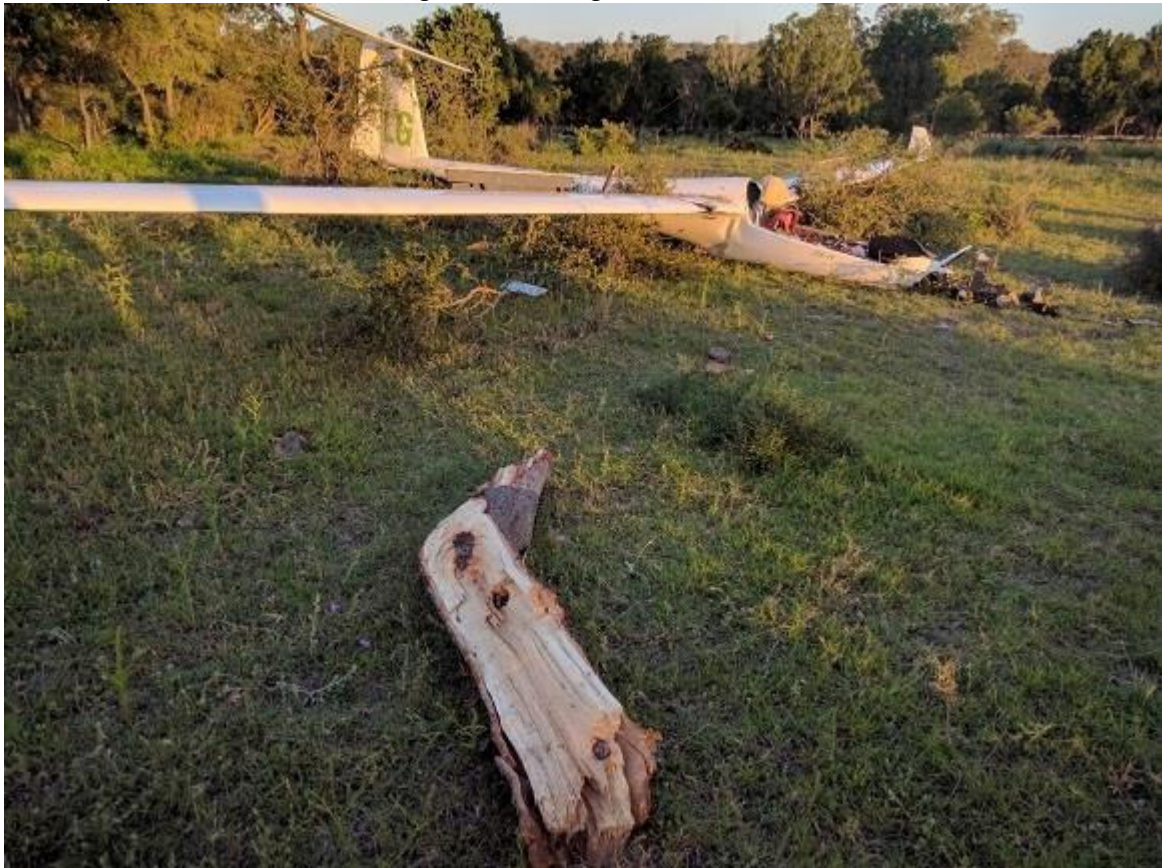
Examination of the wreckage in situ revealed all flight control surfaces were accounted for at the accident site. While there were multiple overload failures of the flight control system in the fuselage and cockpit areas, control continuity was established. The pilot subsequently confirmed the aircraft was airworthy up until the collision with terrain.

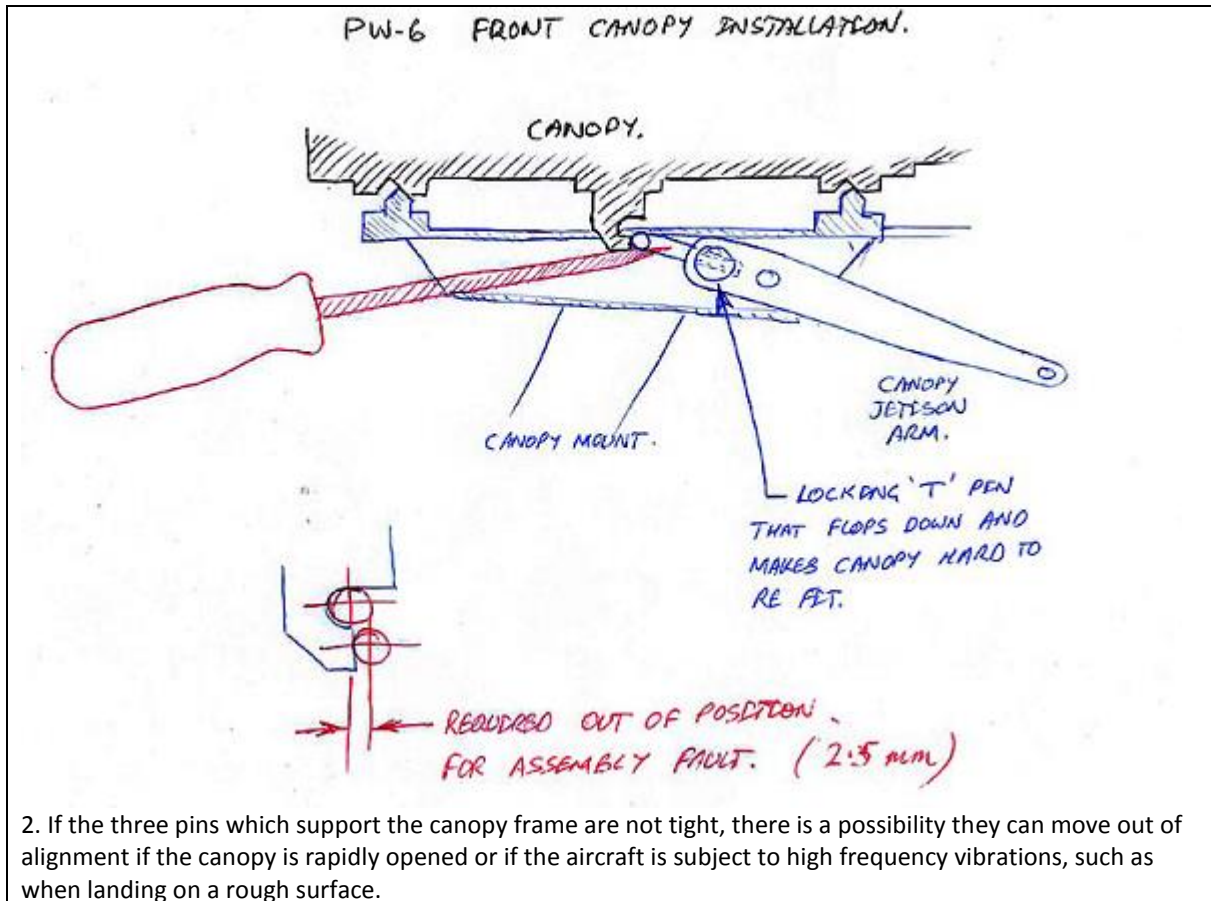
2. If the three pins which support the canopy frame are not tight, there is a possibility they can move out of alignment if the canopy is rapidly opened or if the aircraft is subject to high frequency vibrations, such as when landing on a rough surface.

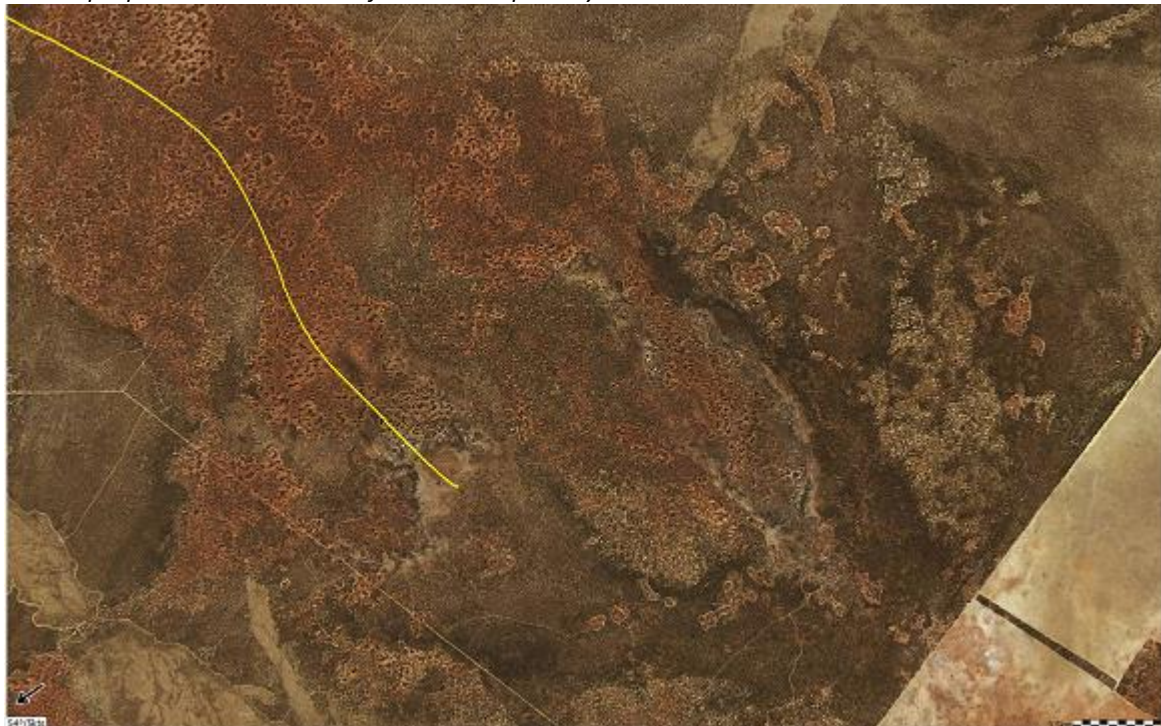
Following the safe arrival in the scrub, albeit with a damaged glider, the pilot was able to take stock of the situation. The aircraft was in a remote area surrounded by dense scrub, some 200 kilometres from the home airfield with no mobile phone coverage. The pilot had ample water and some food, and an out-landing survival kit with strobe lights and a portable aerial for the radio. A call over the radio to provide any listening
