**AIRWORTHINESS ADVICE  
NOTICE**

**TYPE AFFECTED:** SZD-9bis Bocian 1D and 1E.  
**SUBJECT:** Miscellaneous airworthiness information.  
**BACKGROUND:** This AN records airworthiness information which is useful to know.

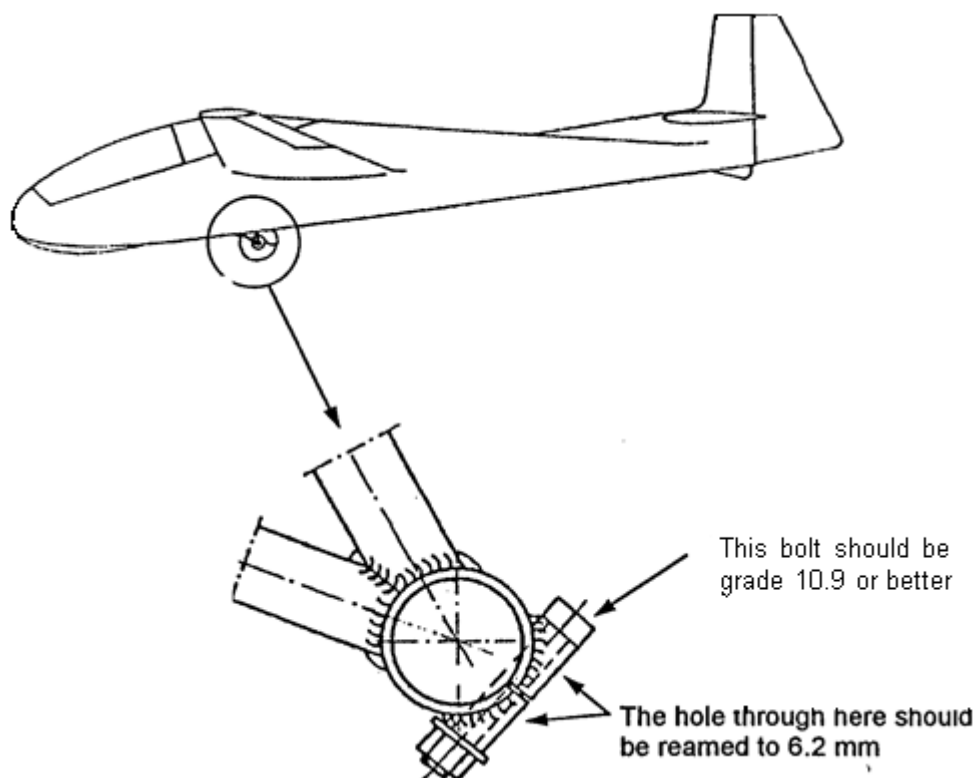
**FIGURE 1 - UNDERCARRIAGE BOLT**

2. Bulletin BK-005/73 Bocian required the replacement of the axle clamping bolt to prevent damage to the axle clamps on all 1E Bocians. These bolts should be checked at each annual inspection and if replacement is necessary then the replacement bolts should be grade 10.9 M6 x 40 mm bolts and the hole which they fit into should be reamed to 6.2 mm Ø. See Figure 1

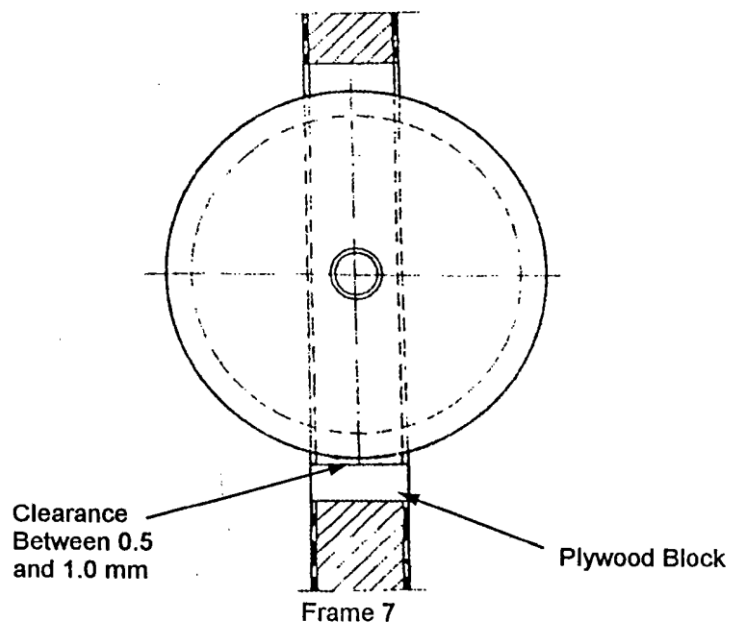
**FIGURE 2. - PULLEY**

4. Bulletin NR-008/76 Bocian describes the possibility of the rudder control cable dismounting from the pulley attached to number 7 bulkhead on IE Bocians up to serial number P-753. A plywood block should be glued onto the bulkhead to reduce the clearance between the pulley and the bulkhead to between 0.5 and 1.0 mm as shown in Figure 2

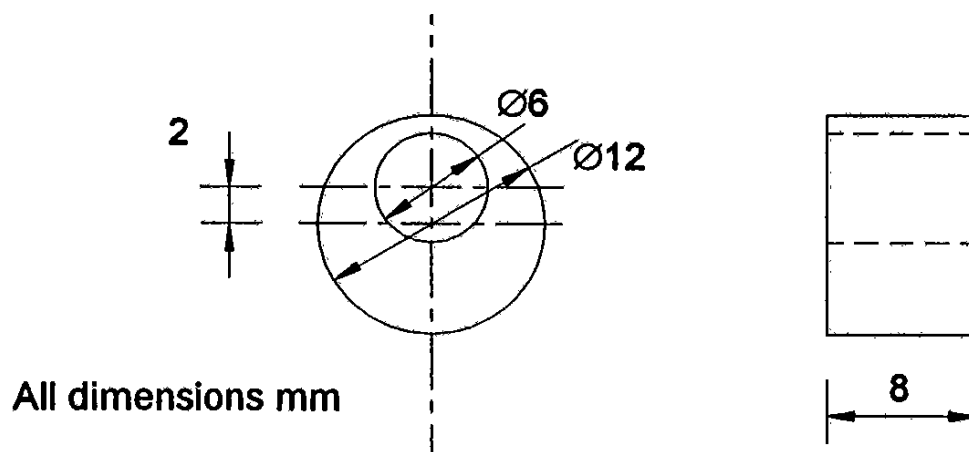
**FIGURE 3 - REPLACEMENT ECCENTRIC**

5. Bulletin BK-14/78 describes the adjustment of the airbrake stops in Bocian IE however the English is so poor it is difficult to know what was required. It is however possible to determine that one of the requirements was to fit a rubber block to the front seat pan to act as an out stop. Also if the eccentric stop in the wing allows the dive brake components to contact each other then it should be replaced with one as shown in Figure 3.

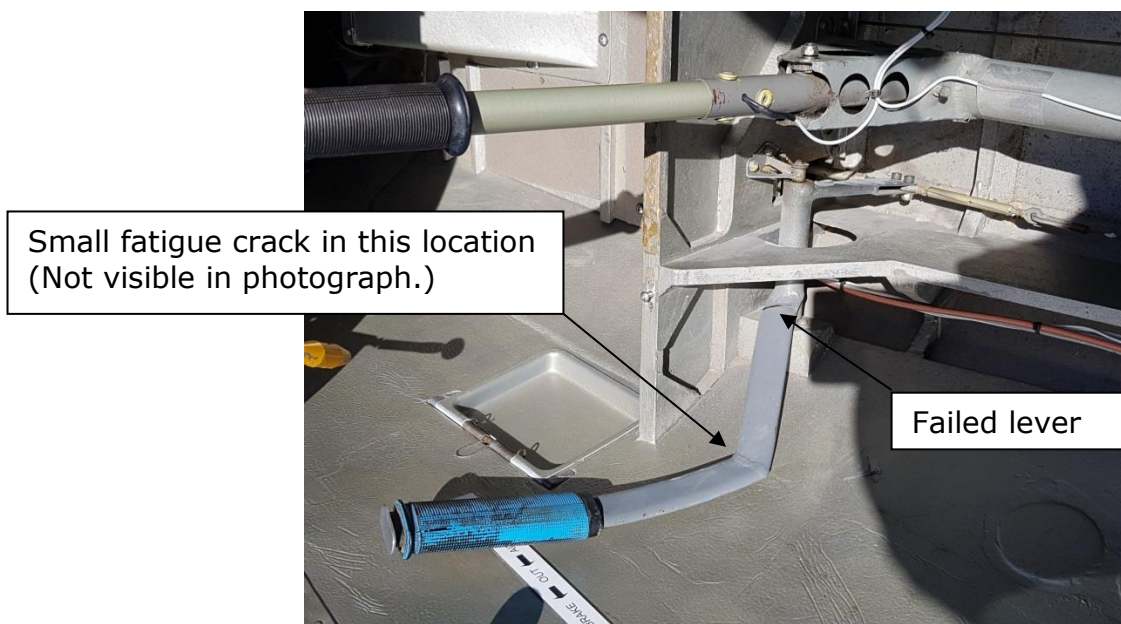
6. There has been one report in Australia of failure of the front cockpit airbrake lever. The lever is quite long and is made of mild steel so that it is possible to overload the lever when applying the wheel brake. In the reported instance a fatigue crack had developed at the lower end of the lever which ultimately led to the lever failing in overload at the location of the fatigue crack. A second small crack was found at the elbow in the lever. Inspectors should be aware of the possibility of cracking in these locations and are advised to check both front and rear levers during annual inspections.
