## GLIDING FEDERATION OF AUSTRALIA

AIRWORTHINESS ADVICE NOTICE:

REF: GFA/AN 40 SCHEMPP-HIRTH 4

MINI-NIMBUS T.C. No. 328

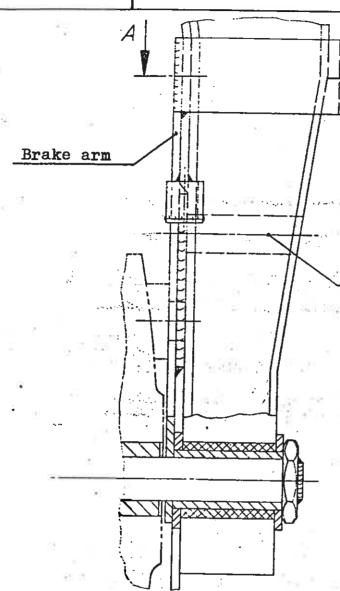
At heavy landings with wheel brake applied it is possible that the front landing gear strut may be damaged by the bearing pin for the brake arm. Therefore a replacement of the brake arm is recommended.

Bearing pin

- a. Solder off the nipple from the brake cable and take off the wheel with the brake arm.
- b. Saw off the bearing pin for the brake arm inside of the front landing strut and file it down.
- c. Put a new brake arm (drawing Mini-Nimbus HS7 No. 10.039A) onto the front landing gear strut. (See sketch attached).
- d. Mount the wheel and the brake cable and solder on the brake cable nipple.

MATERIAL: Brake arm in accordance with the Drawing Mini-Nimbus HS7 No. 10.039A.

Fit without clearance
