The Gliding Federation of Australia Inc

Occurrence Summaries

01/01/2019 to 31/12/2019

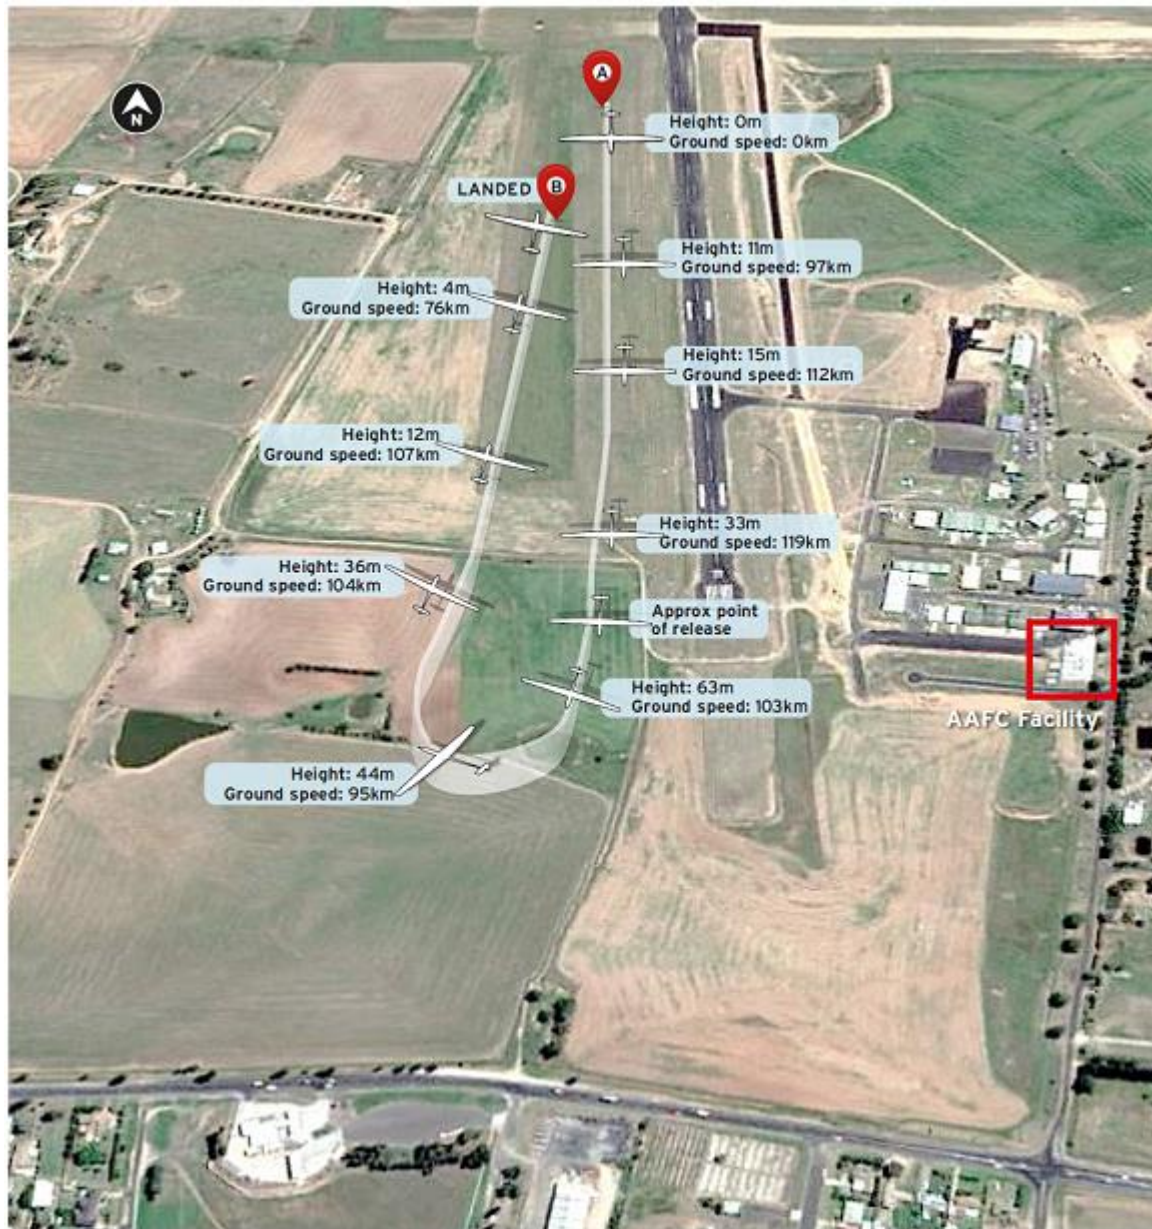
Figure 2. Flight Path

remainder of the recovery), markedly increasing the wind rush noise within the cabin space. Despite the distractions, the pilot conducted a safe turn-back recovery to the airfield before the glider came to rest on Runway 35 Grass Left. The sortie was logged as a two-minute flight. The glider's flight path is depicted in Figure 2.

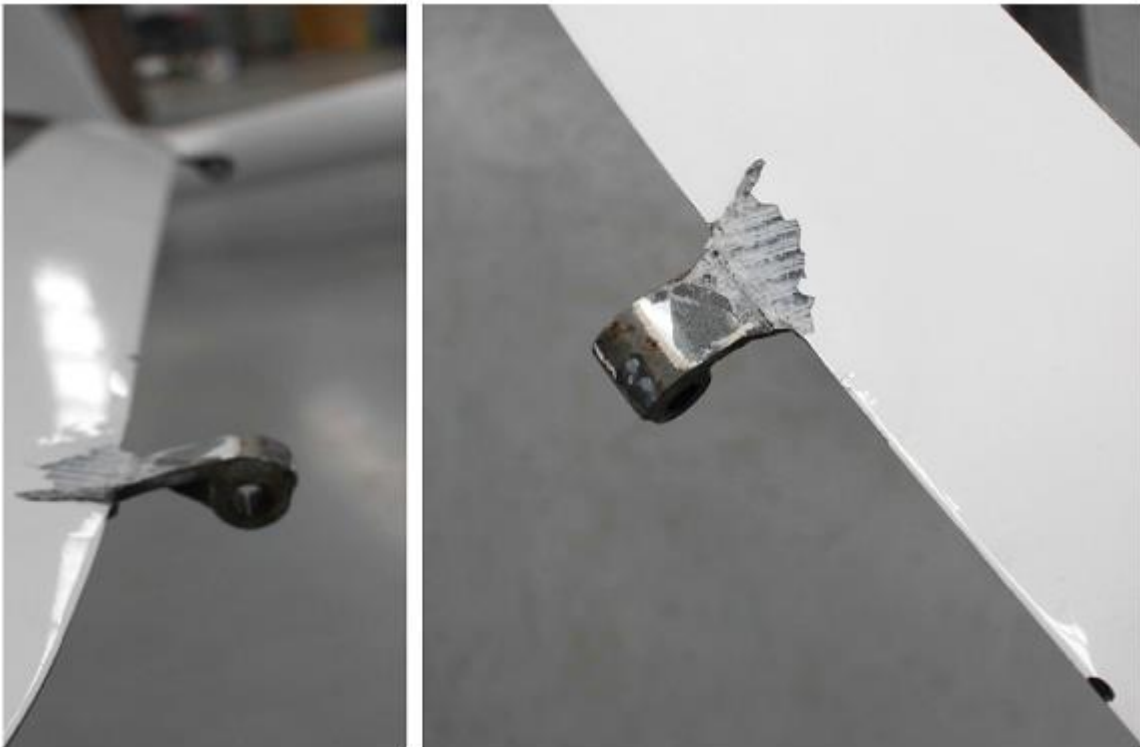
Figure 3. Hinge over-extension and supporting structure damage

Due to the inertia and aerodynamic forces involved when the canopy completely opened in flight, the canopy hinge attachment points sustained over-extension damage which resulted in a canopy misalignment. This was most notable when the Perspex part of the canopy was in the closed position, as it could not be correctly seated and locked. There was also minor delamination to the hinge arm supporting structure of the canopy mount which can be seen at Figure 3.

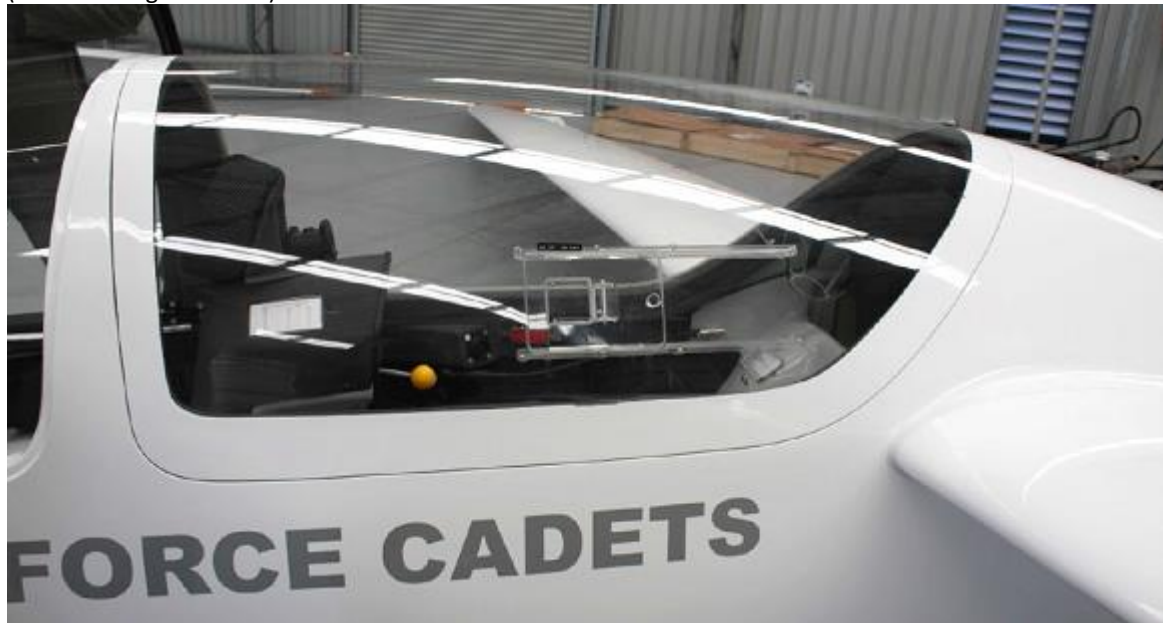
Figure 10. Rear canopy flush with Fuselage

Cycling the canopy locking handle from the open to the closed positions moves the handle lock and pinning mechanism freely through the matching locations on the fuselage (as seen in Figure 8 and 9). When the locking handle is in the closed position the locking pins extend into/through the matching locations on the fuselage ensuring positive engagement of the locking pins to the fuselage. Thereafter, the canopy is fully closed and locked flush with the fuselage (Figure 10), with the handle flat against the inside of the canopy (as seen in Figures 7 & 8).

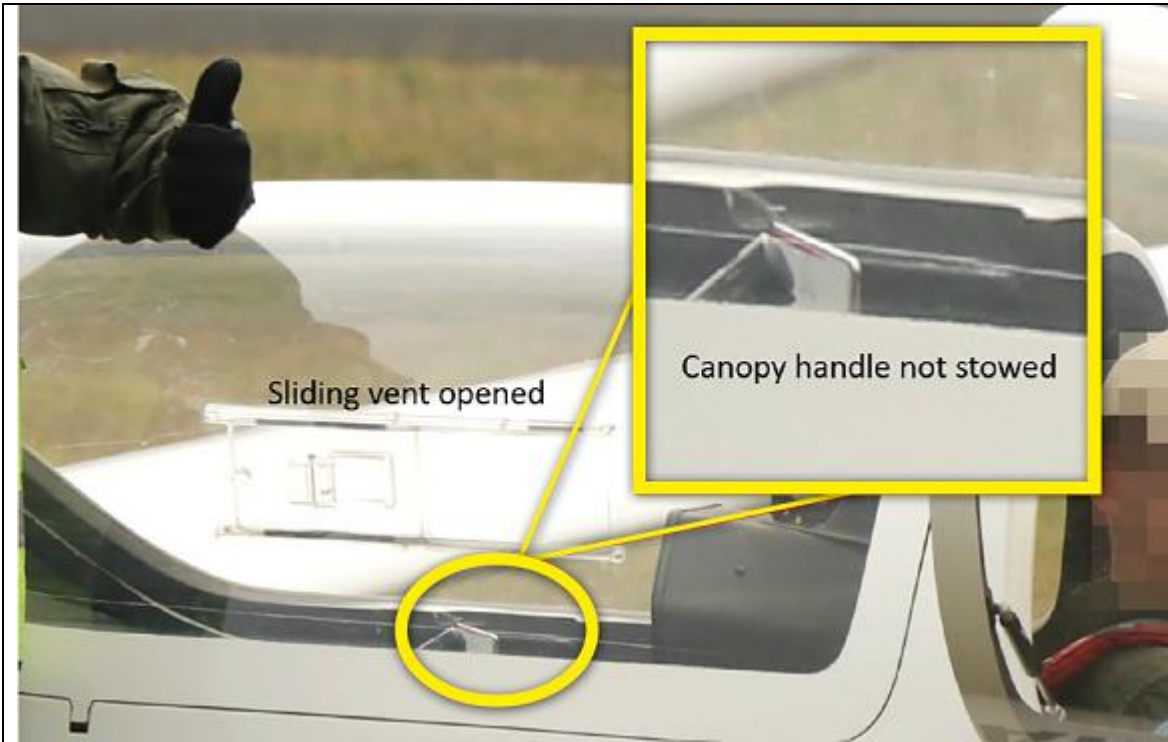
Figure 13. Rear canopy handle in the unlocked position

- a. The canopy was in the closed position but that the locking handle was ajar.
- b. The canopy sliding vent was open.

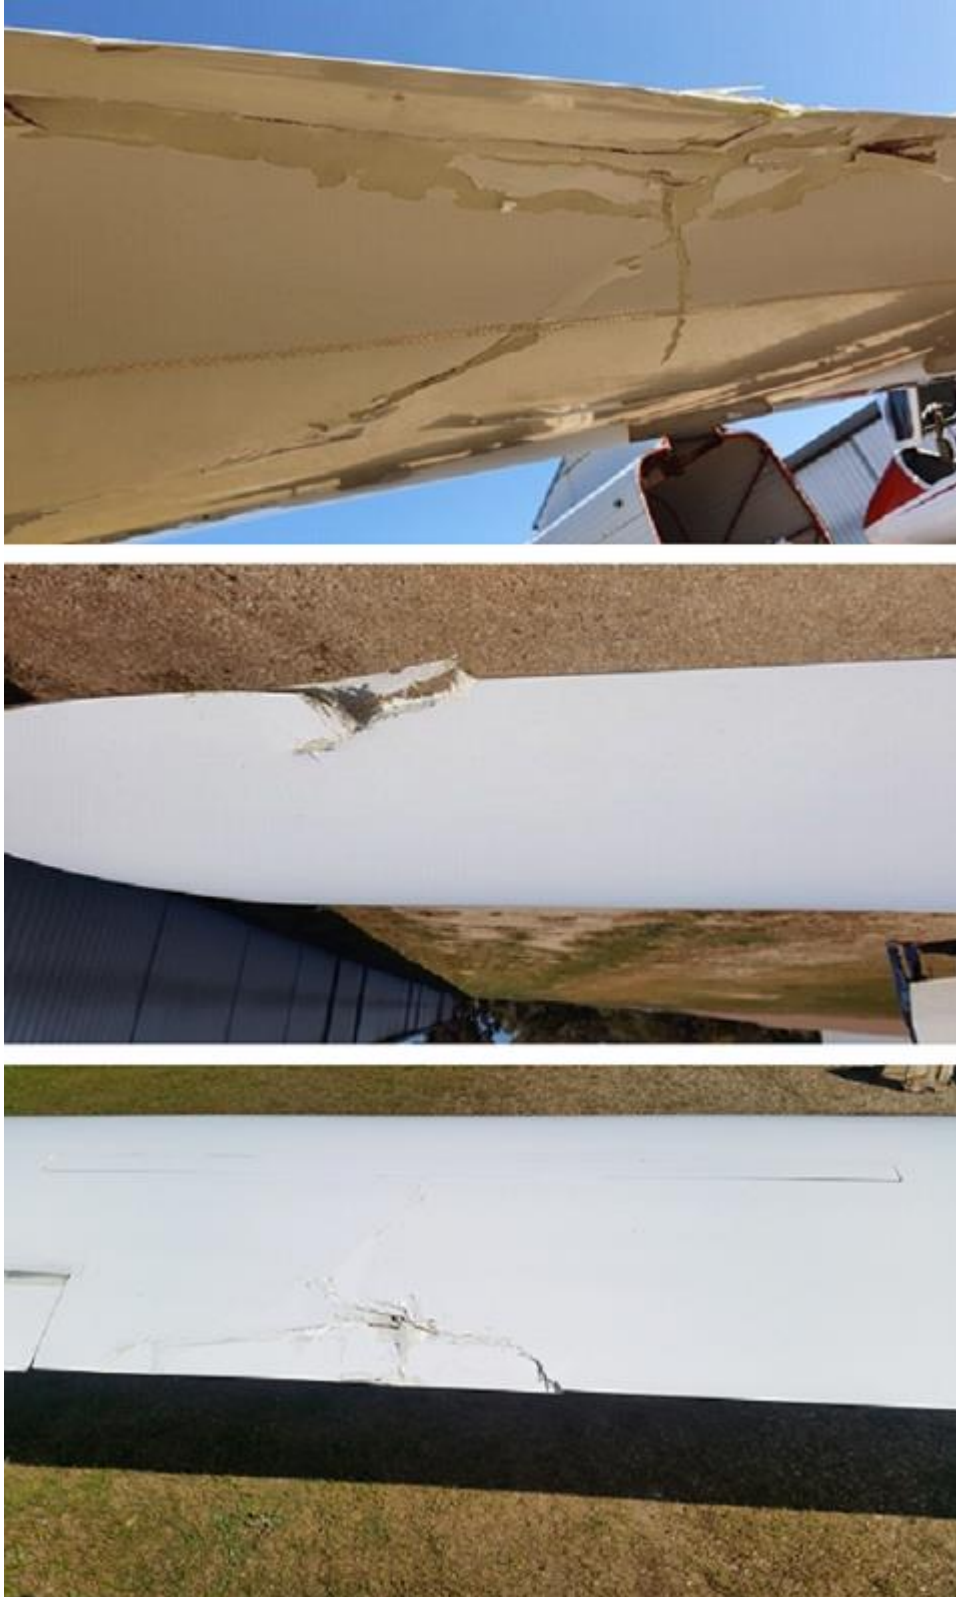
Damage to the wings.

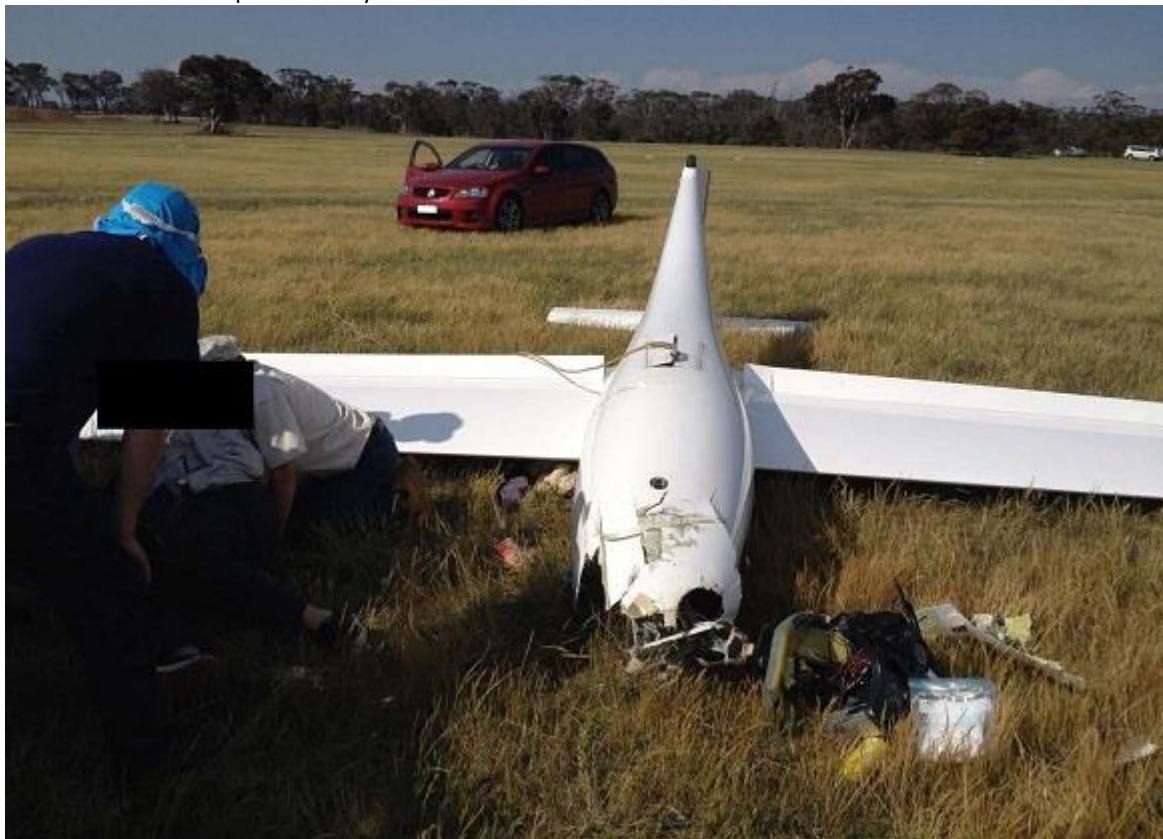
Fig 1. Aircraft after coming to rest. Members are attending to the injured pilot.

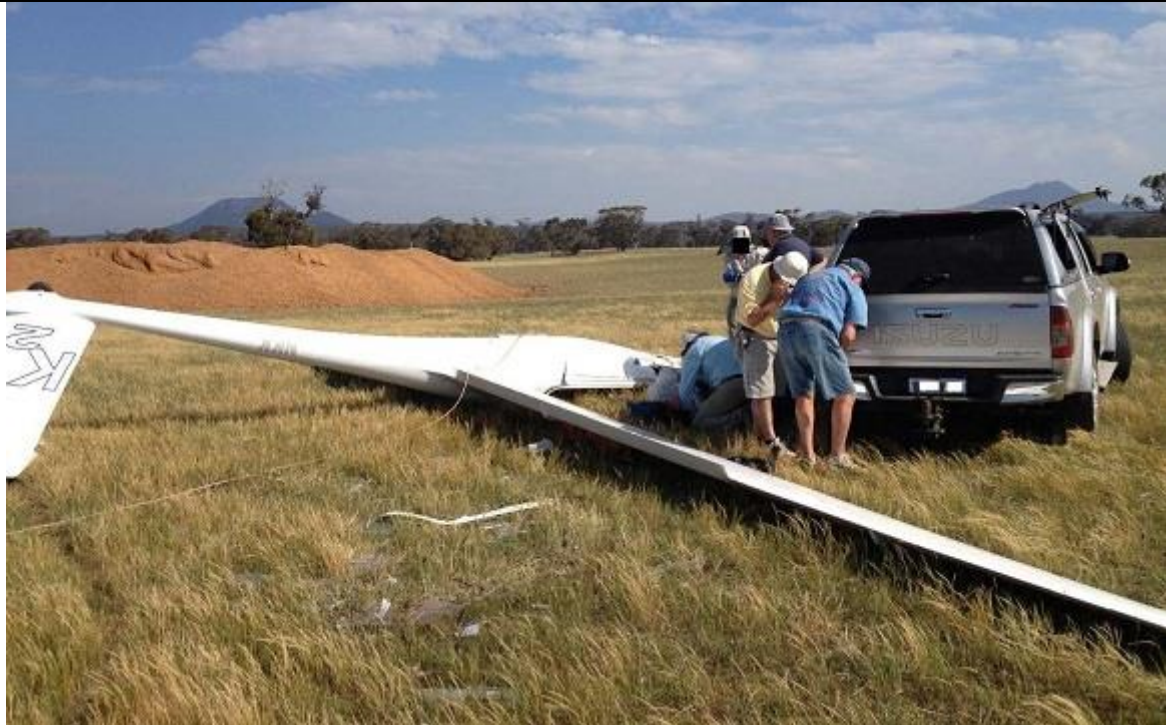
Fig 2. Wreckage showing impact point in the foreground identified by broken canopy fragments.

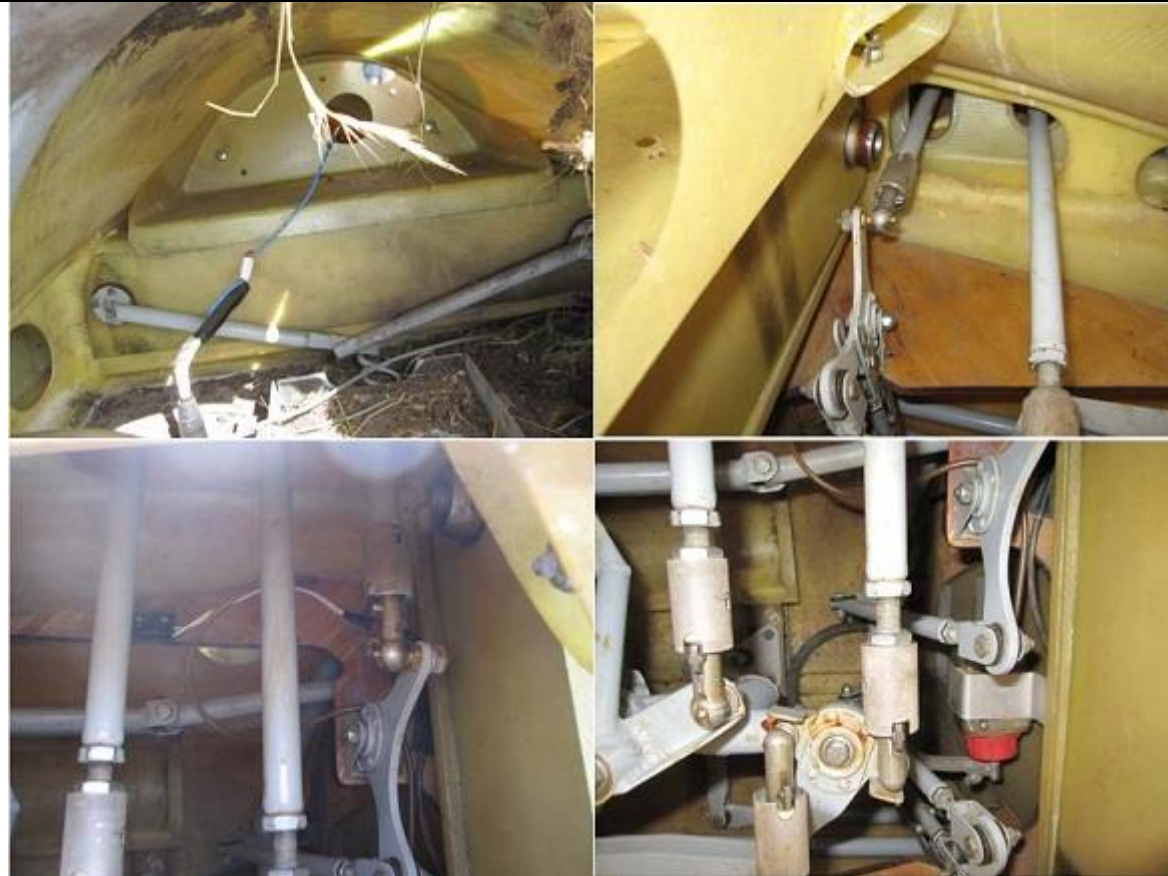
Fig 5. Main pins and control linkages intact.

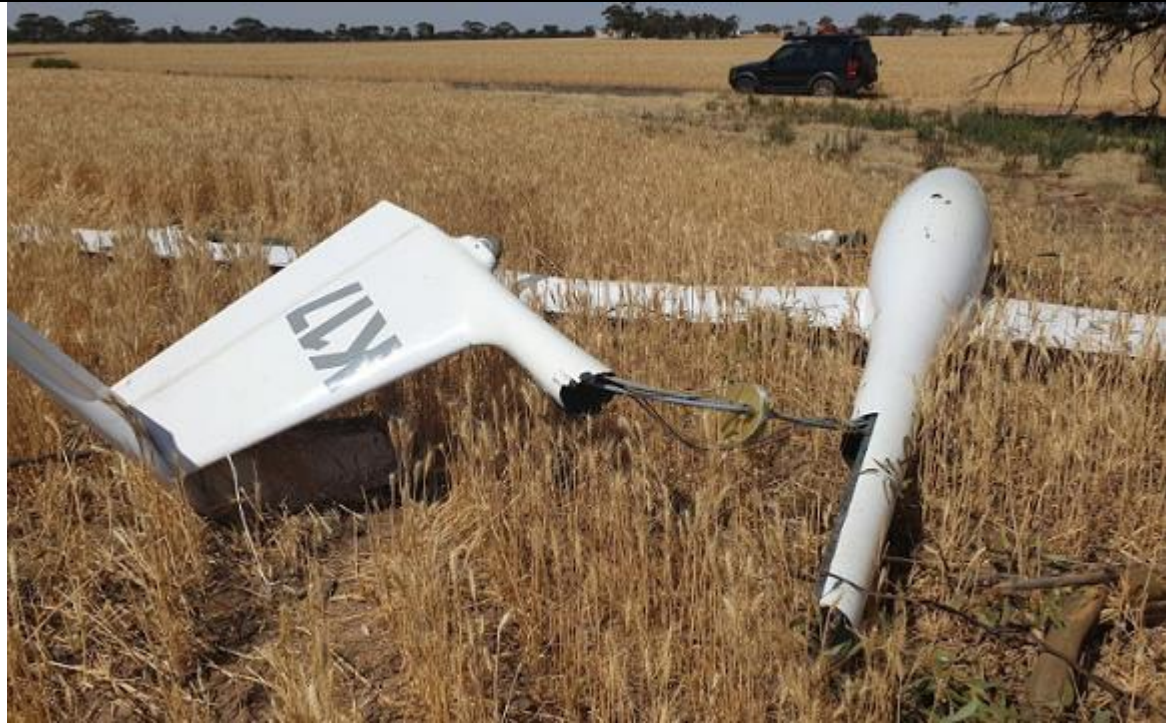
Figure 4: Tail Displacement Showing Intact Control Runs

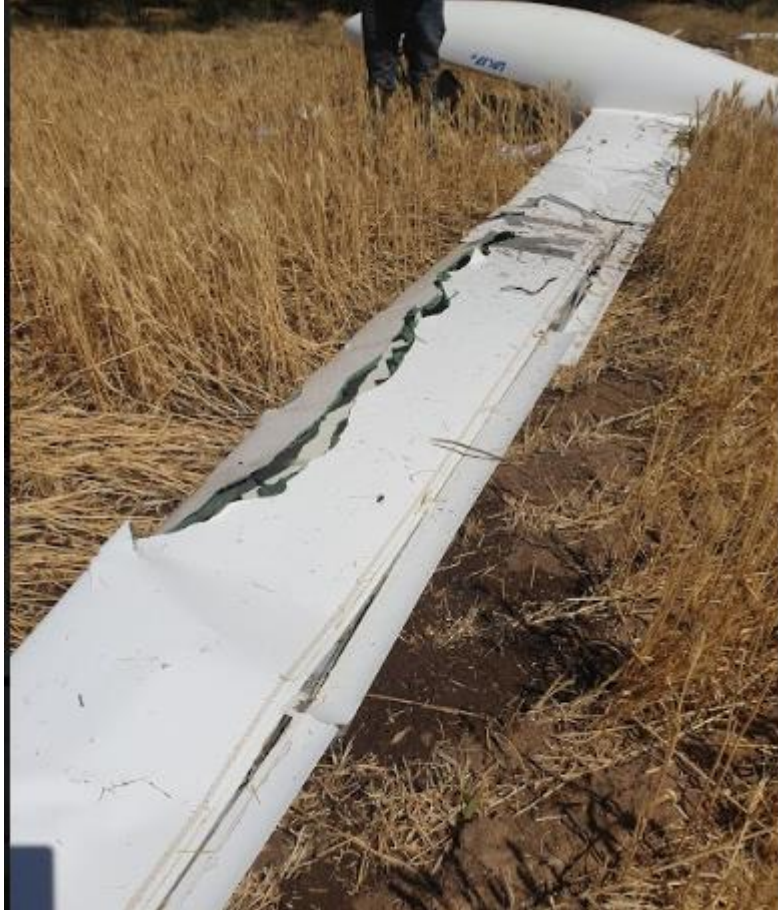
Figure 5: Damage to Starboard Wing

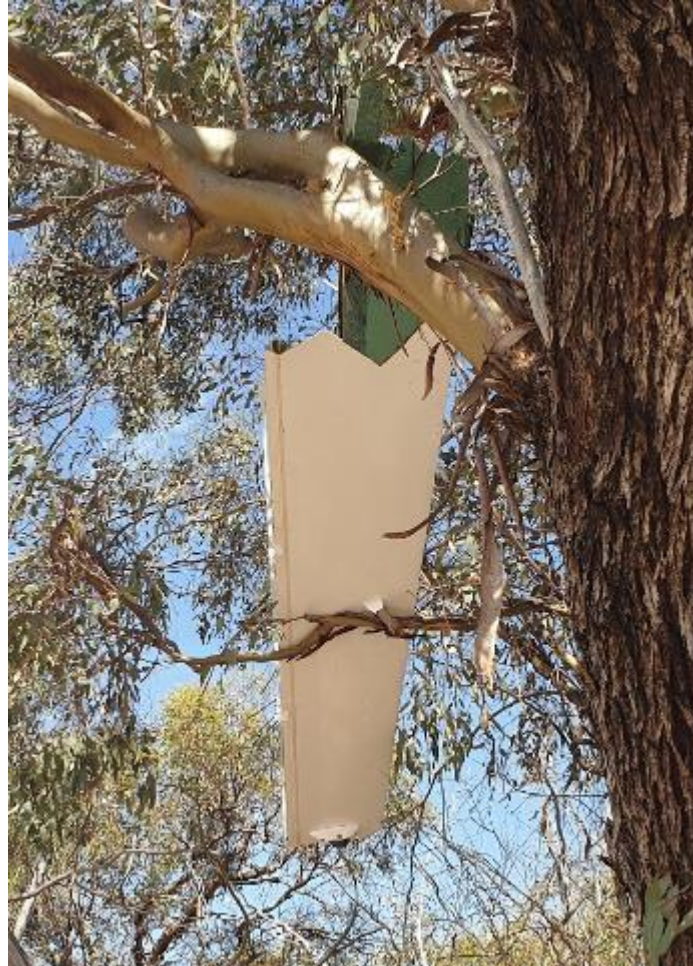
Figure 6: Port Main wing Impact with Tree

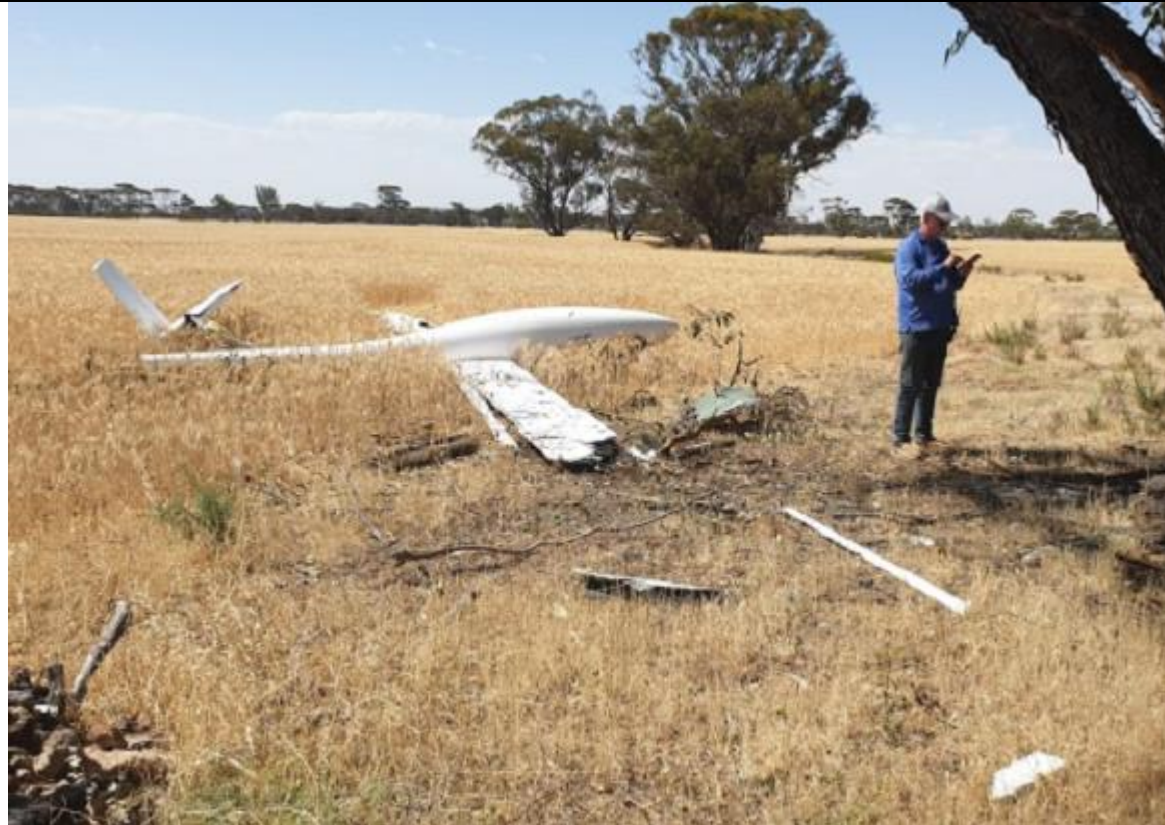
Figure 7: Damage to Port wing

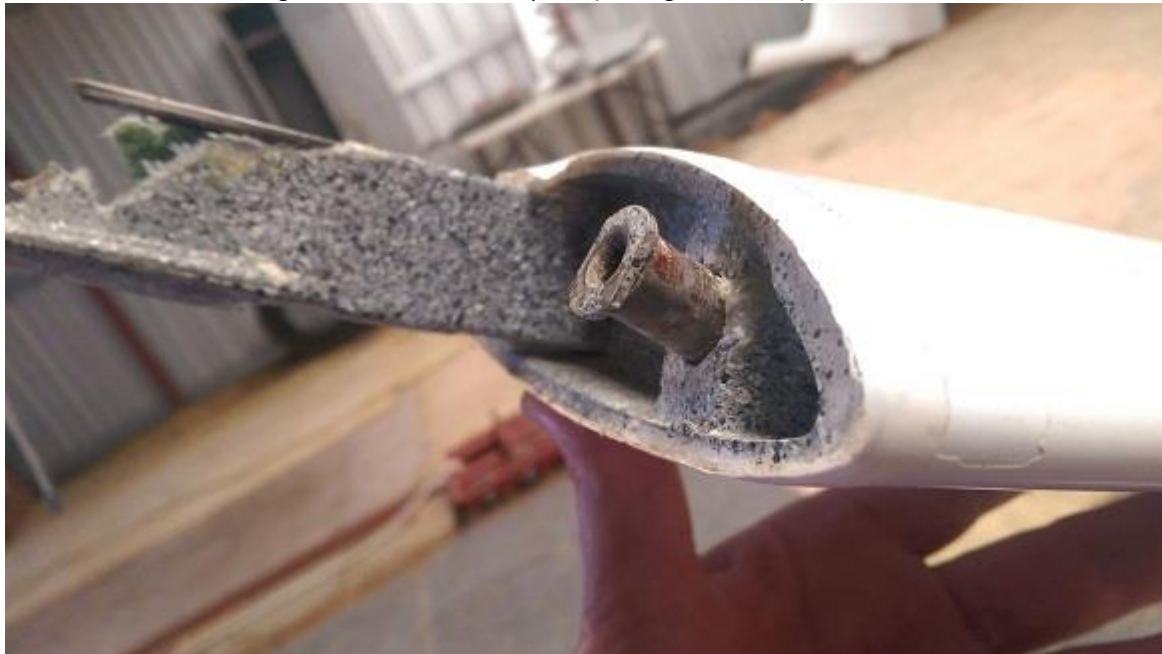
Figure 9: Extension Forward Shear Pin Bush, reinserted In wing extension, demonstrating the sequence of failure.

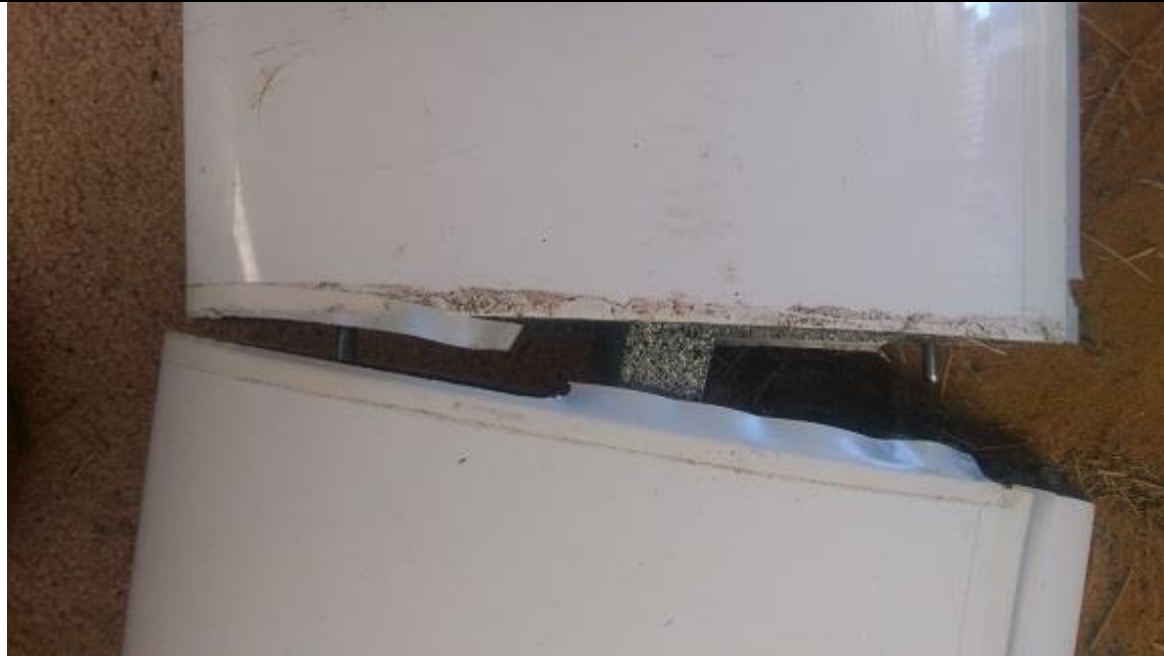
Figure 11: Wing extension Demonstrating Failure Method.

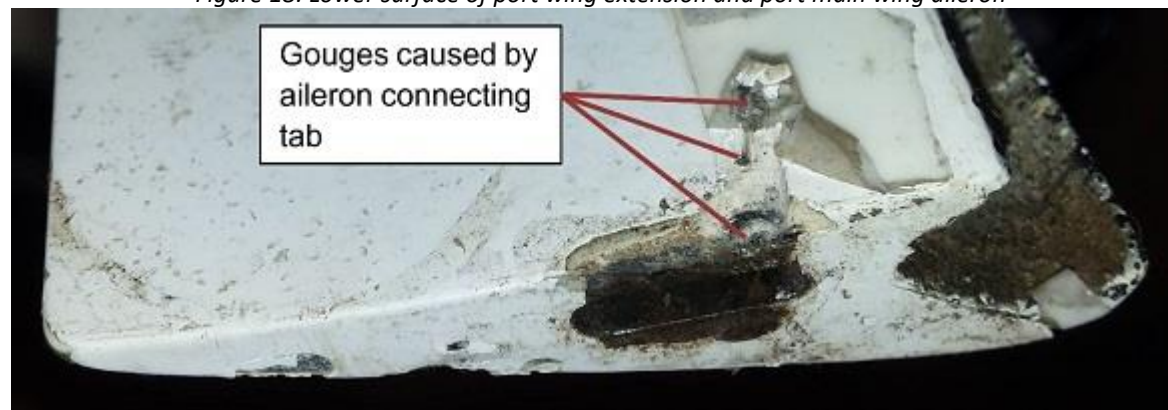
Figure 19: Close up of gouging on lower surface of port main wing aileron.

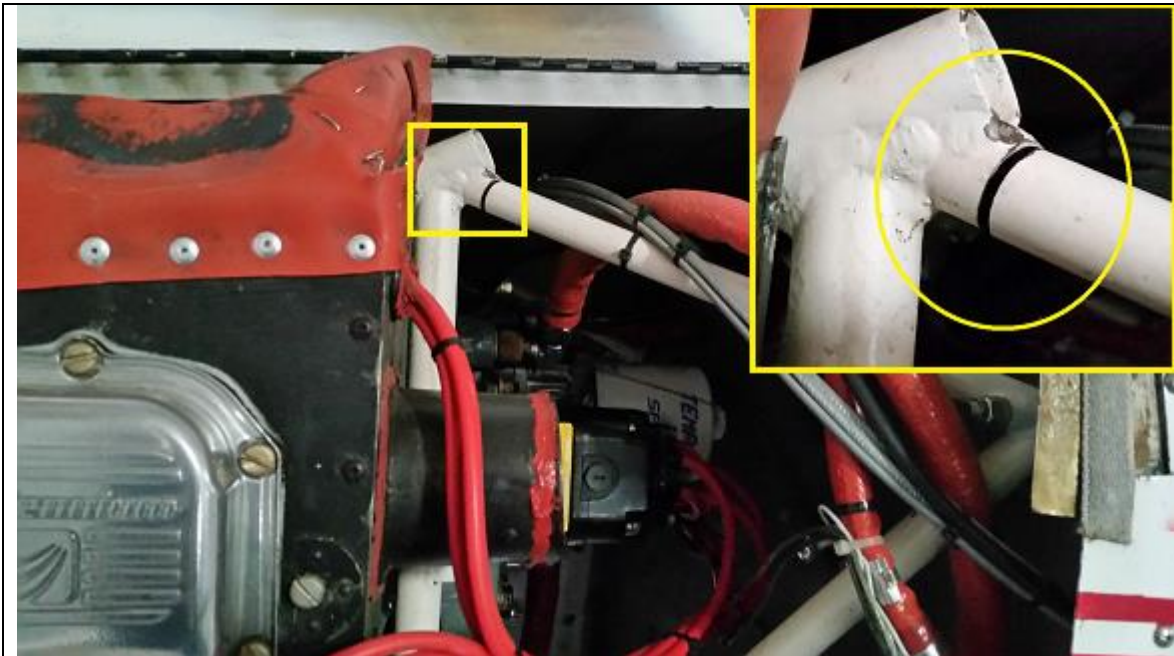
Inspection by a LAME led to the conclusion that the damage resulted from fatigue, most likely initiated by an earlier unreported heavy landing.
