The Gliding Federation of Australia Inc

Occurrence Summaries

01/01/2020 to 31/12/2020

The Gliding Federation of Australia Inc
SOAR Accident and Incident Occurrences

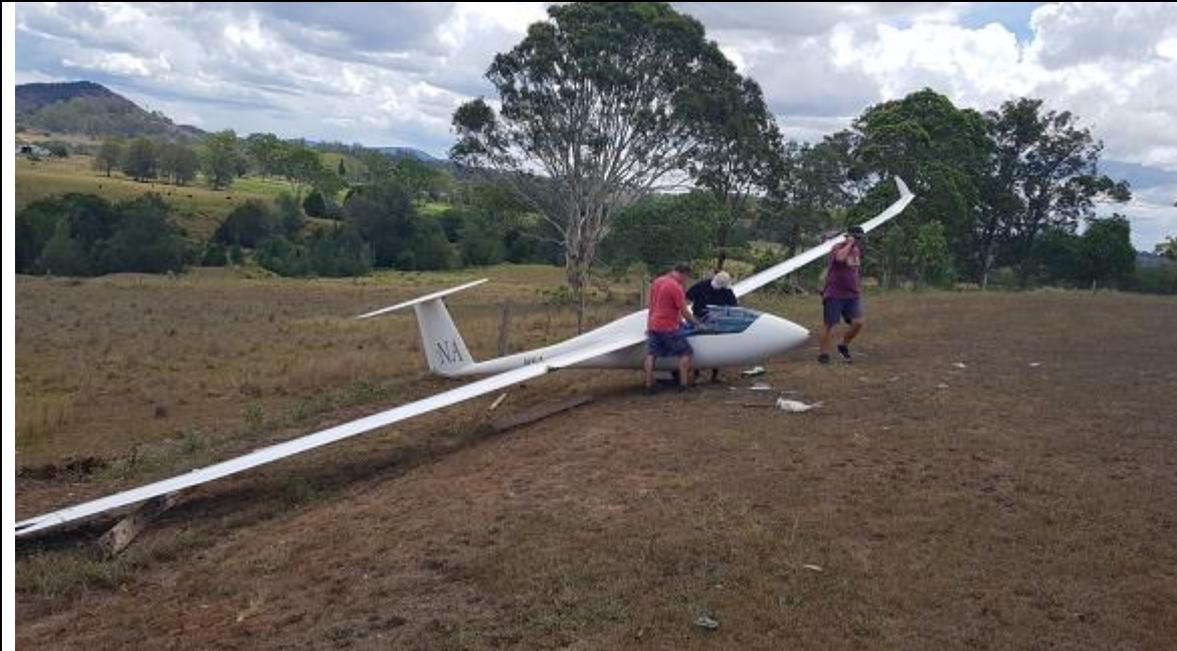
Fig 1. Wreckage facing in direction of travel.

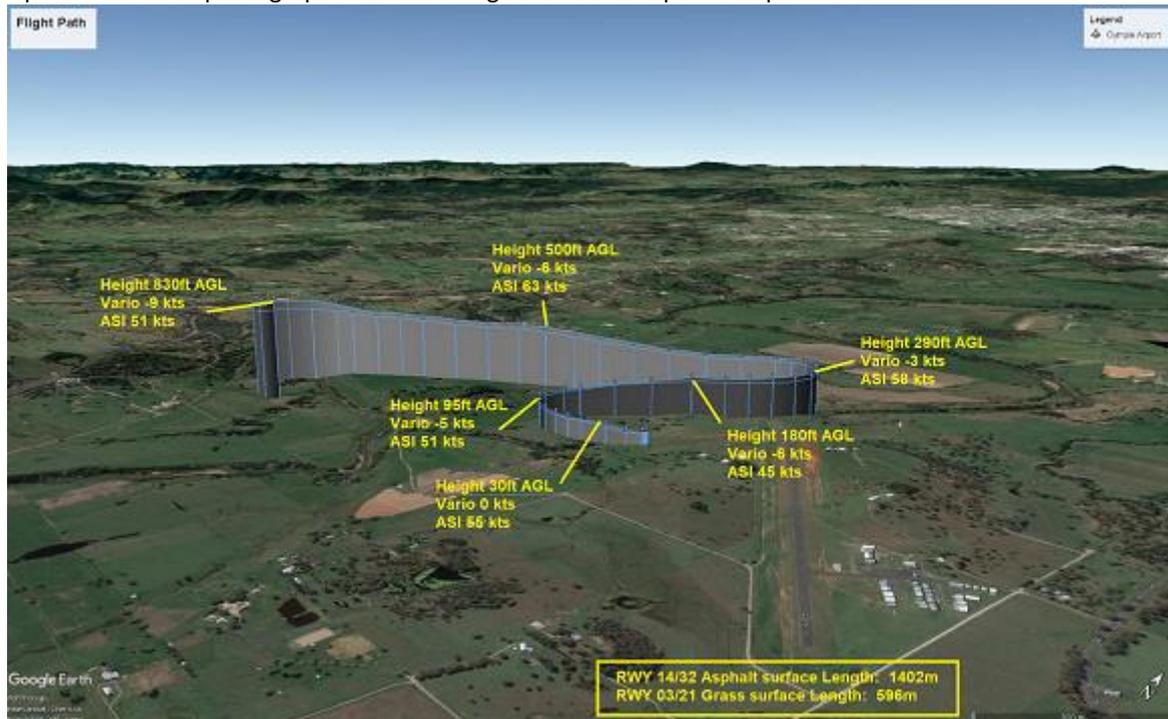
about 20 knots. He decided to change to runway 03. The base turn to 03 was commenced at 190 feet AGL. The turn to final was successfully completed but at an altitude below that required to reach the threshold. The glider undershot the approach and collided with a fence during the rollout. A barbed wire strand broke the canopy and lacerated the pilot's scalp. The glider stopped abruptly. The pilot sustained significant injuries. The glider carried a logger which recorded the flight. A witness at the crash site note the flaps to be in position 1 and a photograph of the wreckage shows the flaps in this position.

Fig 2. Graphic of the flight path showing approximate heights at various positions in the circuit.

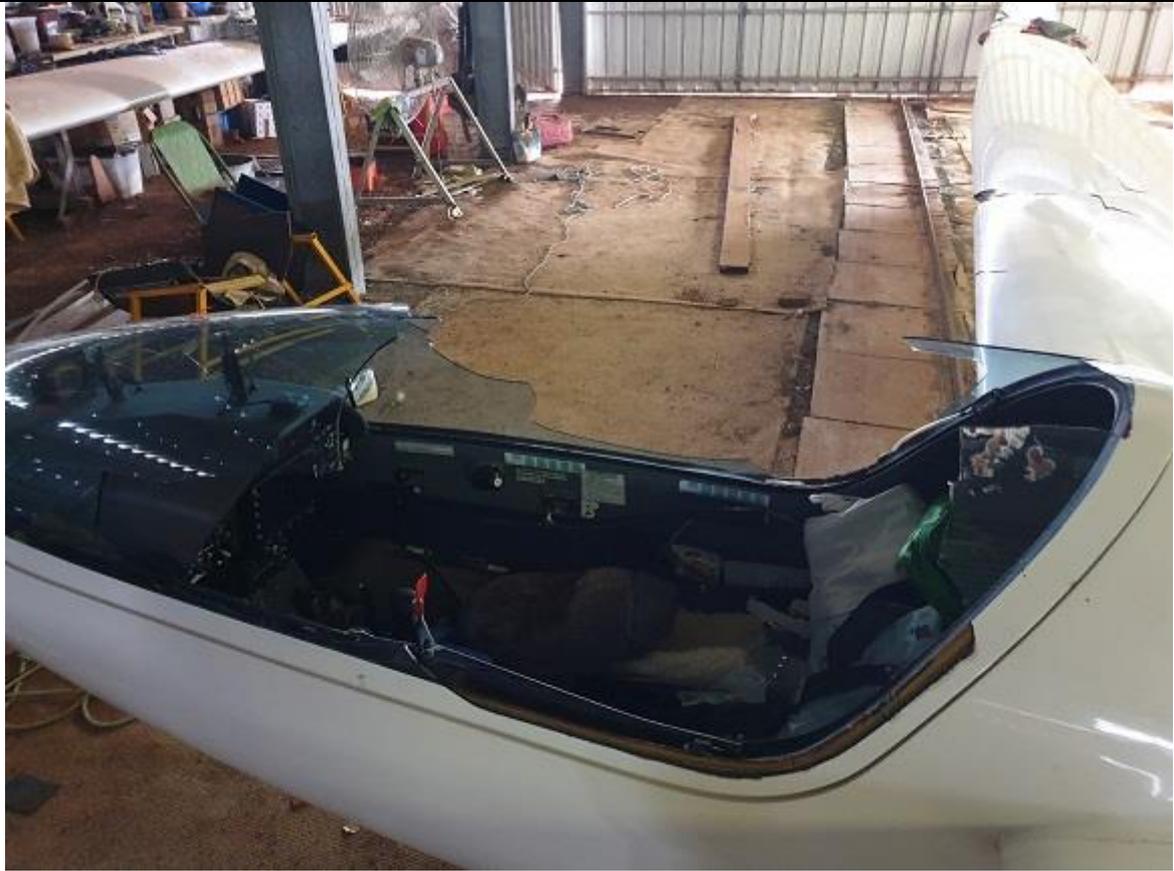
Investigation confirmed the aircraft was properly rigged. It was determined that all control rods and surfaces were connected and functioning correctly prior to the accident. Inspection of the aircraft confirmed substantial damage to the wings from impact with fence posts, and the canopy was smashed where the fencing wire entered the cockpit.

Fig 3. Photograph of canopy damage.

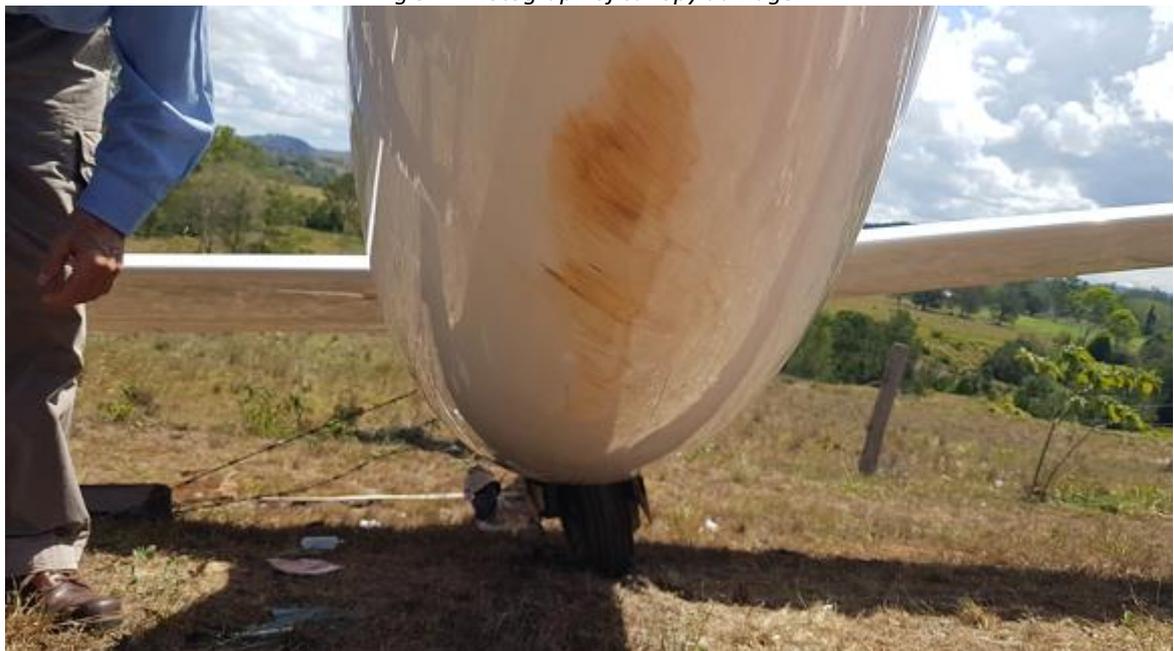
Fig 4. Fuselage damage from impact with rising ground prior to aerodrome boundary.

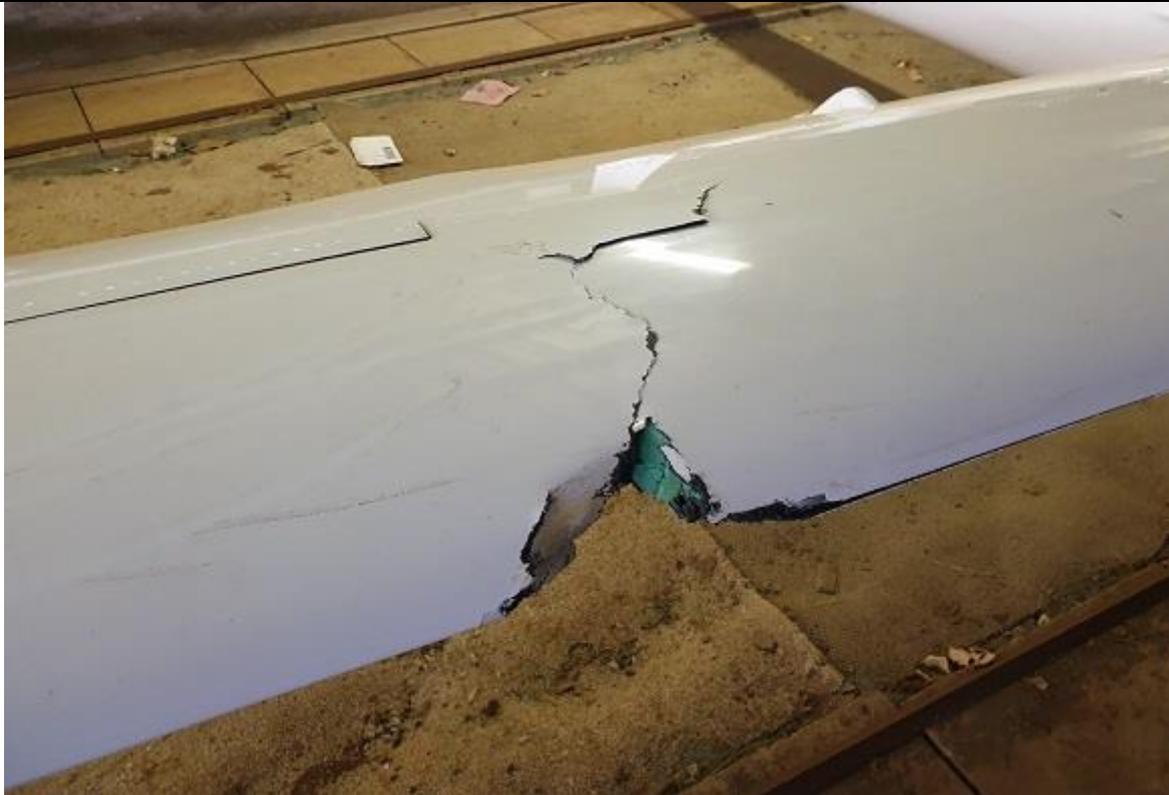
Fig 5. Starboard wing damage from impact with fence posts.

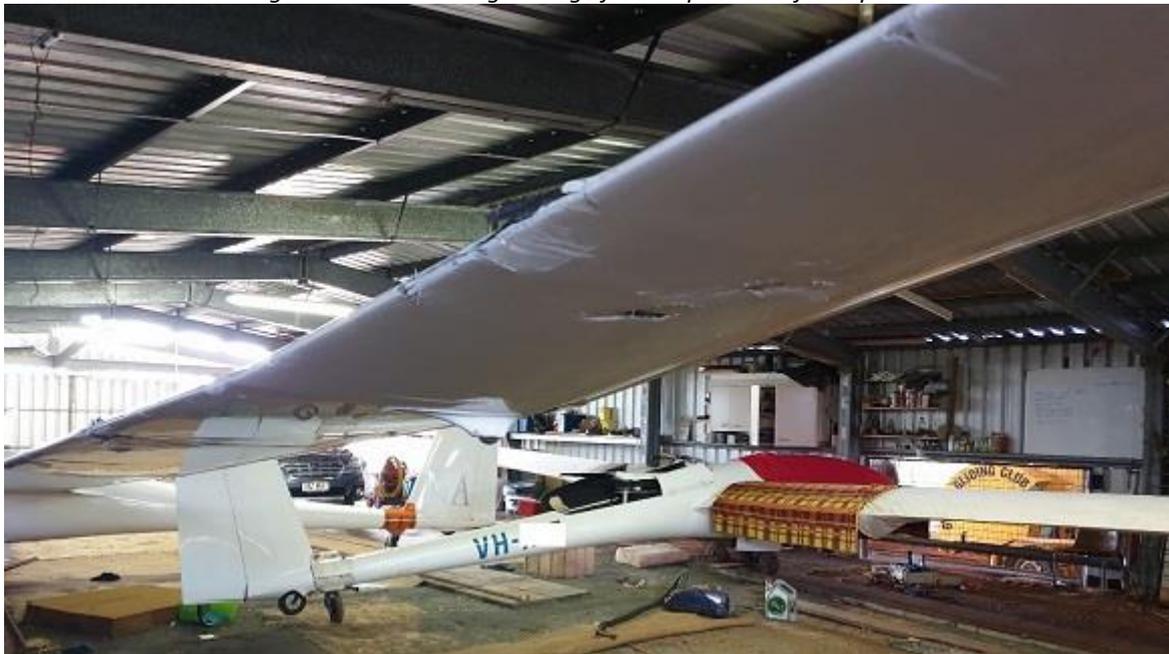
Fig 6. Port wing damage from impact with fence posts.

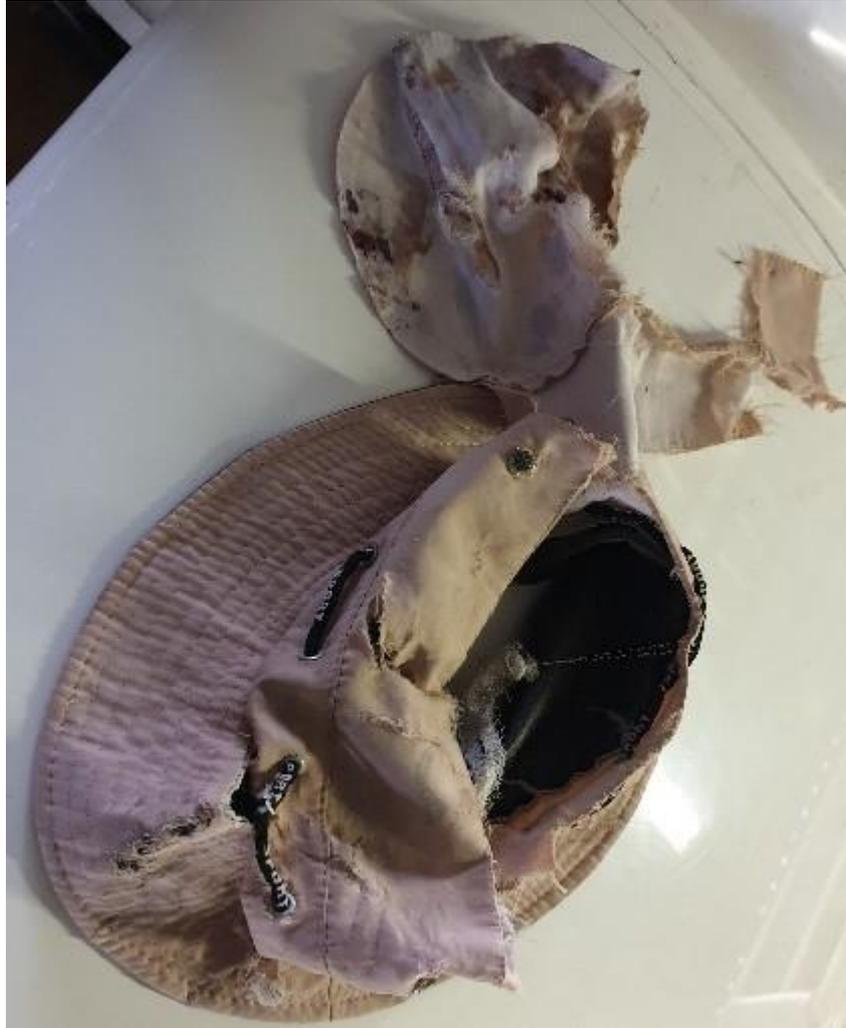
The pilot suffered crush fractures to several lumbar vertebrae indicating high speed deceleration. He also suffered scalp injury from the fence wire passing through the canopy. The photograph below is of the pilot's

hat, showing damage caused. The pilot is rehabilitating from his injuries with a good prospect of full recovery.

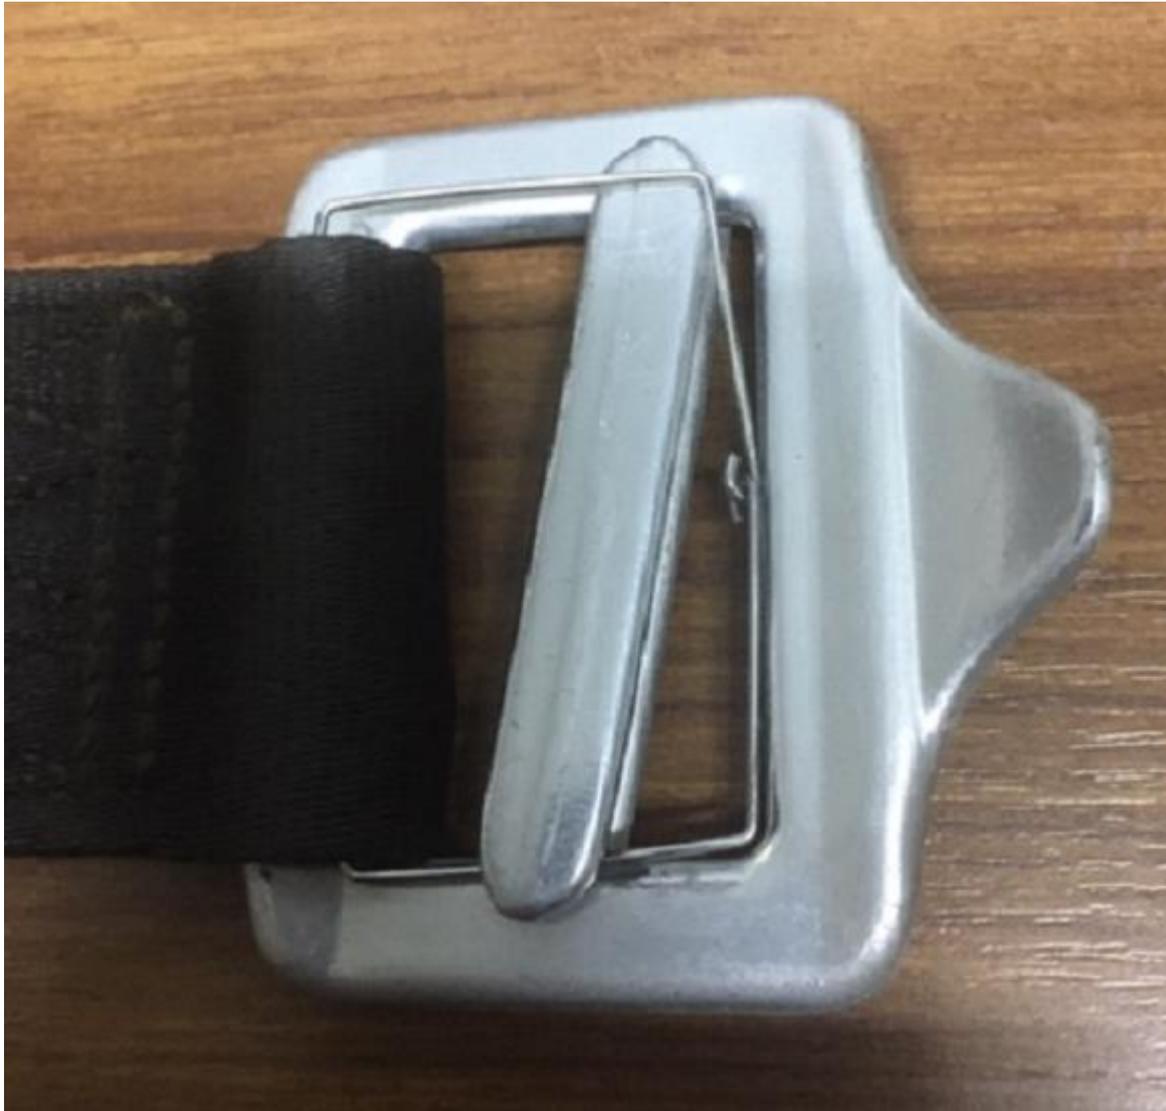
While on a high-speed final glide to the home airfield, the glider flew through some rough turbulence. The left-hand hip strap of the harness came loose and the pilot struck their head on the canopy. Attempts by the pilot to tighten the strap proved fruitless, and it kept coming loose. The pilot reduced speed to minimise the effect of the turbulence and landed safely. The harness was examined by an authorised inspector who identified the thin wire spring tensioner in the buckle mechanism that supplies tension to the webbing was dislodged on both sides, allowing the webbing to move freely within the buckle (see photo).

The inspector removed the buckle end strap from the adjuster, and the spring was removed and inspected for

- safe attachment of the harness to the glider airframe;
- the condition of the harness webbing (e.g. abrasions, wear, damage, pulled or loose stitching);
- the ability of the buckles to secure the webbing; and
- the correct operation of the fasten/release mechanism.

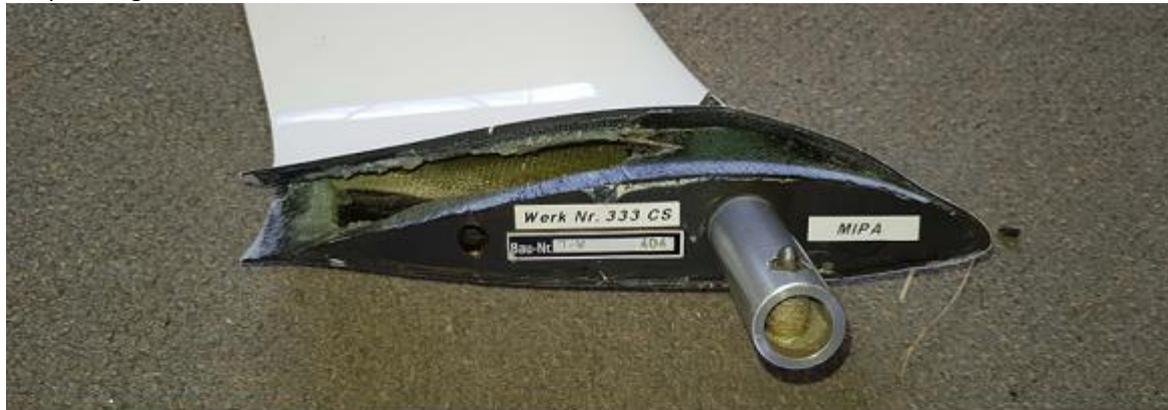
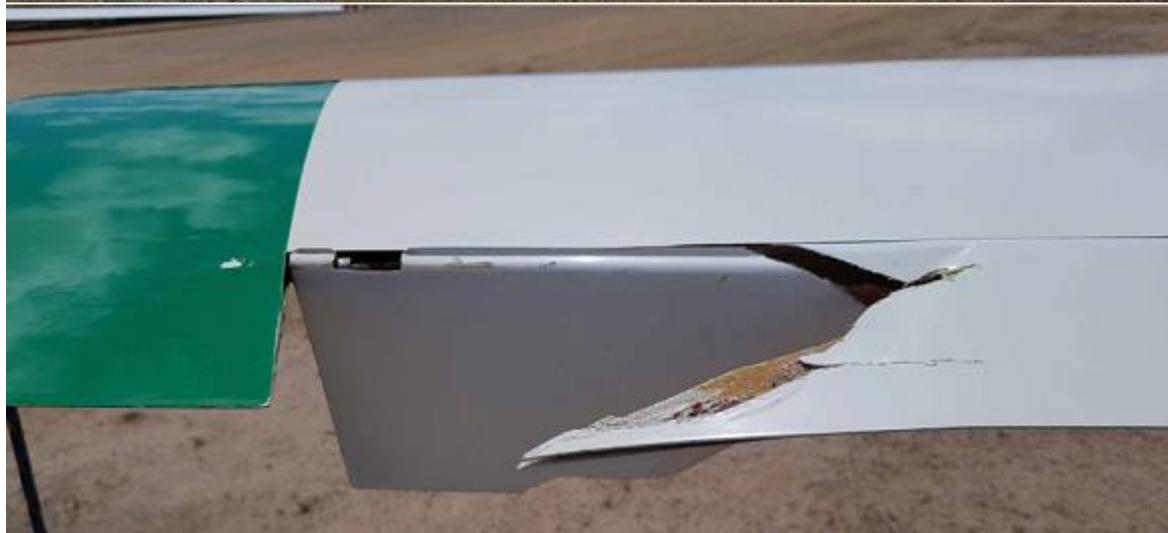
A Discus was being towed to the workshop area to have ballast tank filled. A DG-505 was parked in the immediate area and a Puchacz was tied down nearby. While attempting to negotiate the space between the DG-505 and the Puchacz, the vehicle driver momentarily lost sight of the Discus wing tips, resulting in the Discus port wingtip colliding with the port wingtip of the DG-505. Both aircraft were substantially damaged (see photographs below). Contributing factors included inattention/distraction of vehicle driver, proximity of the parked gliders and lack of crew to assist.

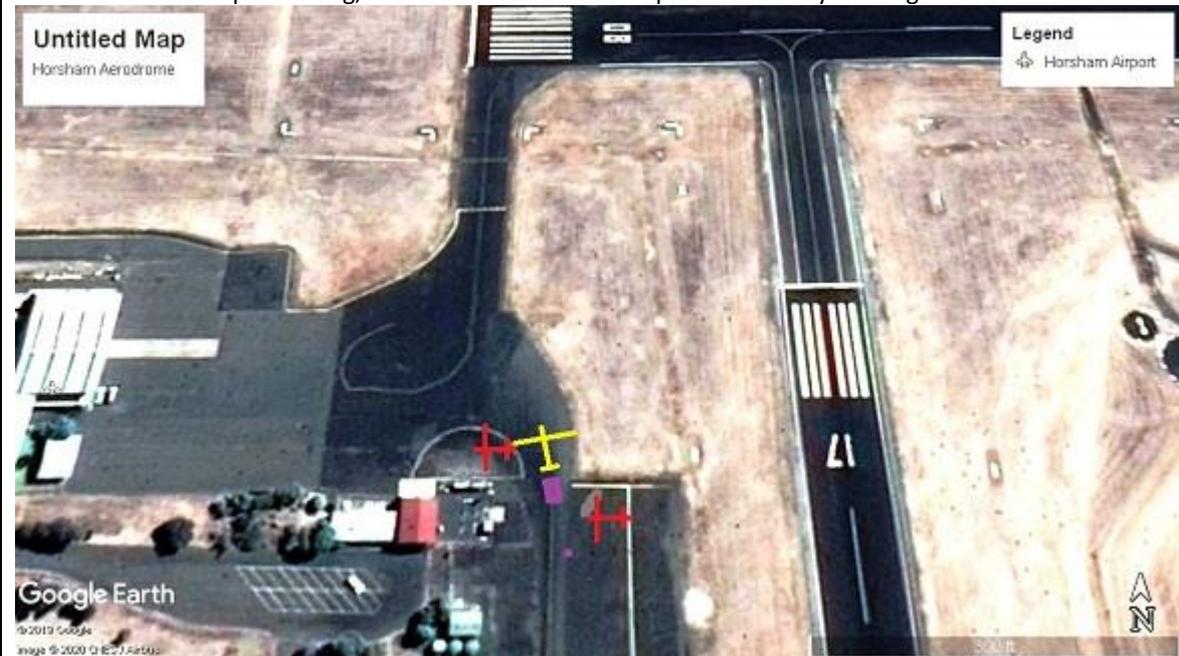
The glider was being taxied back to the hangars at pedestrian speed from runway 08 via the taxiway adjacent to the aerodrome refuelling facility. A Cessna 172 was parked nearby with two crew members in the cockpit. On passing the Cessna, the glider’s starboard wingtip struck the rudder of the Cessna resulting in damage to the Cessna’s rudder skin and trailing edge, and damage to the glider’s wingtip. The glider pilot stated *“In this particular circumstance I was more concerned about safe passing of the aircraft on my left rather than the immediate risk posed by [the aircraft] on my right. I presumed having sufficient distance and directed my attention to the threat yet to develop instead of observing the tail of [the aircraft on the right], thus causing the collision”*. The Club CFI advised that the club encourages members to stop, get out of the car and look before proceeding, and this advice also forms part of the daily briefing.

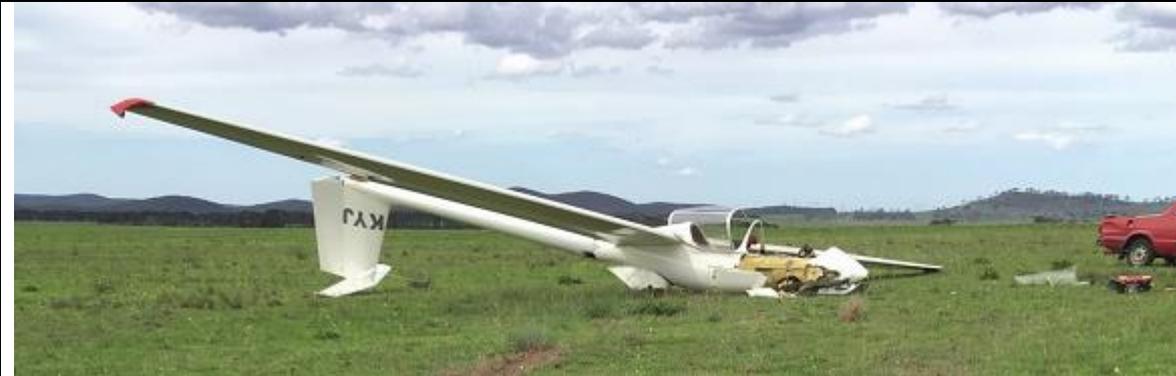
Fig 1. Glider facing 90 degrees to the direction of travel.

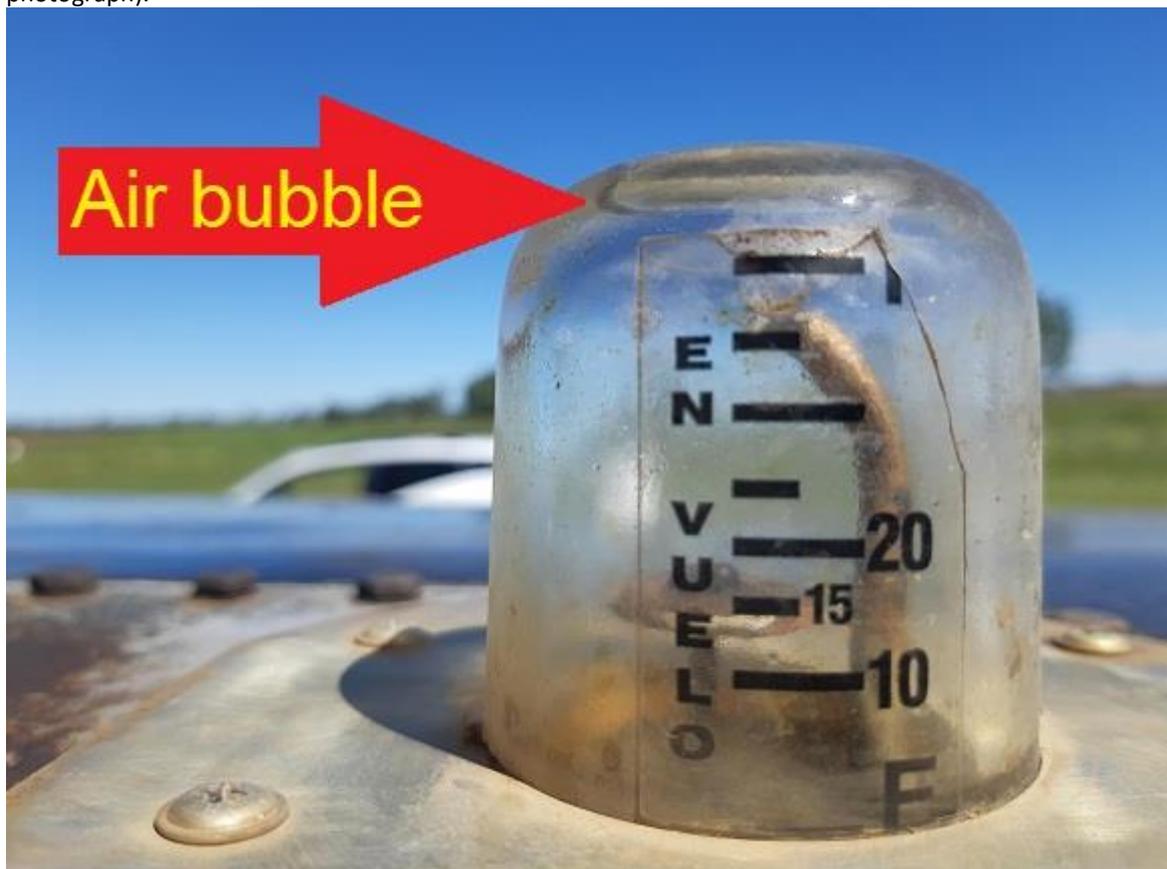
make the runway easy with a 10-knot tailwind, but in the end I only just made it back, touching down just short of the threshold. No Injury and no damage, just relief and a feeling of acute embarrassment. The glider pilot was able to climb away and landed later in the afternoon.” The pilot stated that during the glide back to the airfield, the drag of the windmilling propeller caused the descent to be much steeper than he expected. The pilot noted “The aircraft felt like it would be very easy to stall and lose control.” The Club CFI witnessed the incident and, after the tug landed, noticed that the fuel gauge was still showing full (refer photograph).

After the tow plane was pushed clear of the runway it was noticed that the fuel gauge had dropped to below empty. The tow pilot put some fuel into the tank and the aircraft started normally. The tow plane was then taxied to the fuel bowser and refilled. The aircraft was inspected it was determined that the line to the fuel gauge had become temporarily blocked. The aircraft was returned to service without further incident.

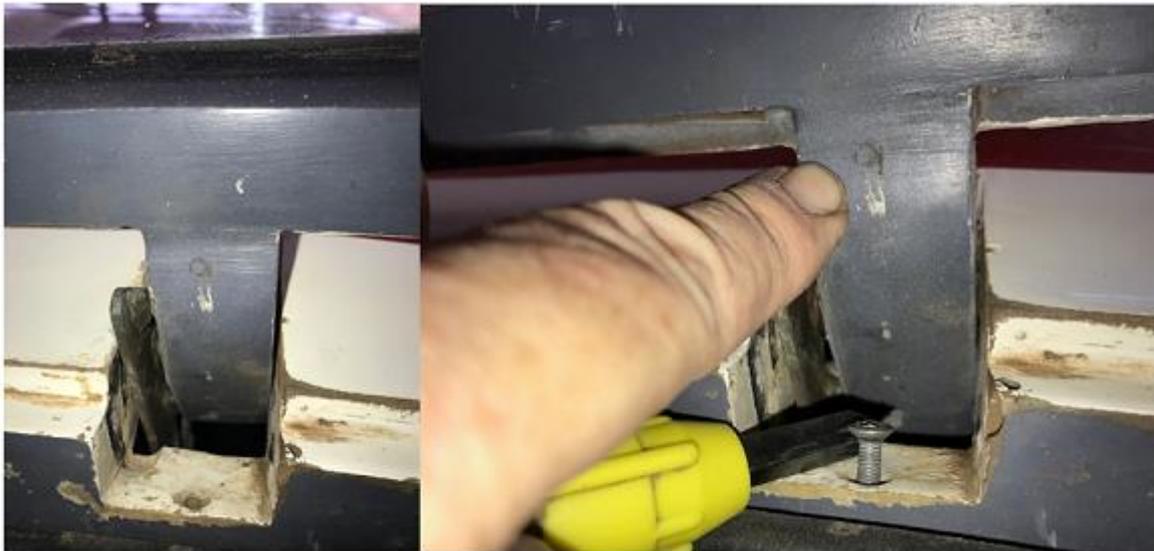
The pilot noted that the canopy is hinged at the front and has a single latch at the rear, behind the pilot's head, that cannot be locked until the canopy is fully seated in place. The pilot stated that it was sometimes difficult to physically turn and look to confirm the canopy was properly closed. The canopy and locking mechanism were inspected by an Authorised Maintenance Organisation who identified two countersunk screws that are orientated near vertically to secure a strut cover plate under the instrument panel had been contacting the forward canopy hinges when closed, thereby preventing the canopy from properly sealing against the fuselage.

Fig 1. Canopy hinge showing wear from ill-fitting screws

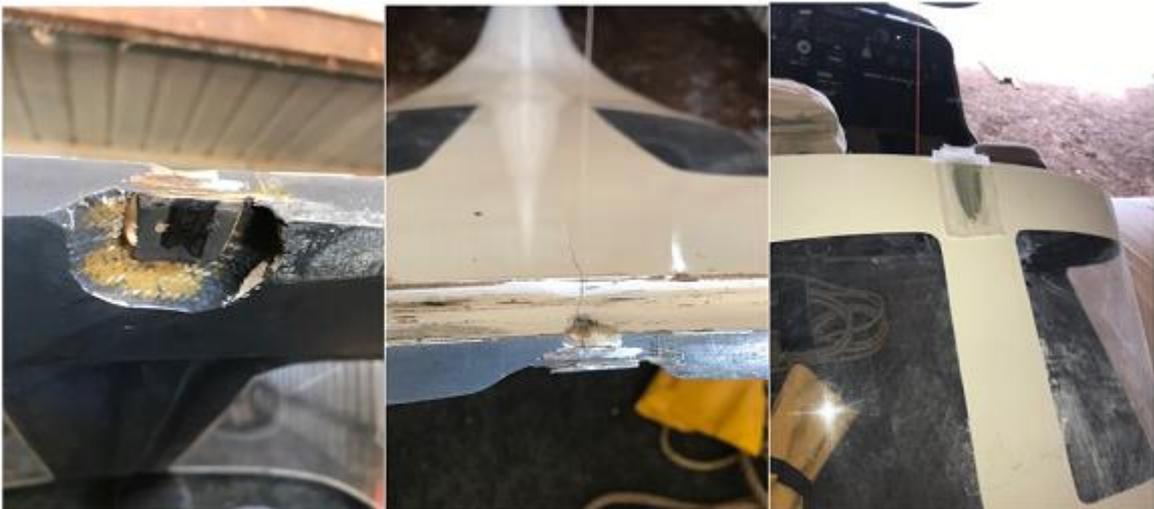
Damage was also identified to the rear frame of the canopy and the top of the fuselage above the canopy locking mechanism.

Fig 2. Damage to canopy locking mechanism

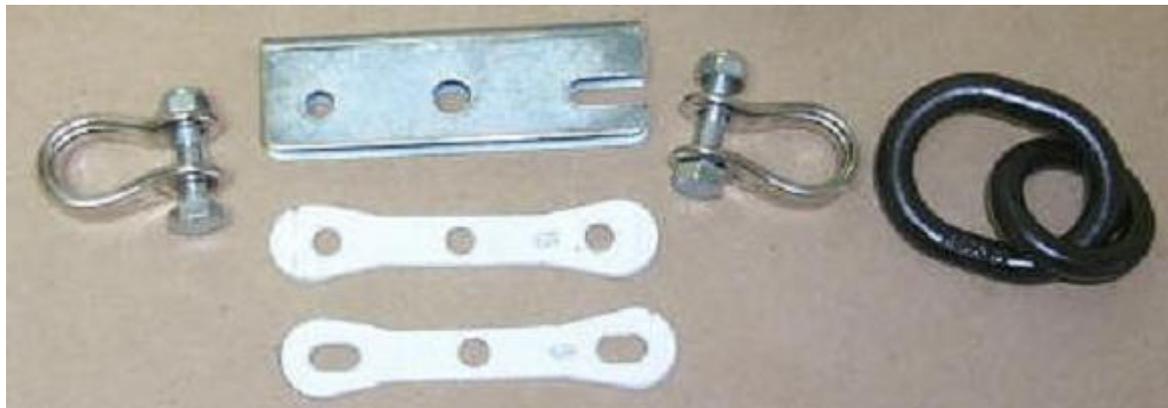
The 'TOST' weak link system uses two metal fishplates in parallel, mounted to the cable and trace by a shackle at each end. A protective steel sleeve is used over the fishplates to prevent wear. The method of protection in the 'TOST' system is simple: one of the fishplates has oval holes at each end and the other has round holes. If the weak link is taken very close to its breaking strength but does not exceed it, the fish-plate with the round holes will break and the fishplate with the oval holes will remain in place allowing the launch to continue.

This incident highlights the main risk with the 'TOST' weak link system. Care is needed to replace the broken fishplate with EXACTLY the same item as the one that broke. Never use two equal inserts, e.g., both with

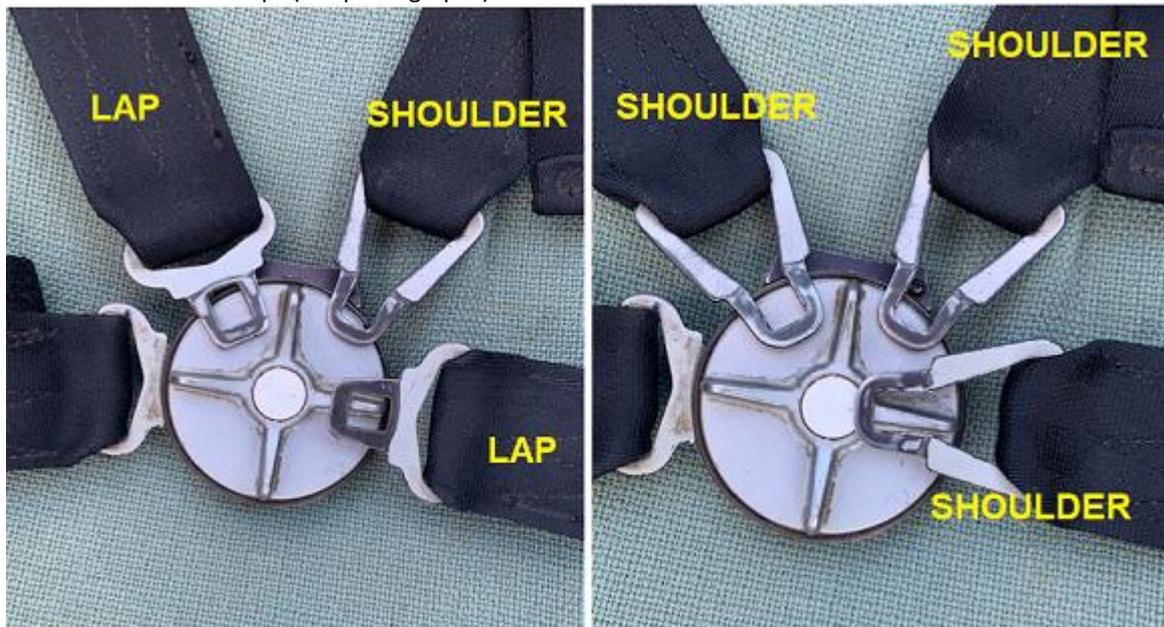
An annual inspection had been completed on the sailplane three weeks earlier (on 27/06/2020) and a dual inspection had been conducted before the aircraft was released to service. The aircraft was flown on that day without incident. The glider was flown on several subsequent days, also without incident. Inspection of both the front and rear harness assemblies revealed the straps had been incorrectly assembled. The front seat harness comprised three lap straps and one shoulder strap, and the rear seat harness had one lap strap and three shoulder straps (see photographs).

Front harness configuration

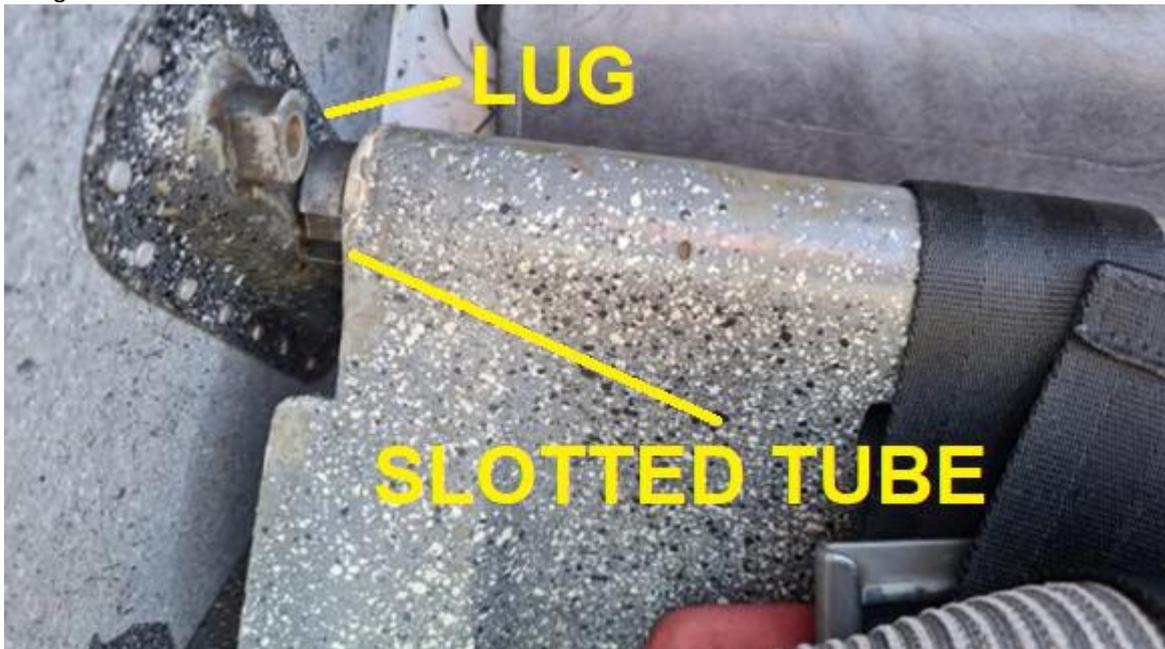
The rear seat in this sailplane can be adjusted fore and aft for pilot comfort. The rear seat adjustment is done by rotating a tube on the rear top of the seat into a position where slots in this tube settle over one of four round lugs flattened on opposing sides to match each slot in the seat tube (see photograph 1). Once slipped over the lugs, the tube is rotated so that the slots are no longer lined up with the flattened sides of the lugs.

1. Rotating tube and supporting lugs

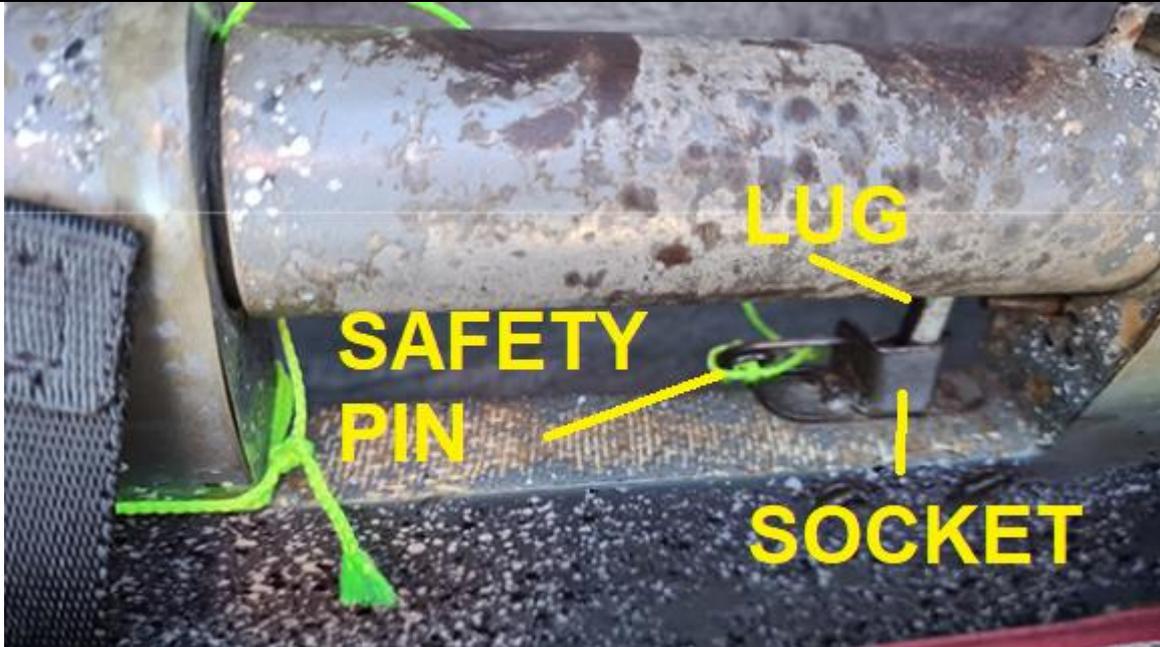
In the middle of the seat tube is a small lug that rotates into a holding socket on the seat back. This small lug is then secured in place by a safety pin. Having the pin in safety does not guarantee that the seat is correctly attached as it merely stops the tube from rotating (see photograph 2).

2. Rotating tube in safety

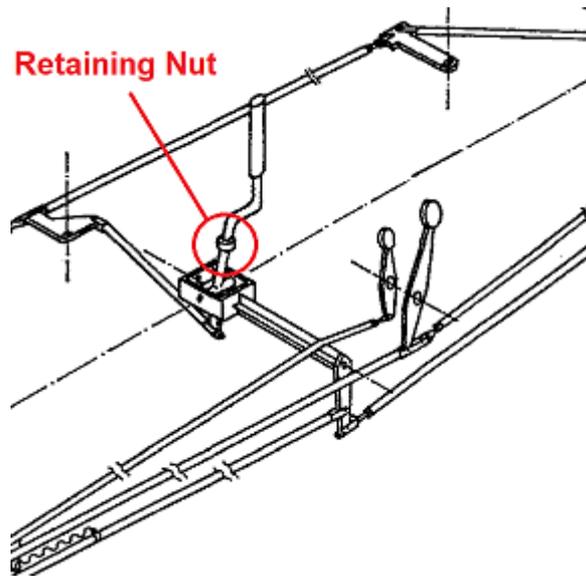
The rear control column in the Twin Astir is detachable and held in place by a knurled retaining nut (see diagram).

The knurled nut is secured by hand pressure in order to facilitate removal when flying passengers in those countries where this is required by law. The knurled nut is hidden from regular sight by a boot over the control column. Post flight inspection revealed the knurled retaining nut had come loose. The glider had been returned to service two days previously after having had an extensive refurbishment and annual inspection carried out at an approved maintenance facility. Investigation determined the knurled retaining nut had previously been secured with a thread-locking compound but, following removal of the rear control column during the recent maintenance, the retaining nut was then secured by hand tightening alone. The Club maintenance inspector applied a thread-locking compound to the nut and it has remained secure since.

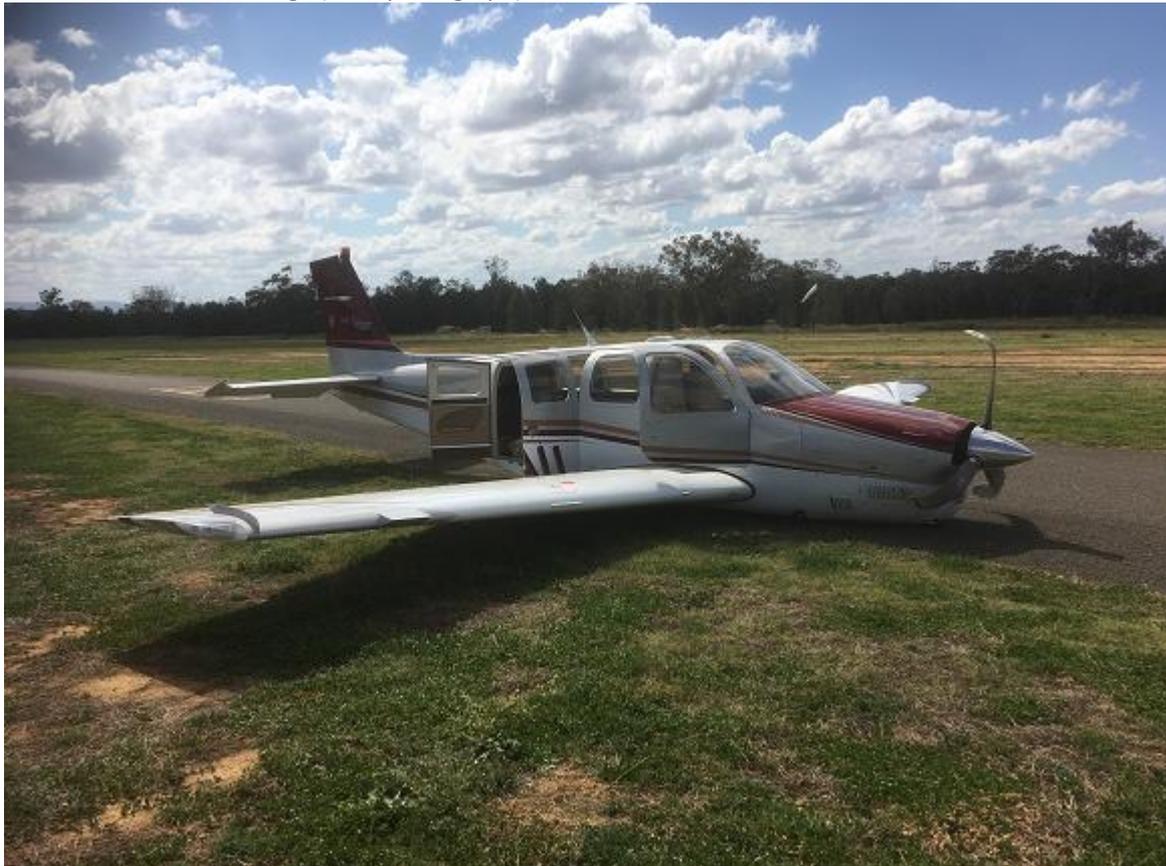
On the day prior to the accident the Beechcraft pilot obtained permission to land at the gliding site to attend a function at the nearby Holiday Park. On the day of the accident the pilot contacted the gliding Operations Manager by radio to advise of his arrival and was informed that the runway *“was clear except for a glider and attending vehicle on the threshold of Runway 14”*. The glider had recently been towed onto the runway by its pilot, who was readying it for flight, and was still attached to the towing vehicle. The pilot of the Beechcraft reported that he was informed *“the glider would not be departing for 30 minutes”*. After joining midfield crosswind for runway 14, the Beechcraft pilot attempted to contact the gliding operation but did not receive a response. This was likely due to the Operations Manager leaving his office to watch the arrival of the Beechcraft, and because the glider pilot was not monitoring the radio (the glider pilot stated he *“had a hand-held radio VHF in the car but the glider radio had not been turned on yet”*). The Beechcraft pilot chose to land beyond the vehicle and glider. The Beechcraft touched down about 700 metres along the 1300 metre runway with the undercarriage retracted, and the aircraft slid a further 100 metres. The aircraft suffered substantial damage (refer photograph).

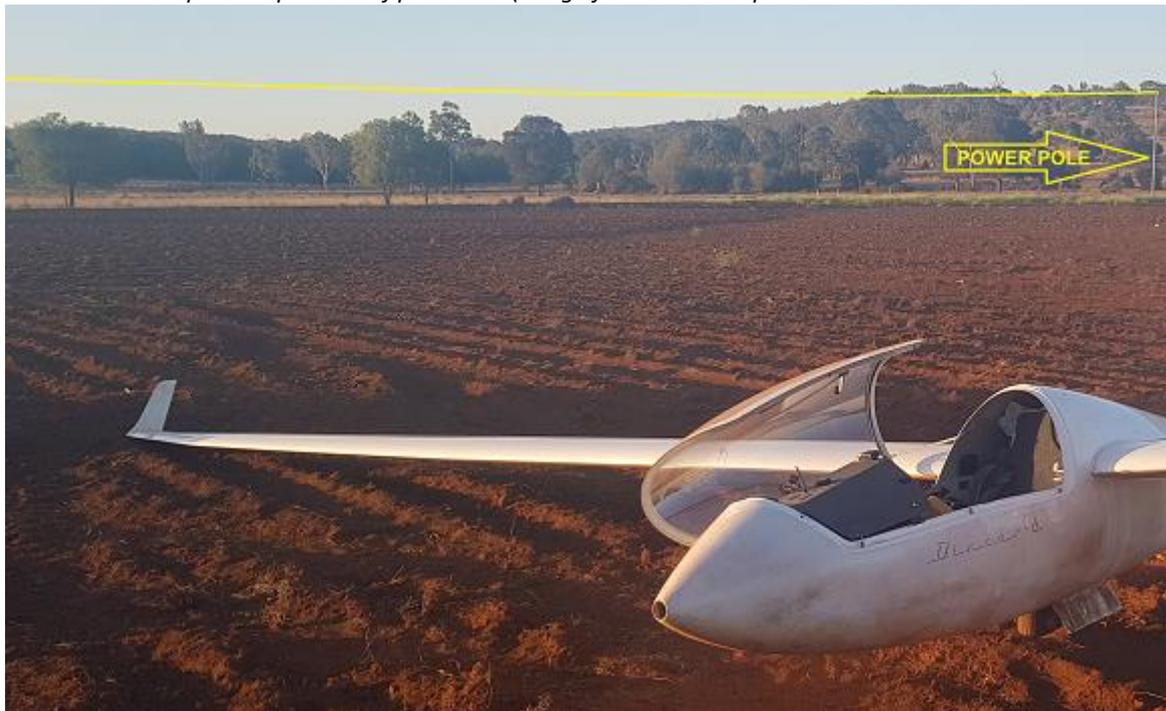
Photograph 1 – Glider, with powerline across approach path marked in yellow.

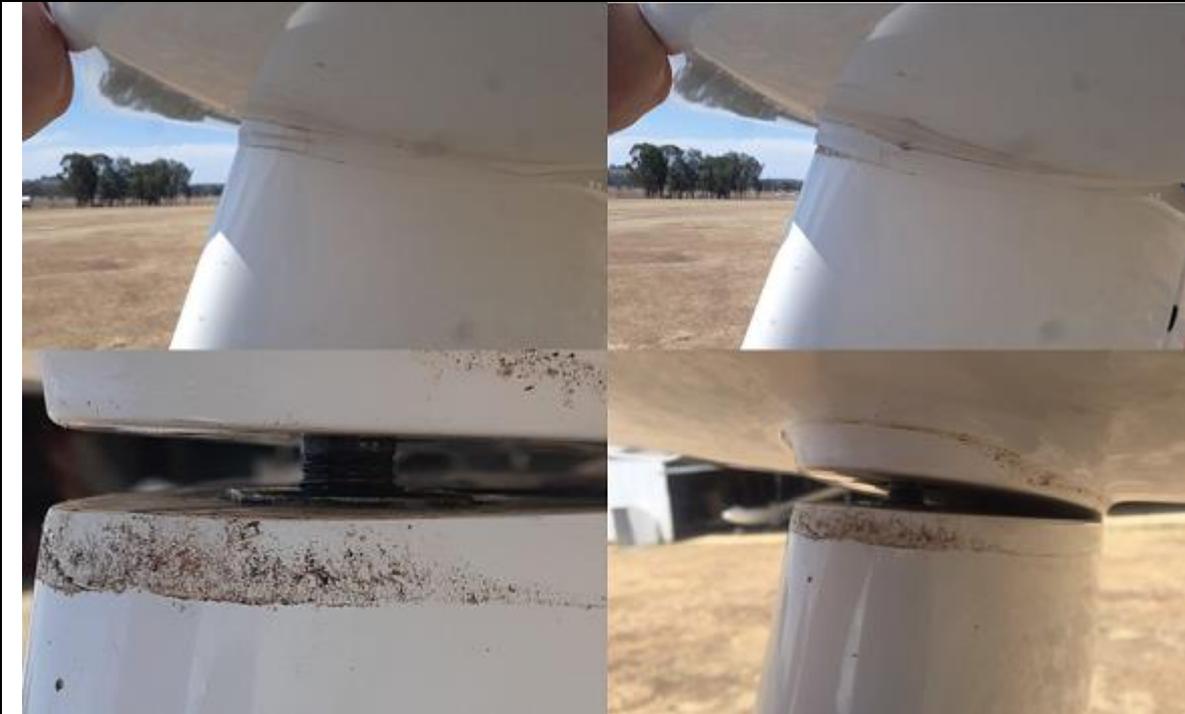
Pic 1 – Ill-fitted tailplane.

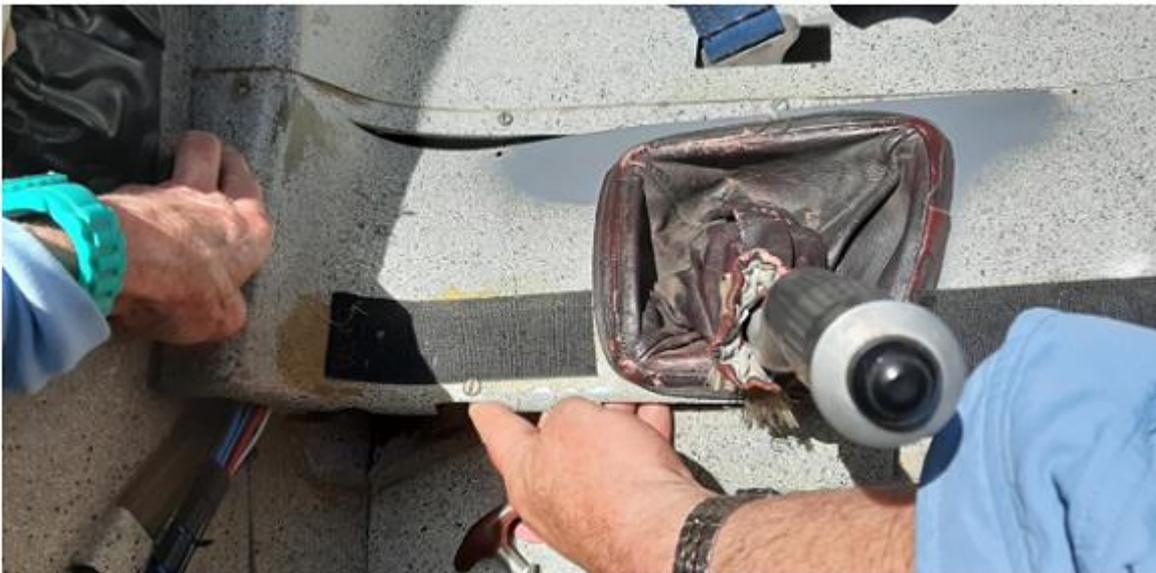
Photo 3 – Seat pan cover displaced and distorted.

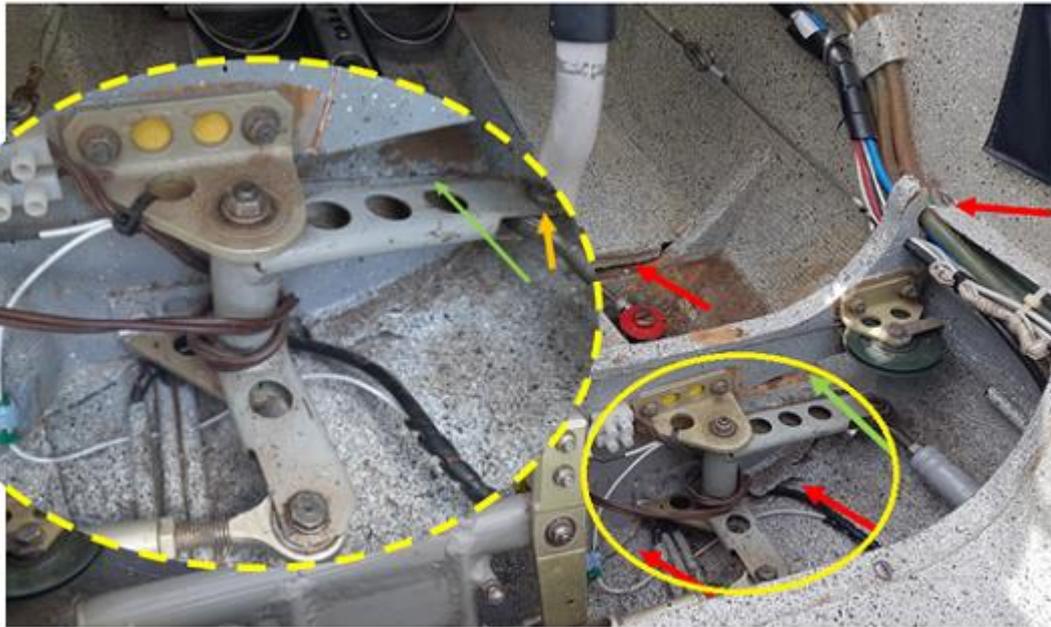
Photo 4 - The nut on the bolt (orange arrow) contacted with the bulkhead preventing movement of the bell crack through the cavity (green arrow).

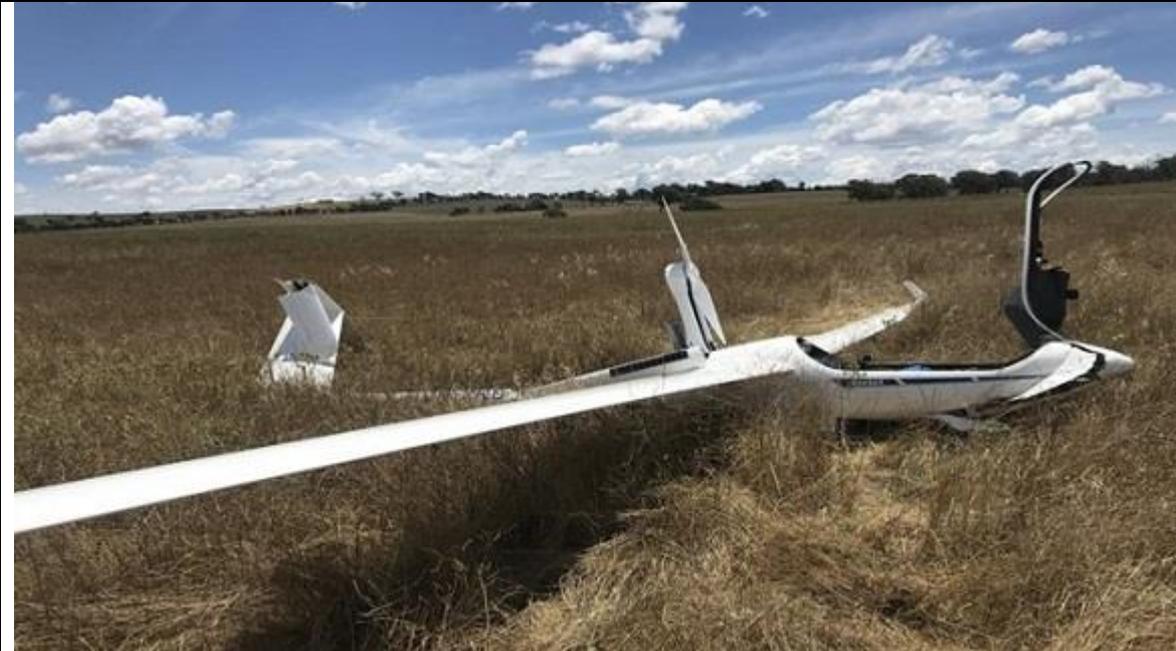
Fig. 1 – Damaged Glider
