# Collision with terrain involving experimental ASH-25E glider VH-GOA

13 km west-north-west of Bathurst Airport, New South Wales, on 21 January 2018

**ATSB Transport Safety Report**  
Aviation Occurrence Investigation  
AO-2018-009  
Final – 17 December 2019

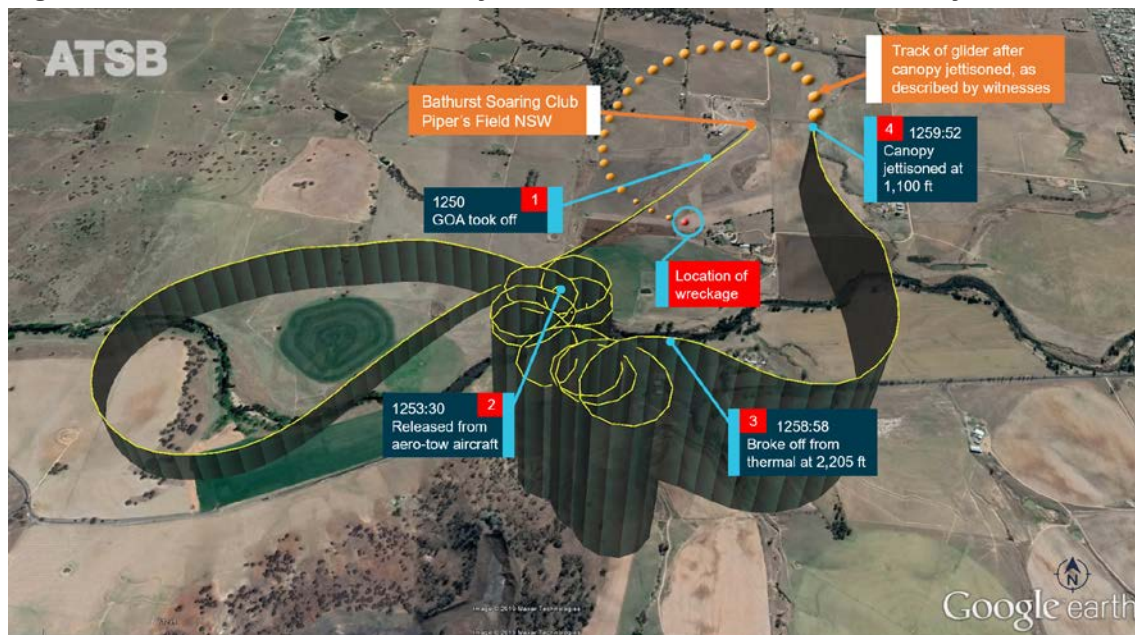
**Figure 2: Aircraft track as recorded by the on-board GPS and as recalled by witnesses**

Witnesses at the airfield reported that, after departing, (Figure 2, item 1), GOA tracked out for about 1.5 NM. The pilot released from the aero-tow aircraft at 800 ft above ground level (AGL)<sup>2</sup> (Figure 2, item 2), made a radio call on the Soaring Club frequency that he had disengaged from the aero-tow. On-board GPS position and altitude information showed that by 1258:58 GOA had climbed to 2,205 ft AGL in a thermal situated to the south of the airfield. The glider then abruptly departed the thermal and started to descend and track back towards the northern end of the airfield (Figure 2, item 3).

Witnesses reported seeing something trailing from GOA, which they thought was smoke or a liquid, while the glider was in a steep nose-down attitude. They then saw flames emanating from the top and bottom of the airframe, behind the cockpit (Figure 3). The pilot jettisoned the front seat canopy at 1259:52, at a height of about 1,100 ft AGL (Figure 2, item 4), but despite wearing a parachute, he did not exit the glider.

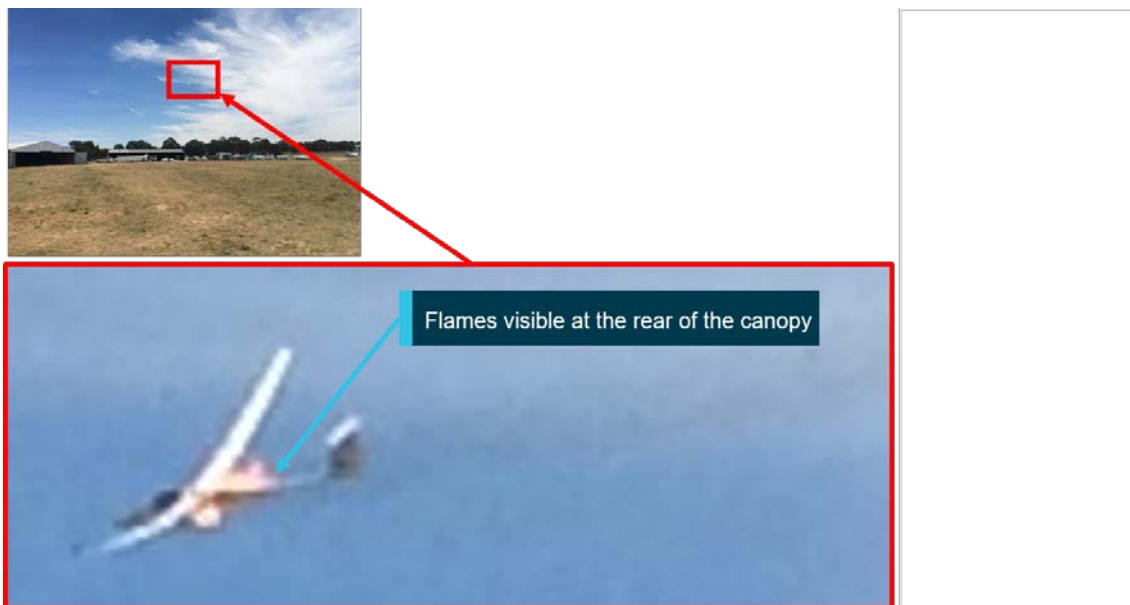
**Figure 3: Photograph of GOA after the front canopy was jettisoned**

At this stage, GOA was seen maintaining a steep nose-down attitude and high speed with a bank angle of about 15°. Witnesses also recalled that there did not appear to be any discernible control inputs after the canopy was jettisoned and by the time the glider descended to about 500 ft AGL, more of the fuselage was engulfed in fire. At about this time, at least one of them called emergency services.

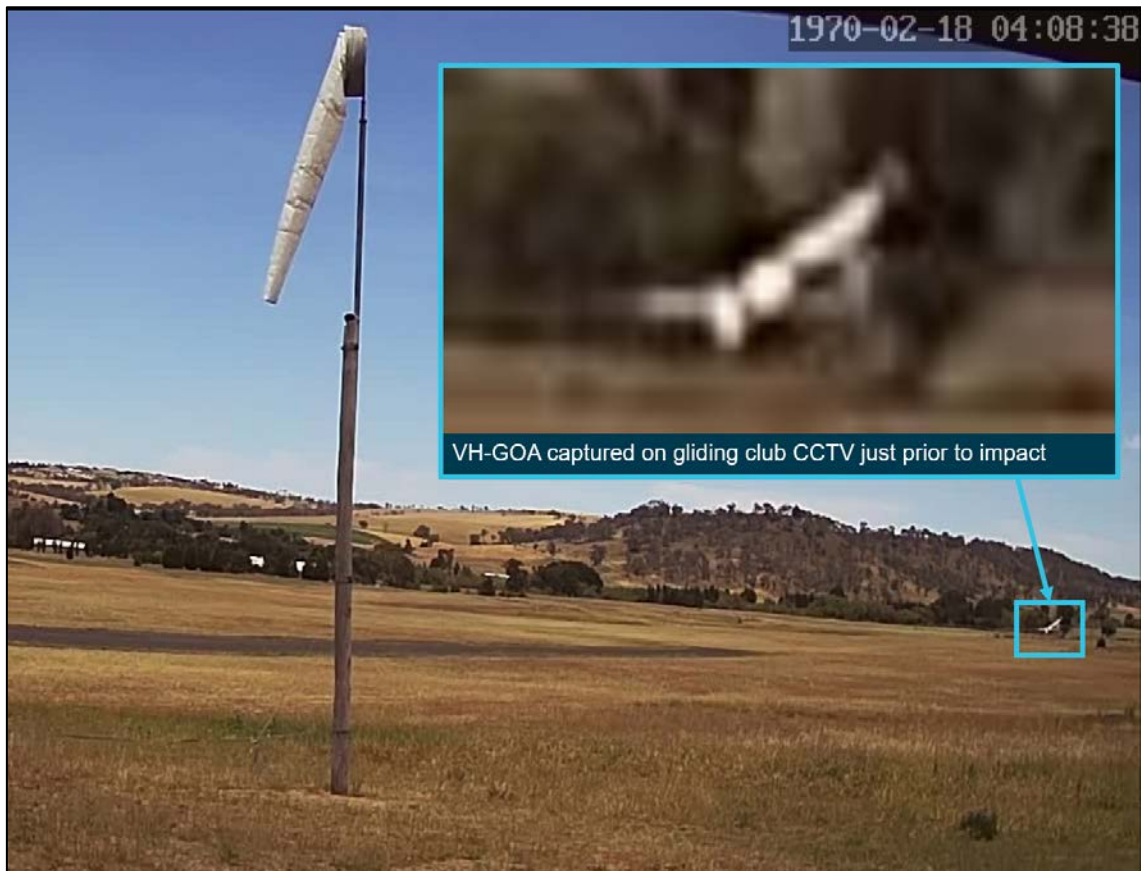
**Figure 4: The glider immediately before impact**

The soaring club's closed-circuit television camera recorded that the glider banked left just prior to impact (Figure 4). A witness similarly reported that the glider's left wing tip impacted the ground first, before it came to rest in an inverted position. The wreckage continued to burn after impact, and a fire spread to the surrounding grass.

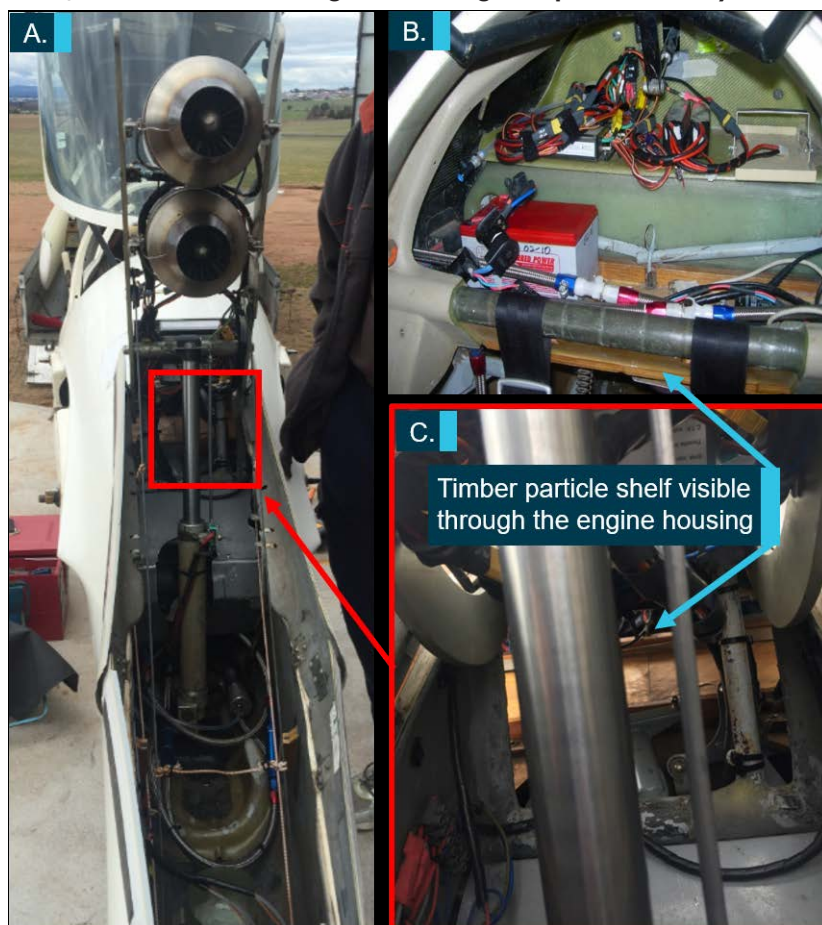
**Figure 7: Engine housing and cockpit (A. Engines – rear view, B. Cockpit area – rear view, C. Area between engine housing and particle shelf)**

Finally, the glider's cockpit and engine housing were not separated by a firewall. That resulted in limited containment of smoke and fire, and reduced the available time to make an emergency exit.

Between the engine housing and the shelf in the cockpit, there was an unobstructed opening through to the timber particle shelf (Figure 7, item B and C). In their investigation report, GFA stated that 'it is likely that when the two stroke engine removal [was done], the electronic shroud cover and carbon fibre electronics bay were removed from the aircraft and not refitted.' An inspection of the images of the particle shelf, and remnants of fuel lines, indicated that there did not appear to be any heat protective sleeves used.

Although not an airworthiness requirement, pilots of powered experimental gliders are strongly encouraged to install fire protection between themselves and the engine housing. The ability to exit a glider relies on avoiding incapacitation that can happen quickly in the event of in-flight fires.

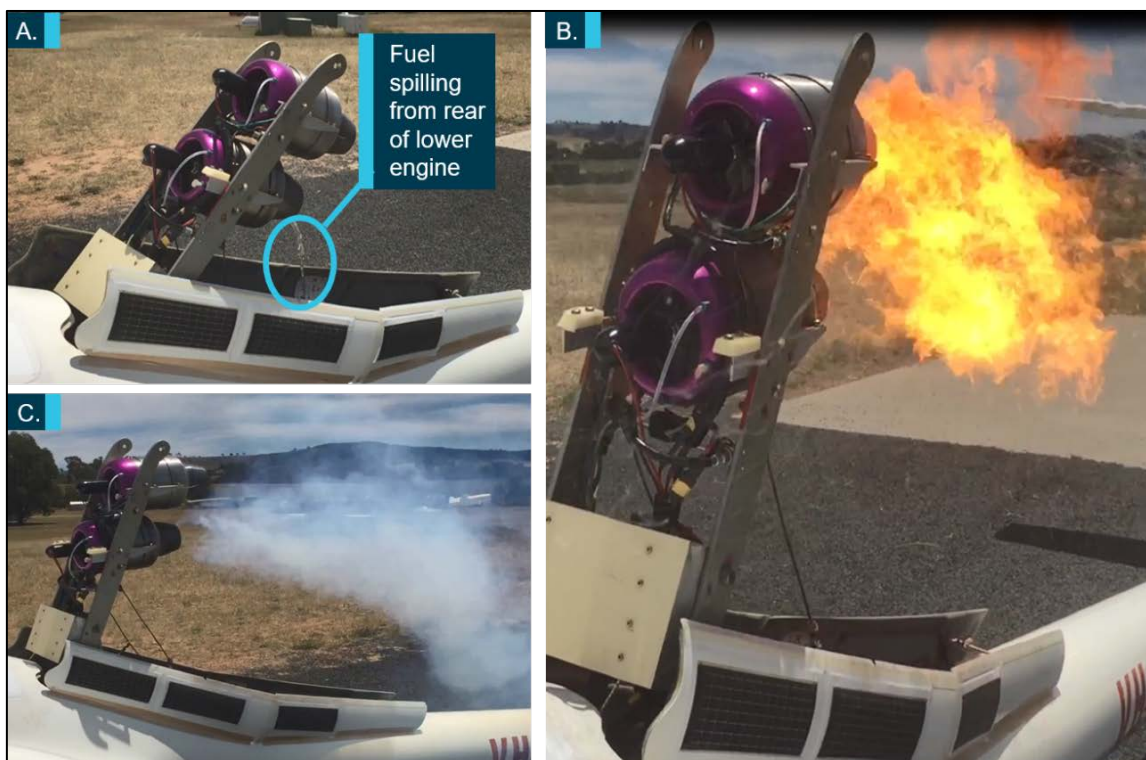
**Figure 8: Photographs from engine testing**

The ATSB considered how the recorded fuel leak from the lower engine may have occurred, and consulted with gliding experts and the manufacturer. They advised that there may have been a leak within the fuel lines, or at the connection point between the PFTE tubing and the engine cowling. It was the manufacturers' opinion that this can occur when the lines are roughly cut (for example using pliers).

It was evident from the video taken that the radial compressor on the lower engine was not rotating. Therefore, another possible source of the leak may have been the way the fuel flow was initiated. The system was designed to engage the fuel pump only when the engine speed reached a certain level. Therefore, it should not have been possible for fuel to flow while the compressor was not rotating.

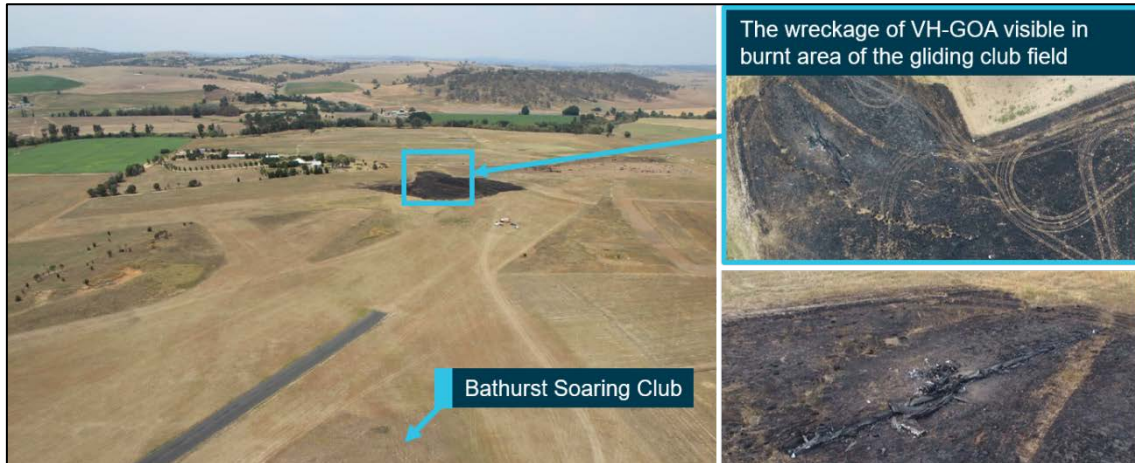
**Figure 10: Location of the wreckage on the Bathurst Soaring Club property**

The aircraft wreckage was located in a large burnt patch of grass on the property of Bathurst Soaring Club, about 445 m away from the threshold of airstrip runway 03. The wreckage trail was spread across about 125 m. Ground scars and evidence from the wreckage indicated that GOA impacted the ground in a nose-down, left wing configuration in a northerly direction, then rolled or tumbled after the initial impact and came to rest inverted. It was determined that the impact

The shattered components of the canopy, as well as the GPS unit and flight recorder, were found on private property adjacent to Piper's Field, about 440 m away from the fuselage.

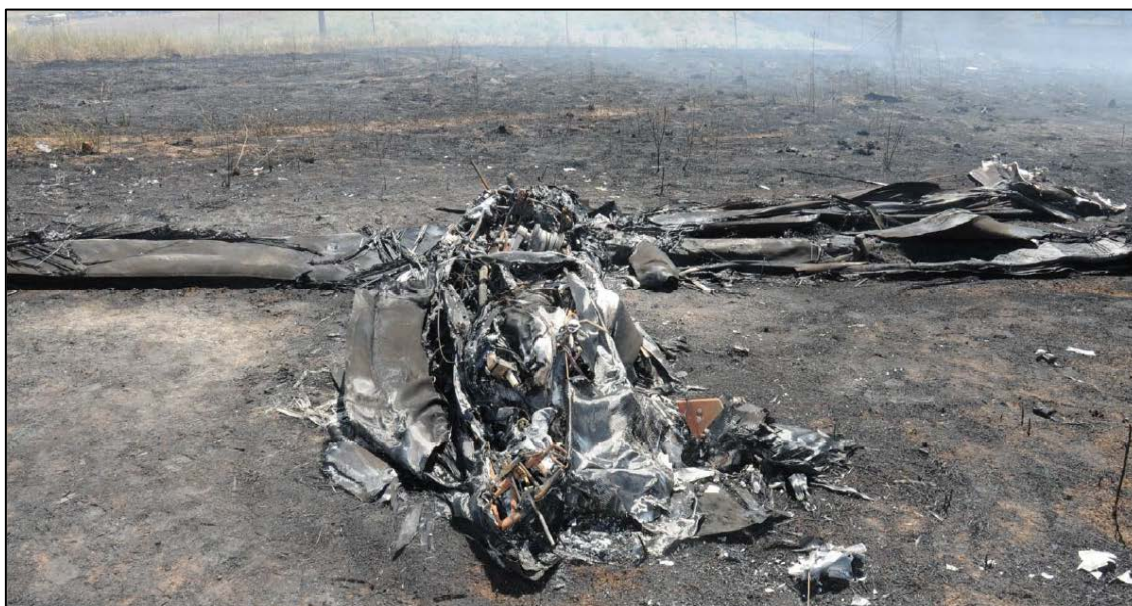
**Figure 11: Wreckage of VH-GOA**

On-site examination of the severely fire- and impact-damaged fuselage, wings (Figure 11) and engines did not identify any obvious pre-existing faults that could have contributed to the accident. The wings, although destroyed in the post-impact fire, had all carbon fibre structures accounted for. The flap position at time of impact could not be determined. The engine pylon appeared to have been lowered at the time. A propane canister was found, but damage from the fire meant that it was not possible to determine whether it had contained any gas. The landing gear mechanism was found in the extended position, suggesting it had been lowered prior to the impact. The pilot was located within the wreckage around the area of the cockpit, although it could not be determined if he was secured in his seat.

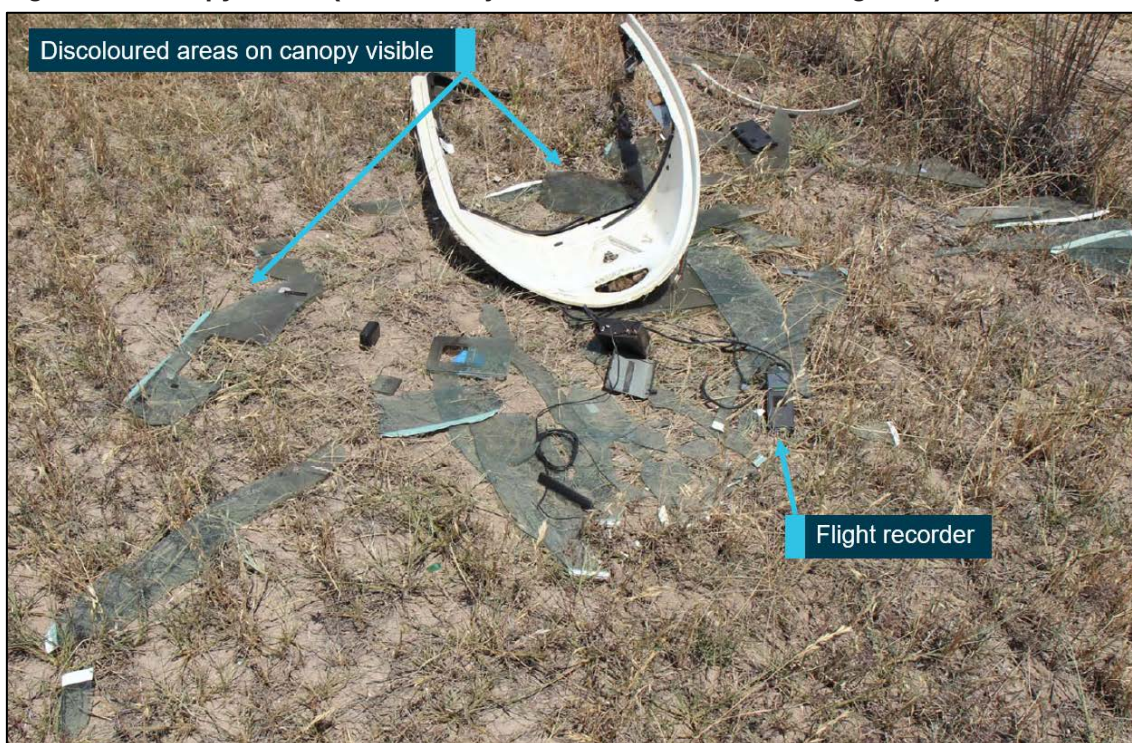
**Figure 12: Canopy in-situ (in a field adjacent to the Bathurst Soaring Club)**

A small number of components were retained for further examination and testing. The shattered components of the canopy's Perspex were also examined. There was evidence of smoke residue on some of the shards (Figure 12) on the internal side of the canopy. There was also some residue on the forward third on the external side of the canopy's 'clearview' hatch. These indicated that there was some smoke inside the cockpit, and it had passed through that hatch.
