AIRWORTHINESS ADVICE NOTICE

TYPE AFFECTED: PW-5 Smyk.

SUBJECT: Miscellaneous airworthiness information.

GFA AN 107	ISSUE: 7	12 May 2023	
-------------------	-----------------	--------------------	--

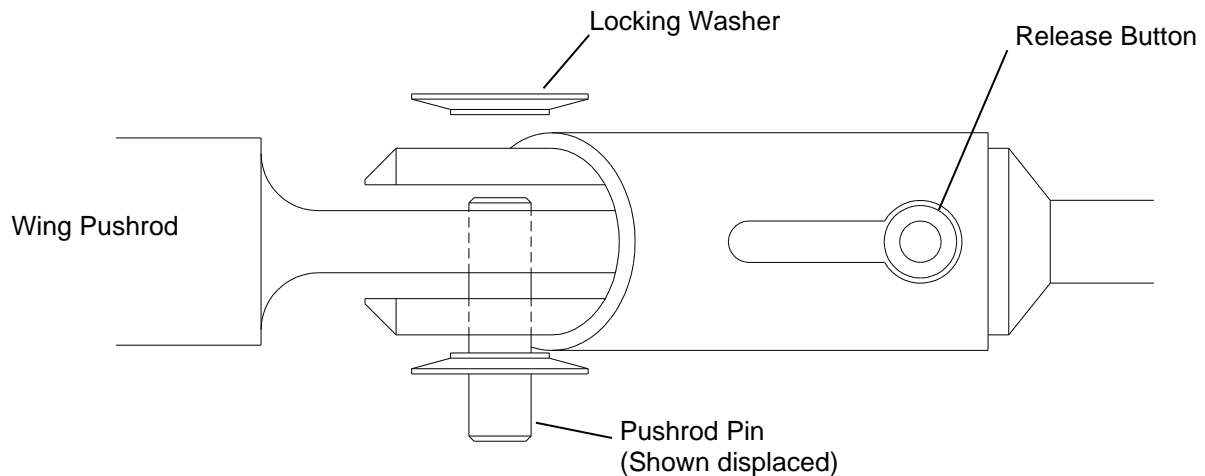
Figure 1 aileron and airbrake connector

DEFECTS: ***1. Quick connectors in aileron and airbrake circuits.***

Experience has shown that the locking washer on the connecting pin in the connectors may work loose allowing the control to be connected incorrectly as shown in figure 1.

Should the locking washer be loose then the defect must be rectified before next flight.

The defect may be rectified by either replacing the washer with a new part (the best option) or by cold forming the washer until the hole is between 5.980 and 5.990 mm diameter.

Cold forming should be done by either pressing flat between plates or by placing a steel ball (~ 20 mm ø) on the hole and then tapping with a hammer. If using the steel ball method the washer should be turned over and the process repeated.

Before pressing the washer on, the pin diameter should be checked for the correct size of 5.992 to 6.000 mm diameter.
