GFA AD 558

GFA AIRWORTHINESS DIRECTIVE

TYPE AFFECTED: DG-400, all Serial Numbers.

SUBJECT: Cracking of rear plate of propeller mount.

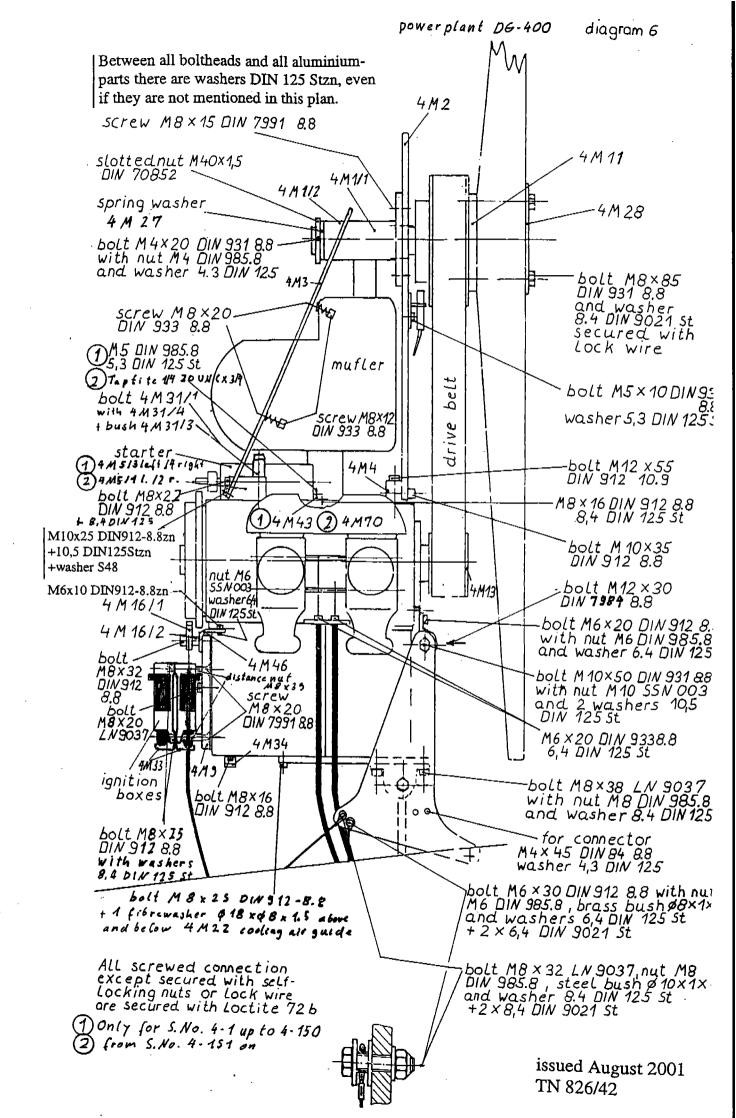
: At one DG-400 cracks occurred in the rear plate of the propellermount starting at the outside diameter of the washer below the bolthead of the lower bolted connection.

Remove the left mounting bolt and its washer first, if necessary heat the bolt to loosen the Loctite securing. Clean the plate in this area and check if the washer has left a mark in the plate and if cracks are visible. Cracks can be seen easily due to the oil residues which have penetrated into the crack. A mark of max. 0.1mm is acceptable. If the mark is deeper and / or if there are any cracks, the plate 4M3 has to be replaced. Check also the mounting blocks 4M5 for cracks and replace them if necessary.

Clean the inside threads according to the instructions on page 46d maintenance manual. Then assemble the new bolt M10x25 DIN912-8.8zn with the aluminium washer S48 next to the rear plate followed by the existing washer 10.5 DIN125 Stzn, use Loctite 243 or 672 (72b) to secure the bolt. Tighten the bolt with a torque wrench, torque 4 daNm (30 ft.lb.).
