GFA AIRWORTHINESS DIRECTIVE

TYPE AFFECTED: Nimbus-3DT

SUBJECT: Amendments to Maintenance Manual

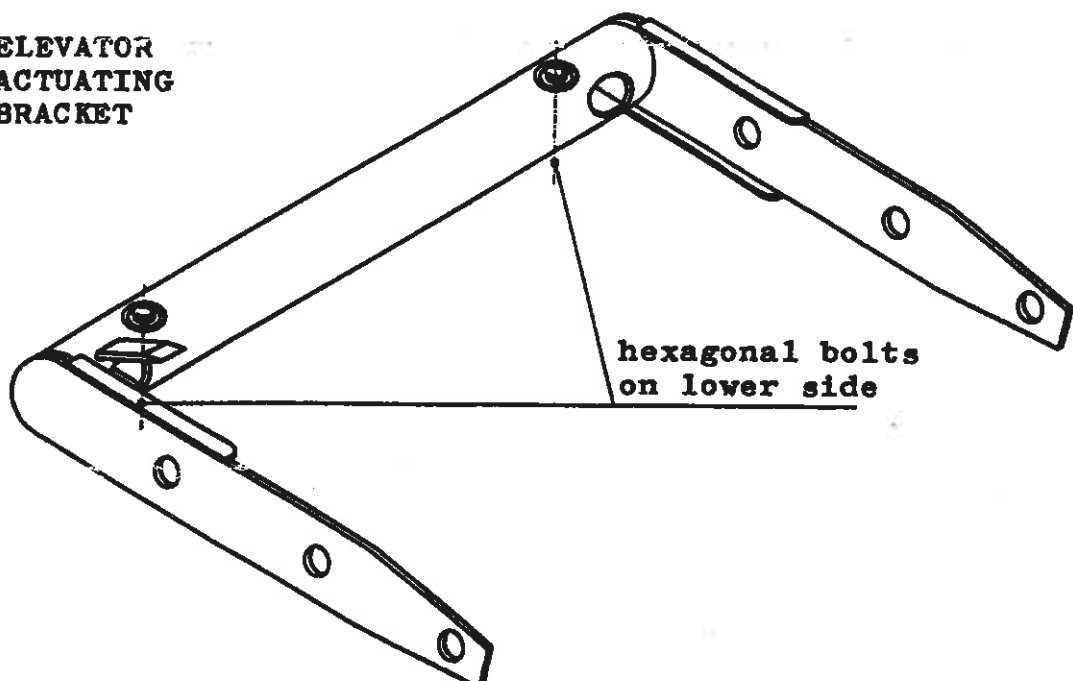
ELEVATOR
ACTUATING
BRACKET

If an excessive vertical play is found at the tips of the horizontal stabilizer, then the adjustable bushings of the elevator actuating bracket should be tightened such (using a 4 mm Allen key) that the tailplane will just slide onto its locating pins.
