AIRWORTHINESS DIRECTIVE

THE GLIDING FEDERATION OF AUSTRALIA Inc

GFA AD 688 Issue 1

Type Certificate Holder	Various
Manufacturer(s)	Various
Types/Models Affected	All aircraft fitted, or previously fitted, with a relief tube
Serial Numbers	All
Subject	Corrosion of Controls and Fittings in Aft Fuselage
Implementation	MANDATORY
Background	<p>An owner of a Schempp Hirth aircraft identified corrosion on the aft end of the elevator pushrod in the fuselage. On removal of the pushrod, the aft end of the rod broke off completely.</p>

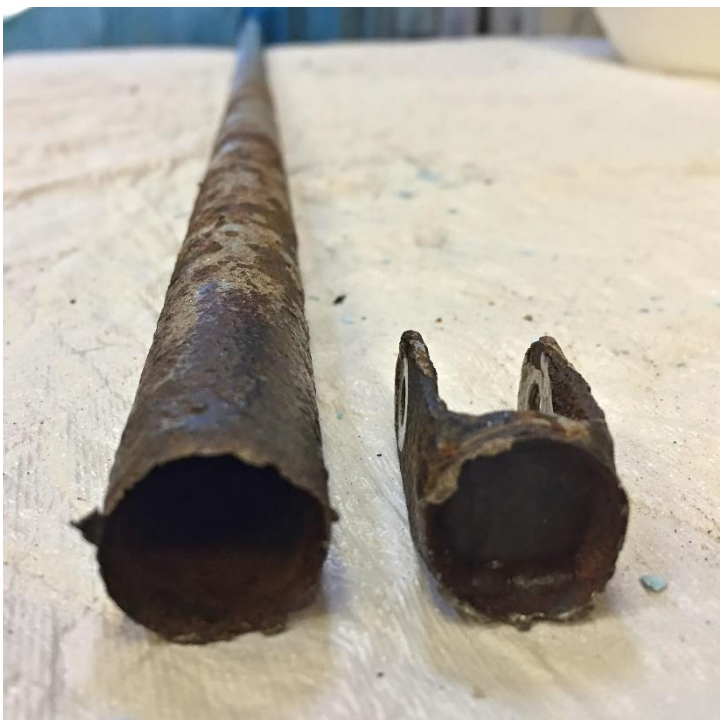
<p>Figure 1: Elevator Pushrod Failure</p>

<p>Other signs of corrosion were seen on nearby fittings.</p> <p>The cause is likely to be urine from the relief tube or water from water ballast flowing along the underside of the fuselage and being drawn back into the fuselage through the drain hole in front of the tail wheel. The area is difficult to inspect and was found by looking down the fin through the slot for the vertical pushrod in the bottom fin rib.</p> <p>This Airworthiness Directive mandates a visual inspection of all metal pushrods and fittings in the bottom of the fin and aft end of the fuselage for corrosion.</p>
Documentation	N/A
Required Action(s)	<p>1. Annual Inspector: By no later than 20 Jul 2020 or before next flight whichever is the latest, visually inspect all metal pushrods and fittings in the bottom of the fin and aft end of the fuselage for corrosion.</p> <p>Tools Required Torch Mirror on extendable handle Inspection camera or boroscope</p> <p>a. For many T-tailed aircraft, inspection can be achieved by removal of the horizontal tail and unsealing the boot around the elevator vertical pushrod (if fitted). Direct a suitable inspection camera or boroscope down the vertical pushrod and inspect the bottom end of the vertical pushrod, the bell crank, the aft end of the horizontal pushrod for the elevator and any mounting brackets.</p>

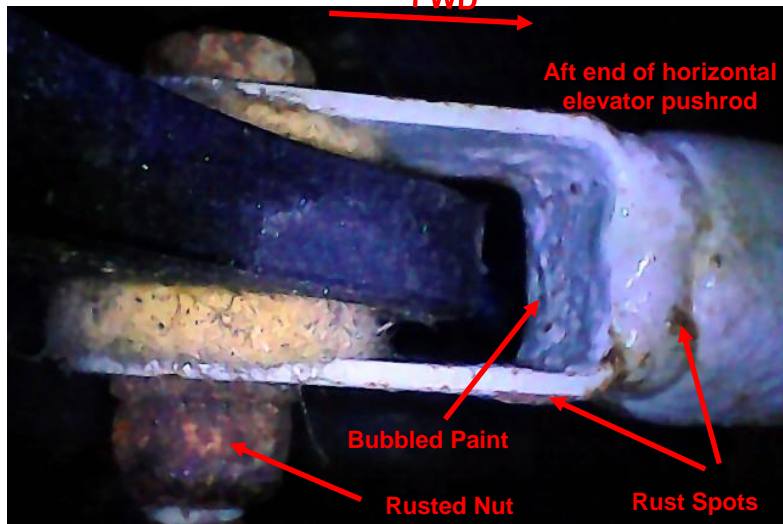
<p>Figure 2: View of Elevator Pushrod Via Inspection Camera Down Through Vertical Fin (Ventus 2)</p> <div style="border: 1px solid black; padding: 10px; margin-top: 10px;"> <p style="text-align: center;">CAUTIONS:</p> <p style="text-align: center;">Underside of pushrod may be in worse condition. Bubbled paint may hide corrosion pits.</p> </div>

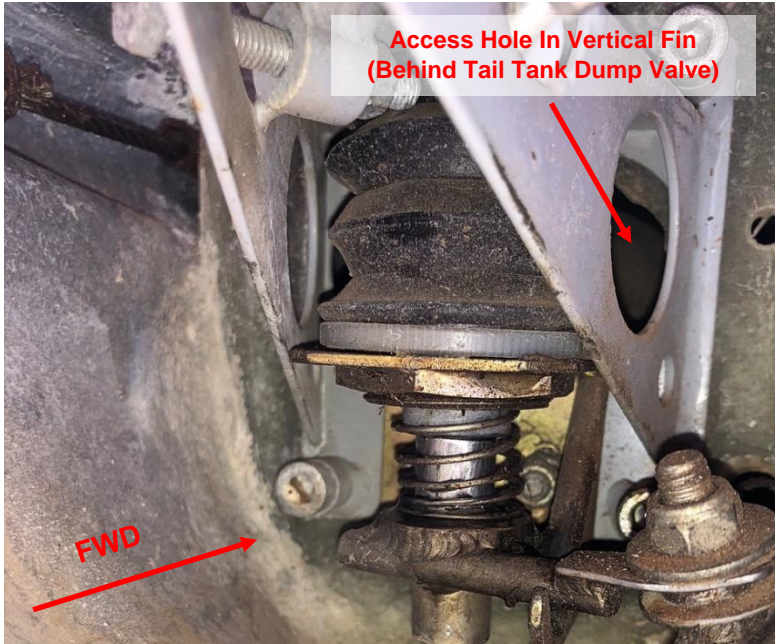
<p>Figure 3: View of Access Hole Through Bottom of Vertical Fin (Behind Tail Tank Dump Valve)</p> <p>c. The maintenance manuals for some aircraft allow for inspection holes to be drilled in specific locations of the fuselage. Consult your aircraft maintenance manual or the aircraft type certificate holder prior to drilling holes for the correct size and location.</p> <p>2. If corrosion is found it must be report to the CTO cto@glidingaustralia.org. The annual inspector must make a judgement as to whether the aircraft is safe to continue operation in its current condition. If the aircraft is allowed to continue operation with rust in situ and without immediate repair, the aircraft is to be reinspected at each annual inspection to determine corrosion growth and continuing safety.</p>

<p>b. For other aircraft, inspection can be achieved by removal of the rudder and using a torch and mirror with extendable handle or inspection camera to view the pushrod and fittings either through an access hole in the fin spar or through rudder pushrod / cable hole(s). This may require removal of the lower rudder mounting bracket and / or the dump valve for the tail ballast tank (if fitted).</p>
