## AIRWORTHINESS ADVICE NOTICE

**TYPES AFFECTED:** Grob G 109 & G 109 B Motor Glider

**SUBJECT:** Miscellaneous airworthiness information.

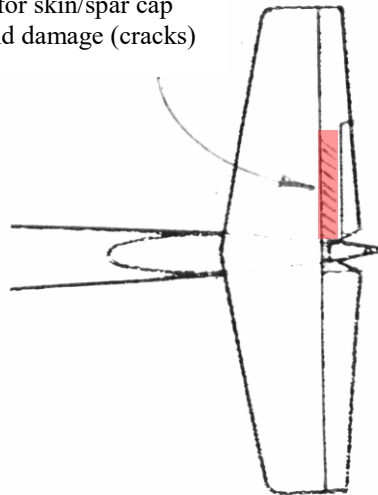
**Figure 1: Elevator Spar Inspection Area.**

4. DELAMINATION OF ELEVATOR SPAR AND TOP SKIN (G 109 B)  
There is a reported incident of the elevator top skin separating from the spar cap, at and either side of the cutout in the spar accessing the trim tab push rod. The cause is considered to be either Grob has cut away the spar web and spar cap to allow the pushrod to clear the structure, thereby weakening the elevator locally or ground impact on the tailwheel may cause bending at the cut out, eventually promoting separation of the top skin and the spar.

Inspect here for skin/spar cap separation and damage (cracks)

A. Annual inspection should include careful inspection of this area.

B. If the separation travels far enough the center hinge will become loose in the elevator - requires inspection, both annually and daily.

C. After any ground impact, inspection of the area is strongly recommended.

D. All defects found are to be reported to your RTO/A or CTO for possible further action.

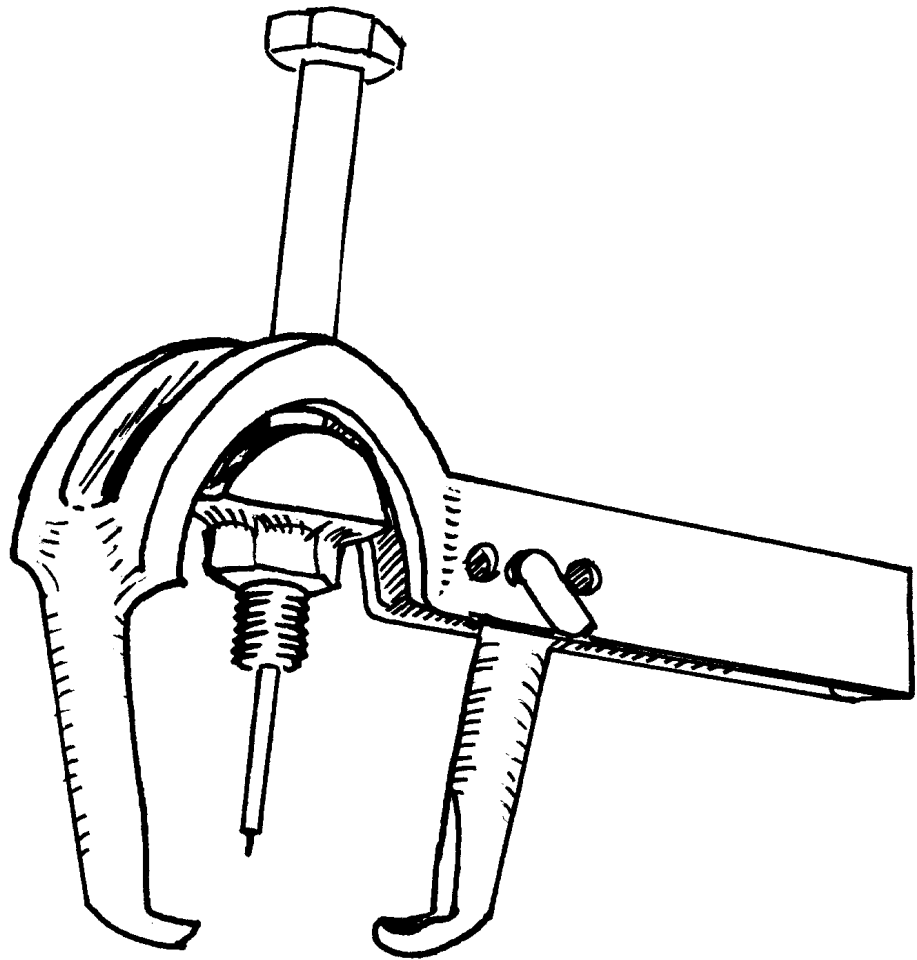
**Figure 2: Hinge Pin Remover.**

5. HINGE ROLL PIN REMOVAL. The most common method of removing the ailerons and elevators is by use of a hammer and pin punch. This type of impact can be quite damaging to the hinge and its attachment to the main structure. The following sketches have been offered by one of our inspectors as an alternative tool for roll pin removal, which does the job quite well and may prevent delamination of hinge attachments. (See GFA AD 213.)

The main problem is that the holes in the pins are individually drilled and are at all sorts of angles, hence the curved arch of the tool and the bolt in the trunnion so that the individual roll pin angle can be duplicated by the tool.

A secondary problem is that not all the hinge pins are the same length so that the tool-must cater for differing spans of hinge. The feet of the tool must slip and hold under the different sized ends of the pins. One foot of the tool (the foot in the handle) has to be loose so that it can be inserted below the end of the hinge pin first and then the main body of the tool presented to it, the foot then being secured to the body by a pin (a bent nail in the prototype). It is fiddly as the aileron/elevator also has to be held at the correct angle so that the roll pin being removed does not pierce the control surface shell. Once the roll pin is moving it slides out very easily

The tool has to span differing hinge lengths of 30 mm, 35 mm and 42 mm. The holes in the main body assembly are drilled to suit these spans.

The feet are chiselled out at the 'instep' to suit the diameters of the hinge pin ends otherwise they will slip off when the bolt is being wound down and damage the aircraft finish. For Roll Pin insertion use another bolt in the tool with a flat ground end.

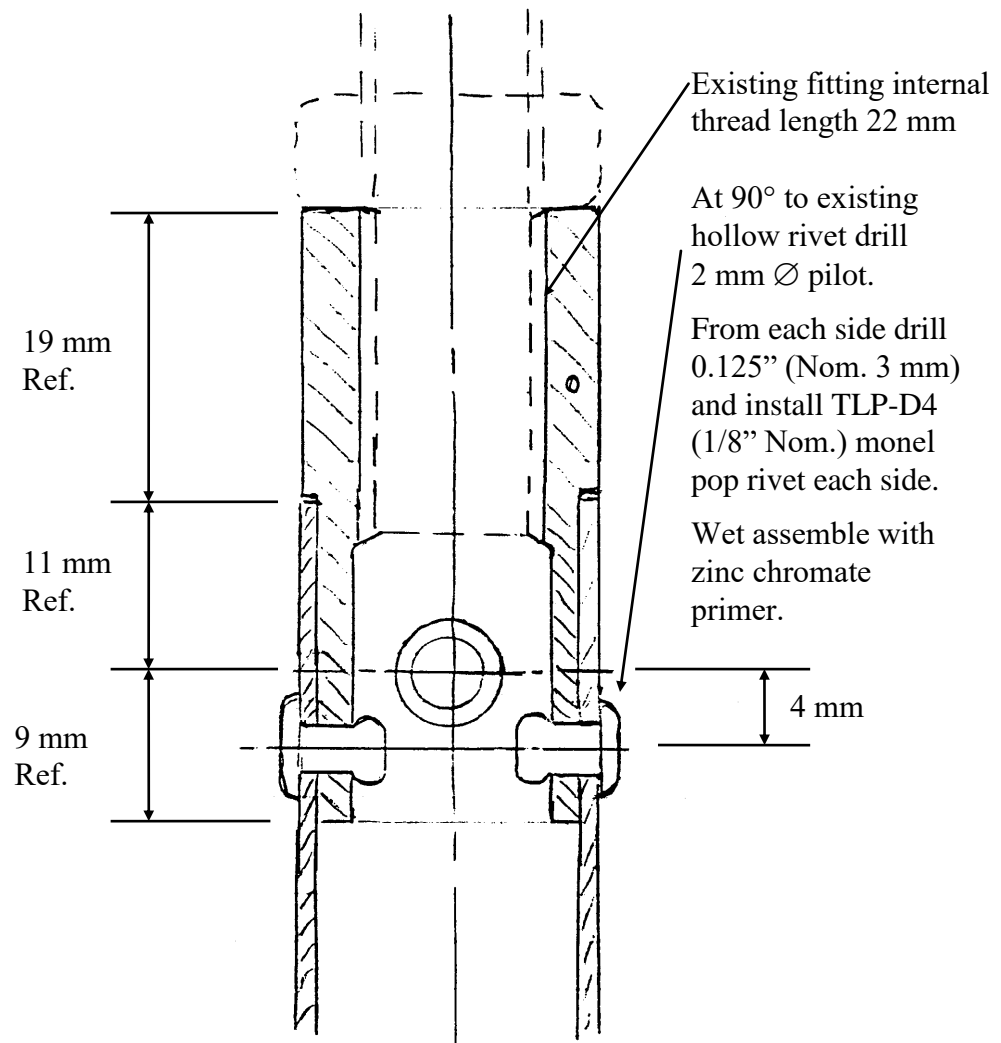
**Figure 5: Loose Rod End Repair Scheme.**

6. LOOSE ELEVATOR PUSHROD ENDS. A number of cases have been reported of loose elevator pushrod ends. The original design only used one tubular rivet to secure this part and so to remove slop a design involving the installation of two monel pop rivets has been developed by G. Sunderland.

**Note:** This repair scheme was developed for an Astir CS and if any difficulties are encountered then the CTOA should be contacted so that any necessary variations which may be required are recorded in this AN.

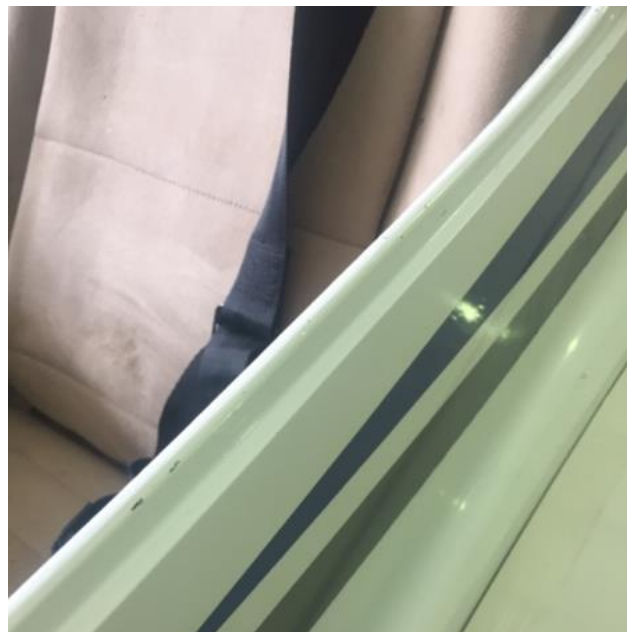
**Figure 6: Canopy Rail After Recent Repair.**

9. CANOPY AND SYSTEM MAINTENANCE. The Grob G 109 canopy at speeds approaching  $V_{ne}$  is known to unseat around the sides. The condition is caused by the shape of the canopy and resultant lift placing the canopy under considerable pressure. An increased in angle of attack when recovering from a dive at or close to this speed places added strain on the canopy and it's attachments.

This occurrence may be exacerbated by a worn attachment of the canopy / jettison system, an ill-fitting canopy frame as a result of a previous repair, replacement of the clear view Perspex resulting in poor fit of the frame, worn and rounded fuselage locating rails, poorly repaired fuselage rails and/ or canopy seal condition. The 'unseat' condition at speed results in a loud 'pop', the canopy remains unseated until being opened on the ground.

- A. Ensure the canopy attachment and jettison system are in good order and tested annually. The jettison handle stowed and locked closed with frangible lockwire. The frangible lockwire should be of a gauge that it will hold closed but break in the event a jettison is required. The lockwire additionally assists in holding the jettison handle closed against vibration.
- B. Ensure the canopy is inspected and lubricated annually
- C. Ensure the fuselage rails and canopy seal are serviceable,
- D. Be aware of the aircrafts condition, idiosyncrasies and limitations and fly accordingly.

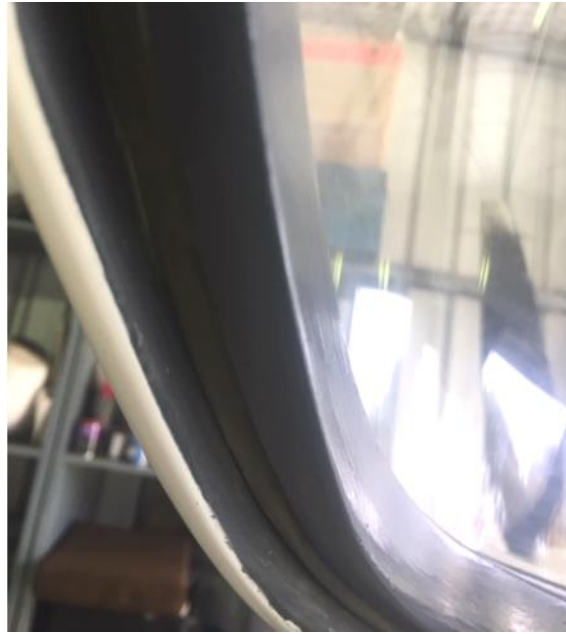
**Figure 7: Canopy Seal In Good Serviceable Condition.**

The silicon seal is hard to see in the frame and it does wear and deteriorate with use. It should be inspected annually at the same time as the canopy jettison function is tested.

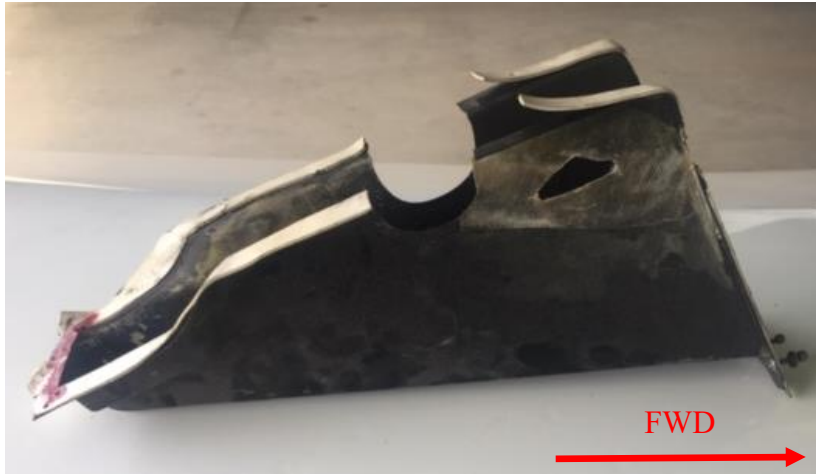
**Figure 8: Canopy Strut Cover Removed from Aircraft.**

When closed, the forward canopy hinges mate closely with a section between both instrument panel coamings. Two counter sunk screws orientated near vertically attach a strut cover plate under the instrument panel. The cover is additionally secured by 4 threaded bolts at the firewall and 2 PK screws under the canopy rail. The cover locates and separates an electrical loom and two canopy gas strut units. It also acts as a water sump and drain when flying through heavy rain. The two countersunk screws, if fitted, must not contact or interfere with the canopy when closed. Check for marks on the underside of the forward canopy hinges. It is noted that many G 109's do not use these screws leaving the countersunk holes unused.
