## AIRWORTHINESS DIRECTIVE

Issue 3

BLANIK L13  
BLANIK L13 A1  
BLANIK with power pack modification.

Aerotow release hook modification.

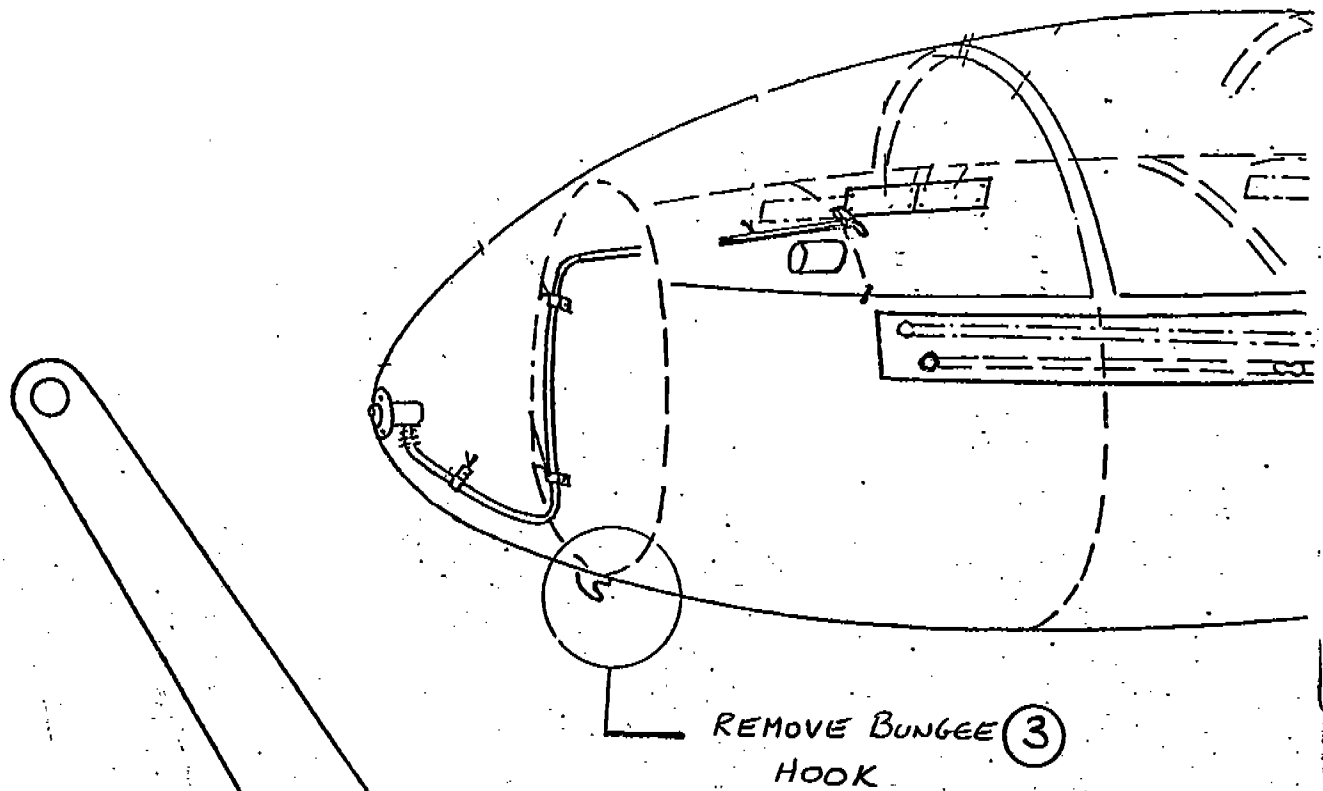
ENLARGED DETAIL OF HOOK.

OVER CENTRE TRAVEL WAS 4mm APPROX,  
NOW REDUCED TO LESS THAN 2mm.

Fit 11 mm. O.D.  
STEEL BUSH OVER PIN  
TO LIMIT OVER CENTRE  
TRAVEL TO 2 mm.  
BUSH LENGTH TO BE  
NEAT FIT BETWEEN  
HOUSING SIDE PLATES.  
REWORK SPRING END  
TO FIT.

GRIND OFF SHADED  
SECTION OF HOOK  
AND ROUND OFF  
THE END OF  
THE HOOK

MINIMUM 45°

THIS LINE PARALLEL TO BOTTOM OF SIDE PLATES

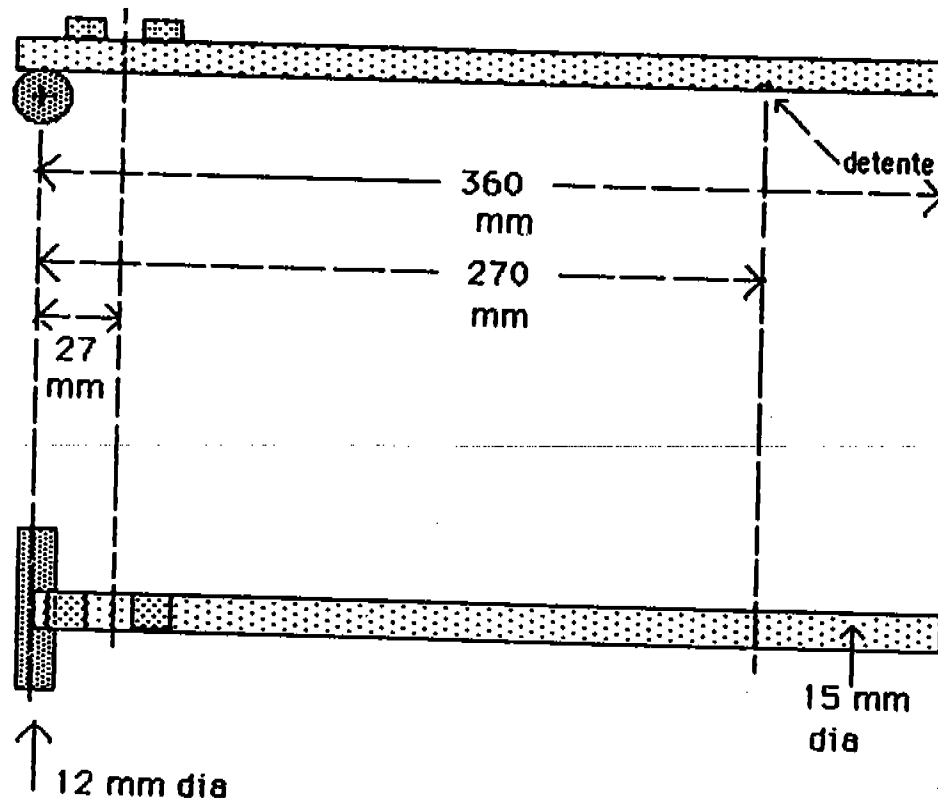
# BLANIK RELEASE TESTER

mild steel throughout - welded construction
