AIRWORTHINESS ADVICE NOTICE

TYPE AFFECTED: Jantar and Jantar Standard. All variants.

SUBJECT: Miscellaneous airworthiness information.

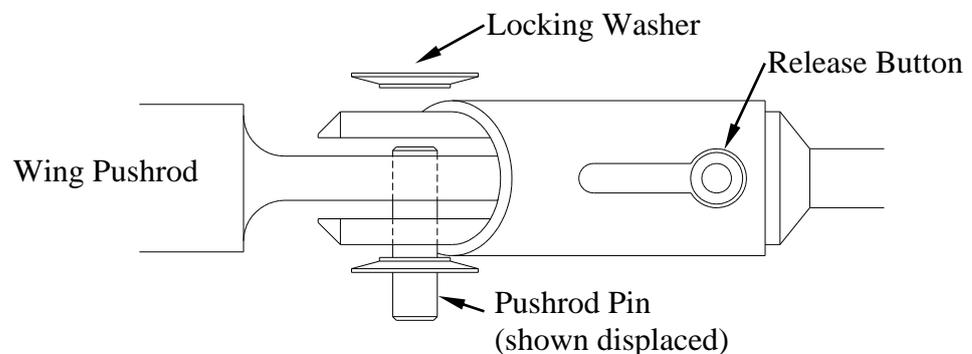
FIGURE 1. LOCKING WASHER SECURITY

Experience has shown that the locking washer on the connecting pin in the elevator and/or aileron connectors may work loose allowing the control to be connected incorrectly as shown in fig. 1.

Should the locking washer be loose then the defect must be rectified before next flight.

The defect may be rectified by either replacing the washer with a new part (the best option) or by cold forming the washer until the hole is between 5.980 and 5.990 mm diameter.

Cold forming should be done by either pressing flat between plates or by placing a steel ball (~ 20 mm \varnothing) on the hole and then tapping with a hammer. If using the steel ball method the washer should be turned over and the process repeated.

Before pressing the washer on, the pin diameter should be checked for the correct size of 5.992 to 6.000 mm diameter.

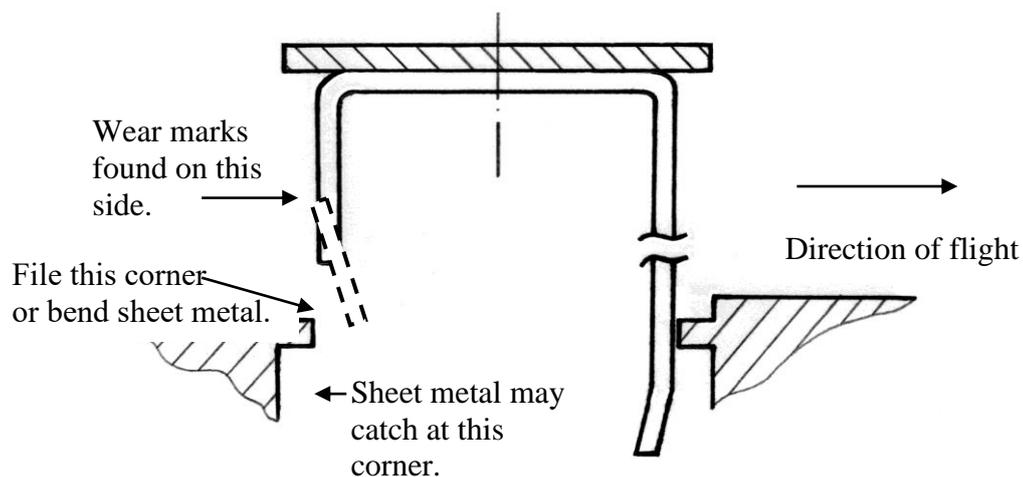
FIGURE 2. POSSIBLE AIR BRAKE JAMMING

3. Scratch marks on the backside of the airbrakes were found on two Standard Jantars (1 and 3). With only little force it was possible to jam the airbrakes when they were extended. So far no incident has been reported but it is strongly recommended to check the airbrakes to prevent possible jamming and perform corrective actions if required (ie. Bevel (file) the corner or slightly bend the sheet metal). See figure 2.

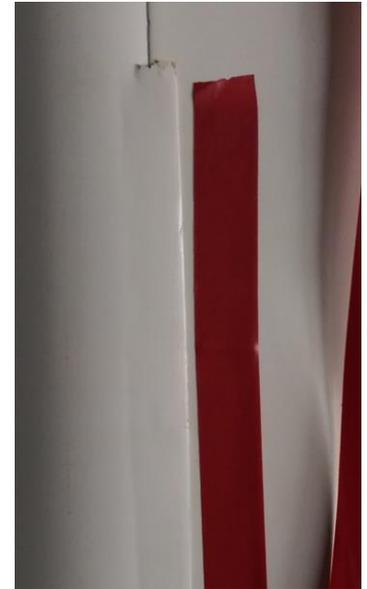
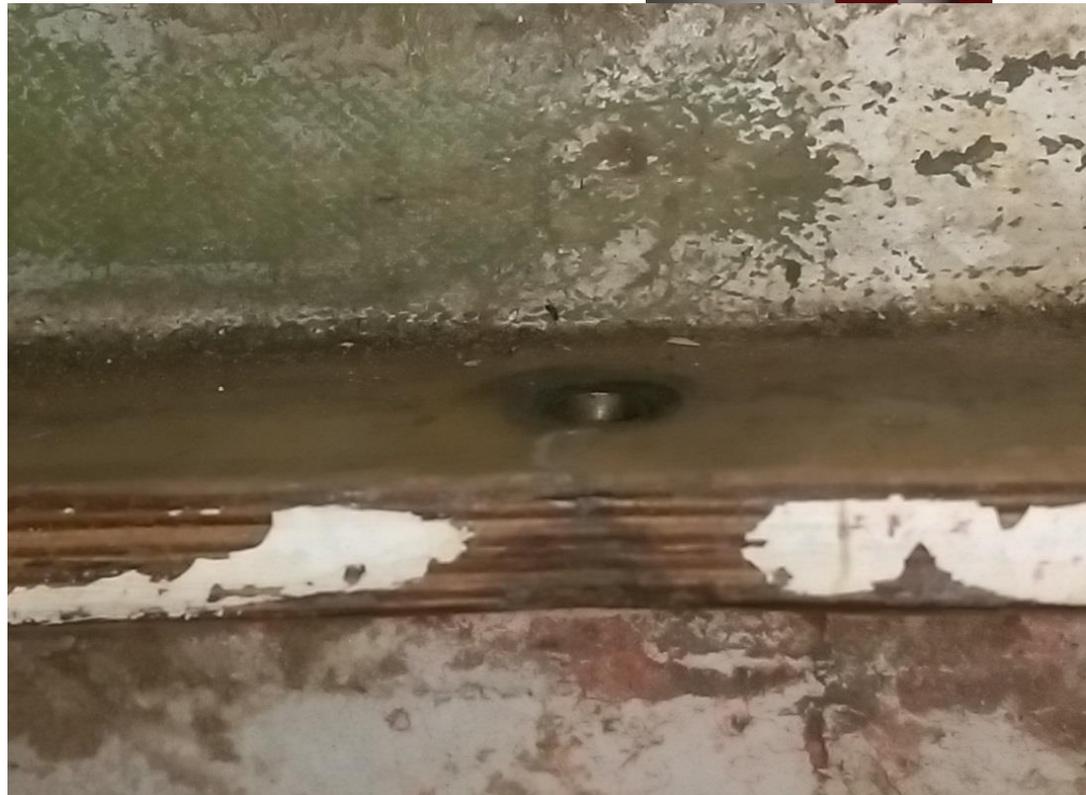
A towing incident applied high twist load to the rudder. This did little apparent damage except for the rudder turning too much and coming out of the fuselage skin – a known defect addressed in AD224. See attached photo with a piece of red tape for scale.

However, on rudder removal it was found that the lower plywood support bracket had cracked loosening the steel bush. The plywood was stressed by the incident and had cracked radial to the hole. See picture below. The bush was loose and at risk of breaking out of the crack.

A second rudder was found cracked in the same location although it was believed undamaged. Both were repaired by reinforcing by an FRP repair around the plywood crack area to secure the bush again. The balance of

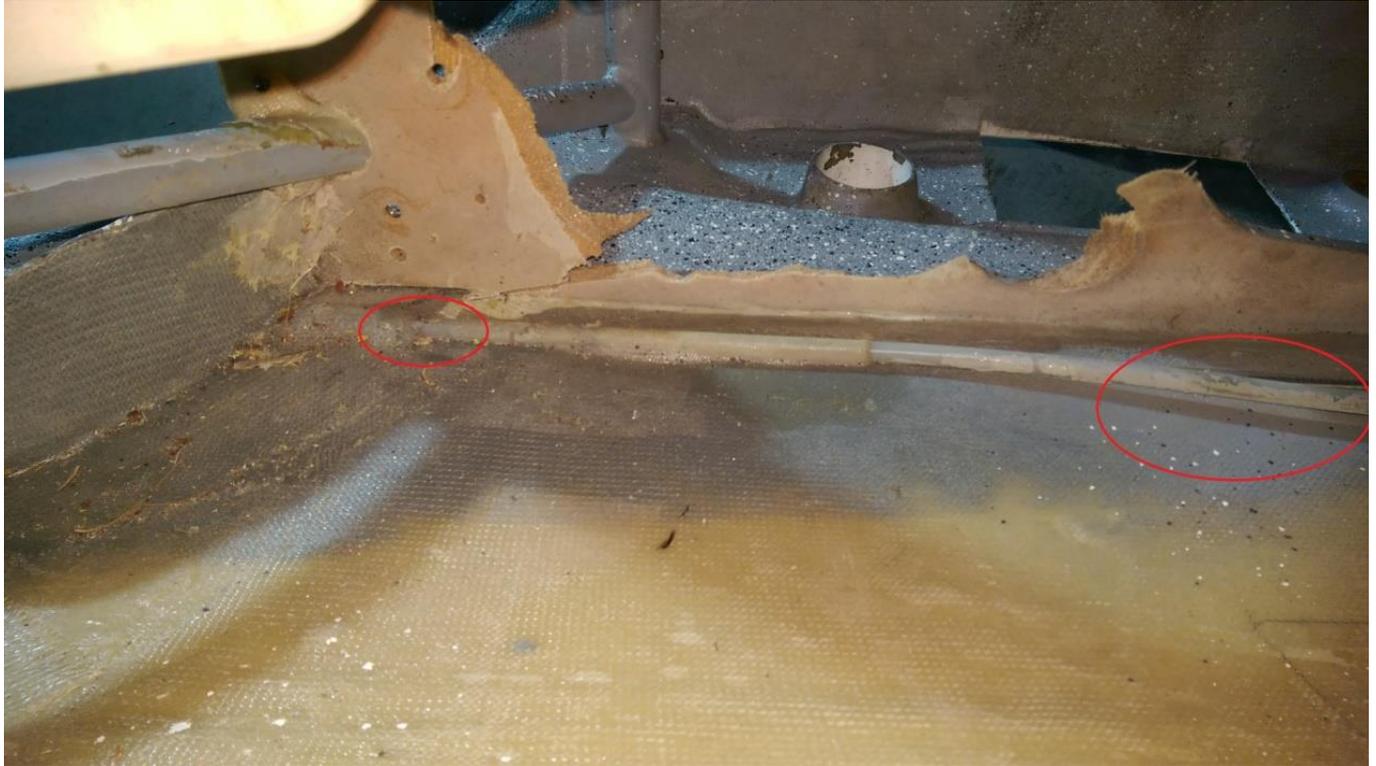
7. It is known that Jantar types are subject to partial disbonding of the rudder guide tube from the fuselage wall. The guide tubes are originally anchored by pressing tube into the wet resin during manufacture. The rudder cables can place large side loads on the guide tube where it forms an S shape. Once disbonded, the rudder cables will try and cut the corners of the 'S', the guide tubes are not stiff enough to prevent this. This allows rudder pedal movement without the rudder moving. The most recent defect report states both left and right cable guide tubes were found totally disbonded in the centre fuselage section resulting in a complete loss of rudder movement. It was found that if the rudder was held in the neutral position, the rudder pedals could be cycled through the full range without resistance. Partial debonding still allows the control to work but as the disbond increases in length, the control on the rudder gets softer and less effective.

The above photo taken of the centre fuselage shows a secured bonded cable guide tube on the left, and a disbonded tube section sagging slightly on the right.

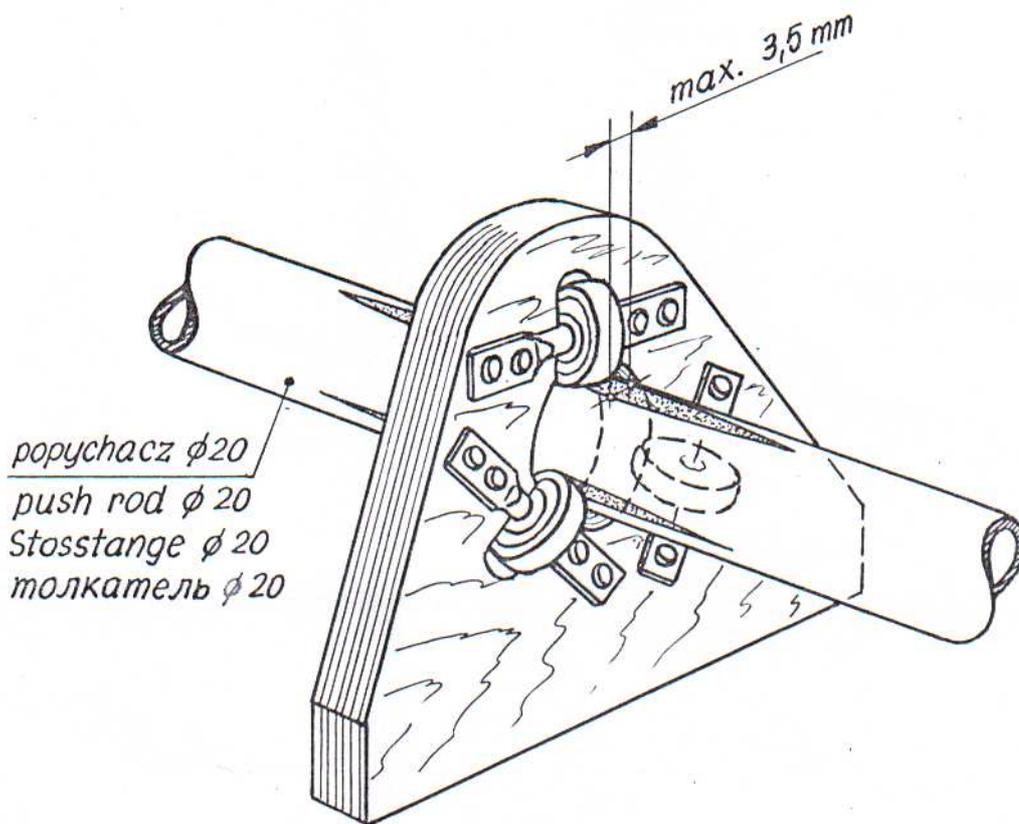
Fig.1.

In the operation (inspections) it can appear the necessity of appreciation of duraluminium push-rod tubes surface wear in areas of contact with the ball bearings which are used as the leading rollers in guides (mainly in the wings).

- 5.1. The allowed limit width of the roller "trace" on the push-rod surface is 3,5 mm (Fig.1).
- 5.2. In case the allowed wear value is exceeded (even on one place-only) - disconnect the control system and turn the push-rod by 180°. Then secure it and check the adjustment.

- 3.1. The allowed push-rod wear is defined.
- 3.2. When the allowed push-rod wear is exceeded the push-rod is allowed to be turned by 180° so that the contact takes place between the previous "wear surfaces".

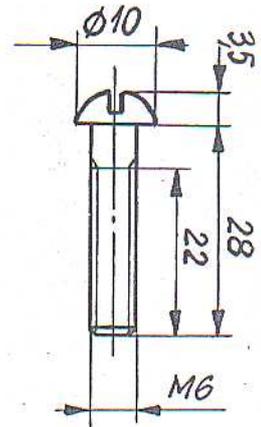
Fig.1.

The additional securing of the bolt connecting the tailplane with the fin, providing the bolt is correctly installed, is got by the M6 screw /Fig.1/.

Screw P-M6x28
acc. to stand. BN-76/1112-03
material - (steel) 10
amount - 1 piece

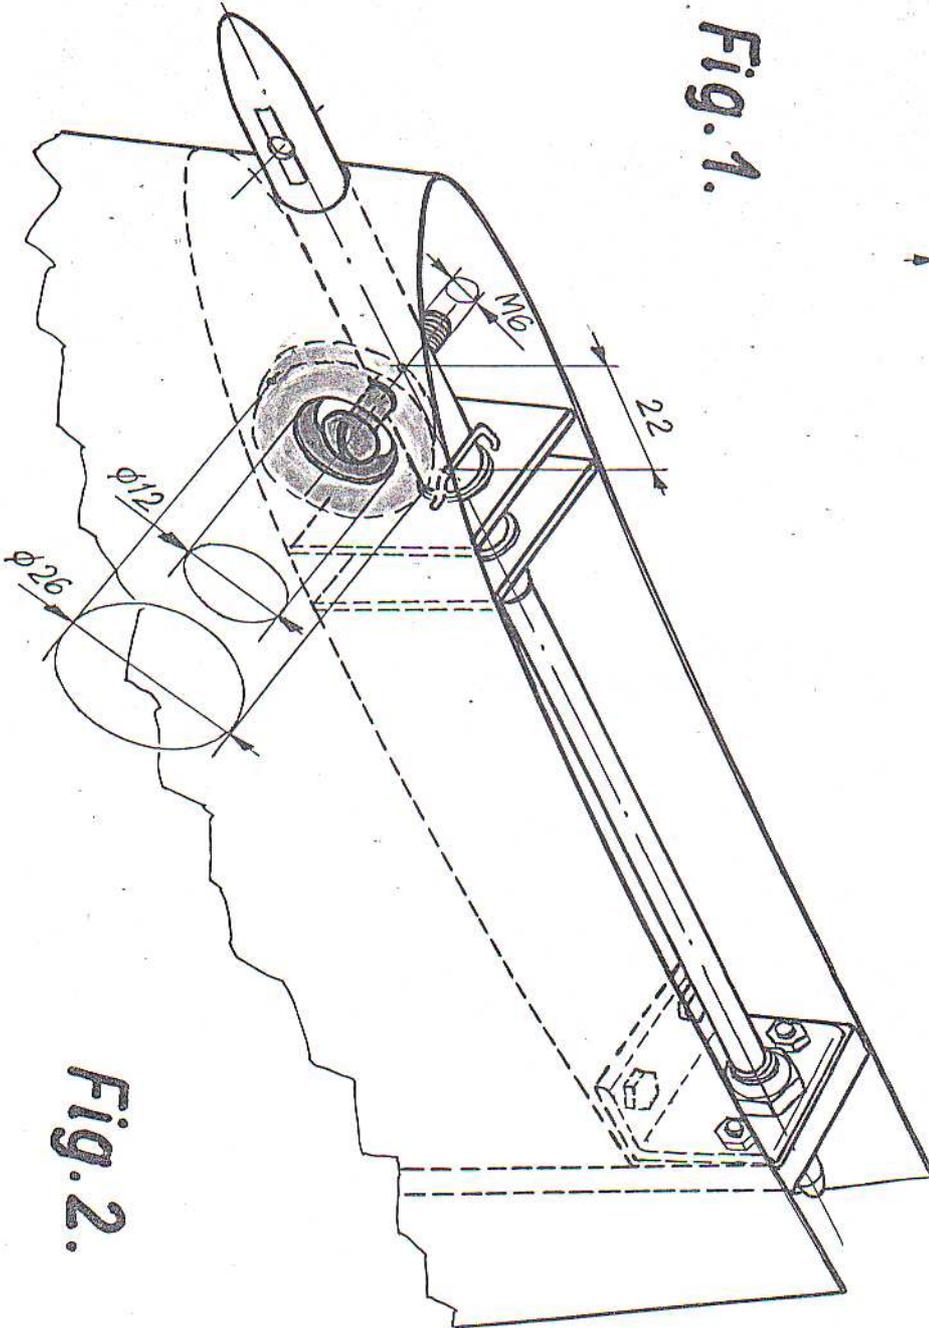
Fig.2.

It is screwed into the bolt pivot, as shown on the sketch of Fig. 2 so that its head touches the external lap.

5.1. On the pivot of connecting bolt (44-40-00) the opening of $\varnothing 4,8$ (for M6 thread) should be traced and drilled through on the distance of 22 mm from the stop surface (in respect to the front nest sleeve face - see Fig.2). The opening axis should be parallel to the cuts for the locking spring. Smooth the opening edges.

- 5.2. After derrigging the tailplane insert the bolt (44-40-00) into the fin nests till the locking spring clicks. Using the \emptyset 4,8 hole trace the hole \emptyset 12 location on the fin left skin. Drill the preliminary opening (e.g. \emptyset ,8) and check it to be axial. Then enlarge it to \emptyset 12 or regain the axiality, if necessary, by means of fileing.
- 5.3. Make the M6 thread in the bolt.
- 5.4. Make the composite stop block in the from of the ring \emptyset 26/12 and 6 mm thick. Glue it in using the epoxy composition.
- 5.5. Check the correct securing with the screw. (taiplane derrigged). The srew head should contact the stop block.
- 5.6. On the glider ready for flight the bolt shall be secured with the M6 screw and the hole \emptyset 12 should be plugged with the \emptyset 25 ring of tixo-tape.
