COMMONWEALTH OF AUSTRALIA
DEPARTMENT OF TRANSPORT
AIR TRANSPORT GROUP

Airworthiness Directive Gliders

GFA/FFA 3/74

F.F.A. Diamant 16.5 & 18.

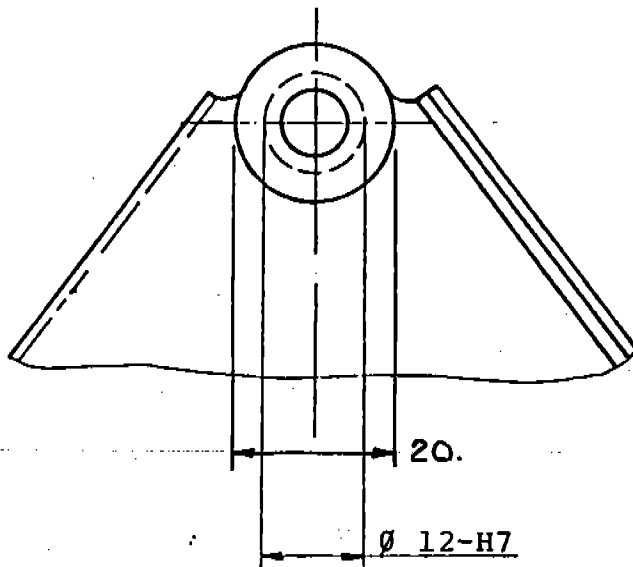
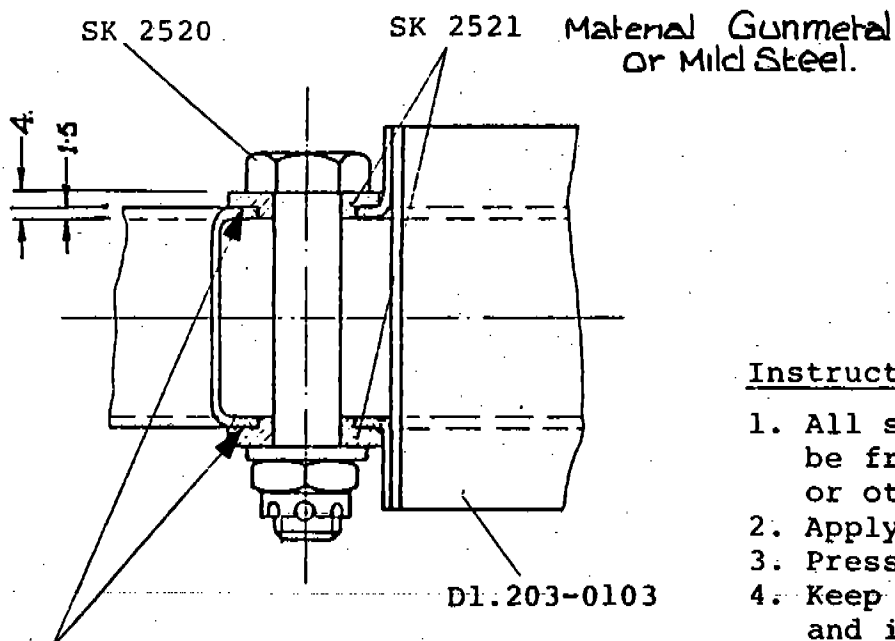
AD. GFA./FFA 3/74

Reason : The stick control of one DIAMANT sailplane had too much play. The result of an exact investigation was showing wear of the stick bearing in the torsion tube.

1. Inspect stick control for excessive play immediately after receipt of this Service Bulletin.
2. If the stick bearing shows normal play the inspection must be repeated every 50 flight hours.
3. If the stick bearing shows play accomplish the modification in accordance with para 4 before the next flight.
4. Modification:
 The present two holes in the torsion tube D1.203-0103 must be drilled and reamed to the diameter of 12-H7 ($12 + 8,018$ mm).
 According to the attached drawing, two bushings SK 2521 have to be bonded into the torsion tube. Due to the new dimension of the bearing depth, the pivot bolt D1.203-0106 must be replaced by a new bolt SK 2520.
5. The inspections according to para 2 are no longer necessary if modification has been carried out.

Adhesive:

Loctite No. 40

Araldit Resin AW 106

Hardener HV 953U

1. All surfaces to be bonded must be free of paint, oil, grease or other foreign substances.
2. Apply the adhesive.
3. Press in the bushings.
4. Keep the bore of the bushings and inner surface free of adhesive.

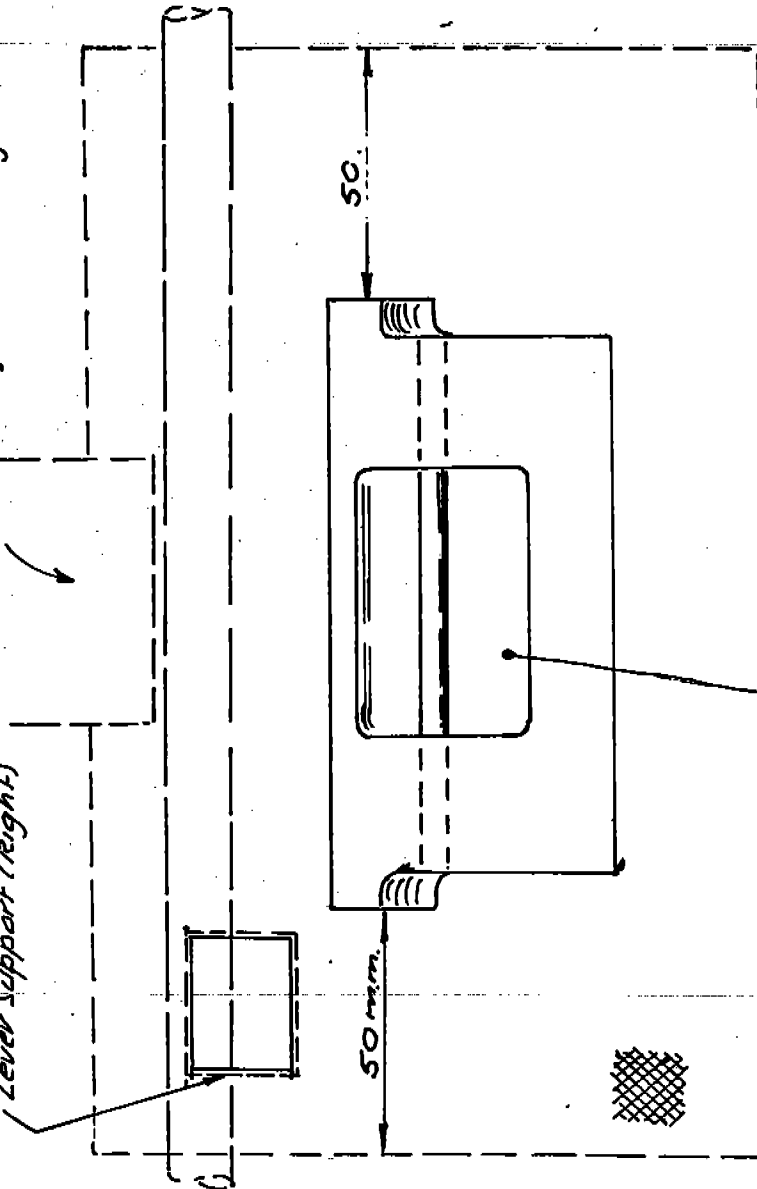
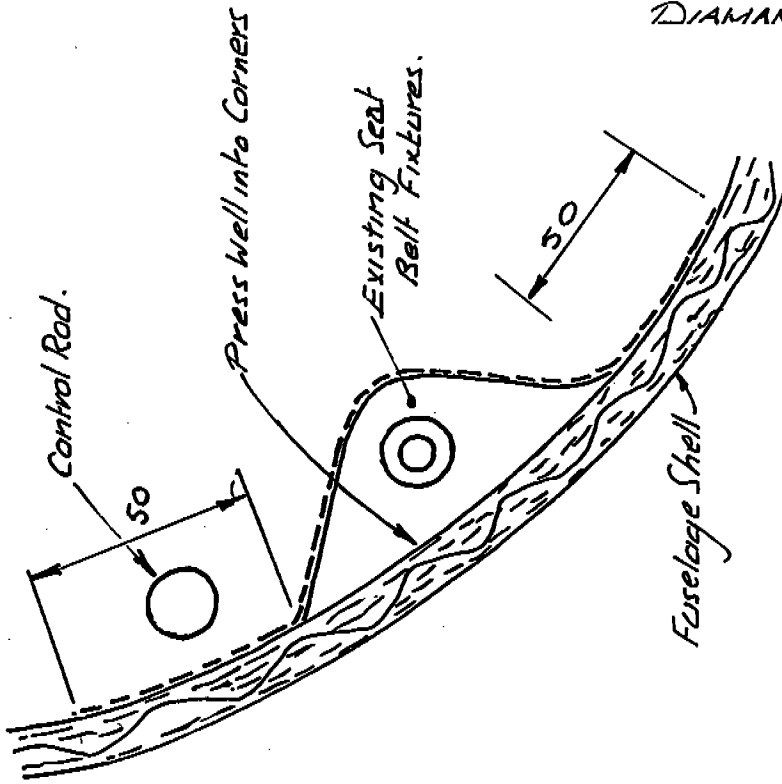
DIAMANT. SEAT BELT FIXTURES.

REASON : The lower harness attachments of a DIAMANT sailplane can be loose due to an incident. The investigation showed that the bonding of the attachments was insufficient.

A reinforcement of every lower harness attachment is required since checking the bonding of all active DIAMANT sailplanes is not possible.

- : Two each fiberglass clothes 140 diagonal have to be laminated across the harness attachments in accordance with the attached drawing SK-HBV 189:
1. Remove LH and RH sidewall panels.

7. Sand fuselage and harness retaining area to the size of the reinforcement laminate.
 8. Cut to size glass clothes in accordance with the attached drawing SK-HBV 189.

9. Laminate tailored fiberglass clothes with Araldit resin LY 554 (5 parts) and Araldit hardener HY 554 (1 part). Minimum temperature for bonding procedure is $20^{\circ}\text{C} = 68^{\circ}\text{F}$.

10. Cut out opening for harness attachment after curing.

2 Fabrics X
Laminated.

To be cut out after
Laminating

Materials 2 Glasscloth Fabrics N° 140 - 200x220 mm.
Resin LY 544 5 Parts
Hardener HY 544 1 Part.
