THE GLIDING FEDERATION OF AUSTRALIA INC

Airworthiness Alert 2018-3 DG-500/1000 **Undercarriage Lock**

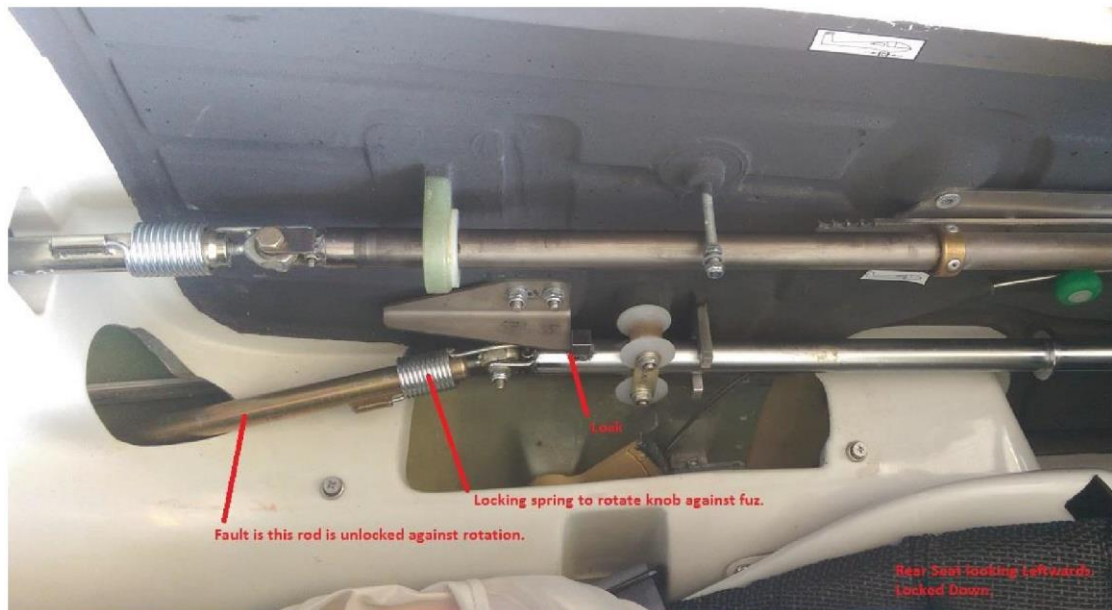
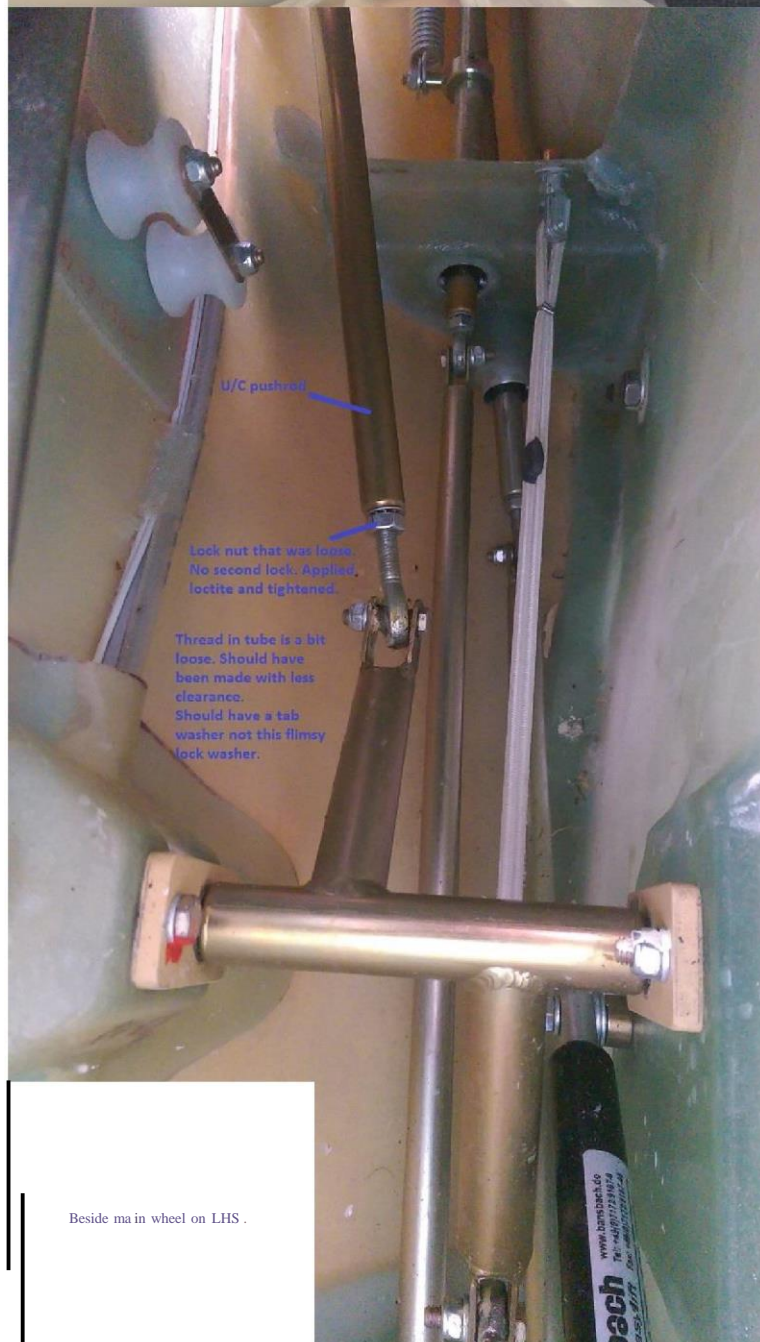
Removed left side rear seat control cover. Found rotation spring was not in tension. The pushrod should apply rotation tension to spring but was unlocked (See photos attached). De-rigging allowed access to rear connection of pushrod. Found jam nut loose.

The spring washer is inadequate to lock the tube that wants to rotate loose. Design defect.

1. Applied Loctite stud locker high strength to second lock and re-tighten
2. Report all cases of unlock that have or do occur.
