AIRWORTHINESS ADVICE NOTICE

TYPE AFFECTED: IS-28M2 / IS-28M2/80HP

SUBJECT: Miscellaneous airworthiness information.

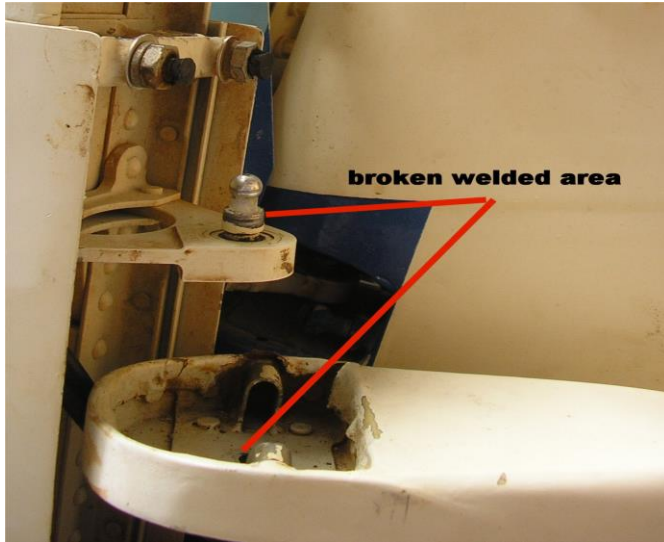
1. The empennage structure on IS28M2 types is similar to the IS-28B2 so the following defect is included in this advice notice. AWA 2008/1 was raised at the time but is now cancelled. An IS-28B2 left elevator hinge pin was found broken in 2008. Further inspection showed the right hinge pin on the right elevator was also cracked. The hinge pins in question are the inner ones and also serve as a locating pin for the elevator connecting yolk which couples the left and right elevator root ribs together during rigging and transmits the drive from the elevator push rod. It is not possible to detect the failure unless the tailplanes are in the folded position and the connecting yolk is separated from the elevator root ribs. At annual inspection it is recommended that hinge pin and flange area is thoroughly cleaned and visually inspected for cracks. Use X10 magnifying glass. A high-resolution digital camera with magnification may also assist in the inspection. Refer photo 1 to 3 on page 2 of this notice.

Photo 1. Left elevator hinge and root area showing hinge pin completely detached from bracket on root rib.

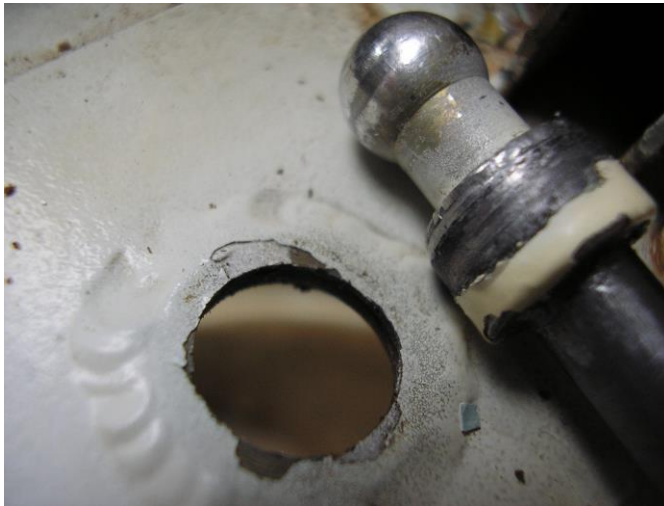
Photo 2. Left hinge pin failure area.

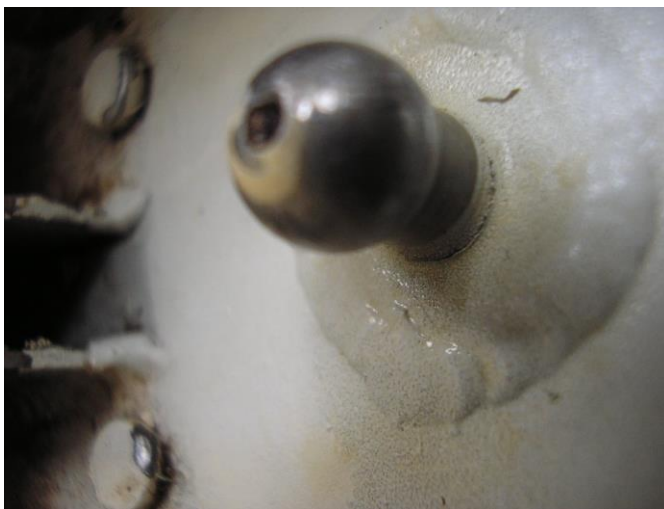
Photo 3. Right elevator hinge pin showing cracking around 40% of the circumference.
