## AIRWORTHINESS ADVICE NOTICE

TYPE AFFECTED: Nimbus-3 / Nimbus-3 24.5 / Nimbus-3D

SUBJECT: Miscellaneous airworthiness information.

<b>GFA AN 146</b>	<b>ISSUE: 1</b>	<b>12Dec2022</b>	<b>Page 2 of 2</b>
-------------------	-----------------	------------------	--------------------

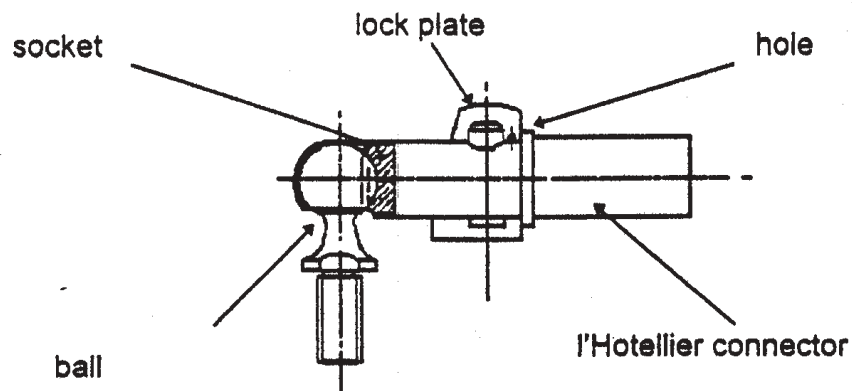
If the connectors are not yet equipped with safety pins (e.g. l'H 140-31 made by Hotellier), these safety pins have to be retrofitted. In certain cases it may become necessary to rebores the hole in the lock plate, which is provided for visual inspection, to  $\varnothing 1.2$  mm so that the safety pin can be inserted.

Unsecured ball and socket connectors may open automatically in flight!

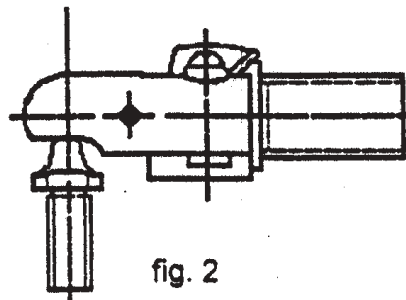
fig. 2

The following systems to secure l'Hotellier ball and socket connectors are LBA-approved: Uerlings sleeves or Uerlings type sleeves (see section III), safety pin (figures 2 and 2a), LS-safety sleeve (figure 3), Schempp-Hirth spring (figure 4) und Wedekind locking system (figure 5).

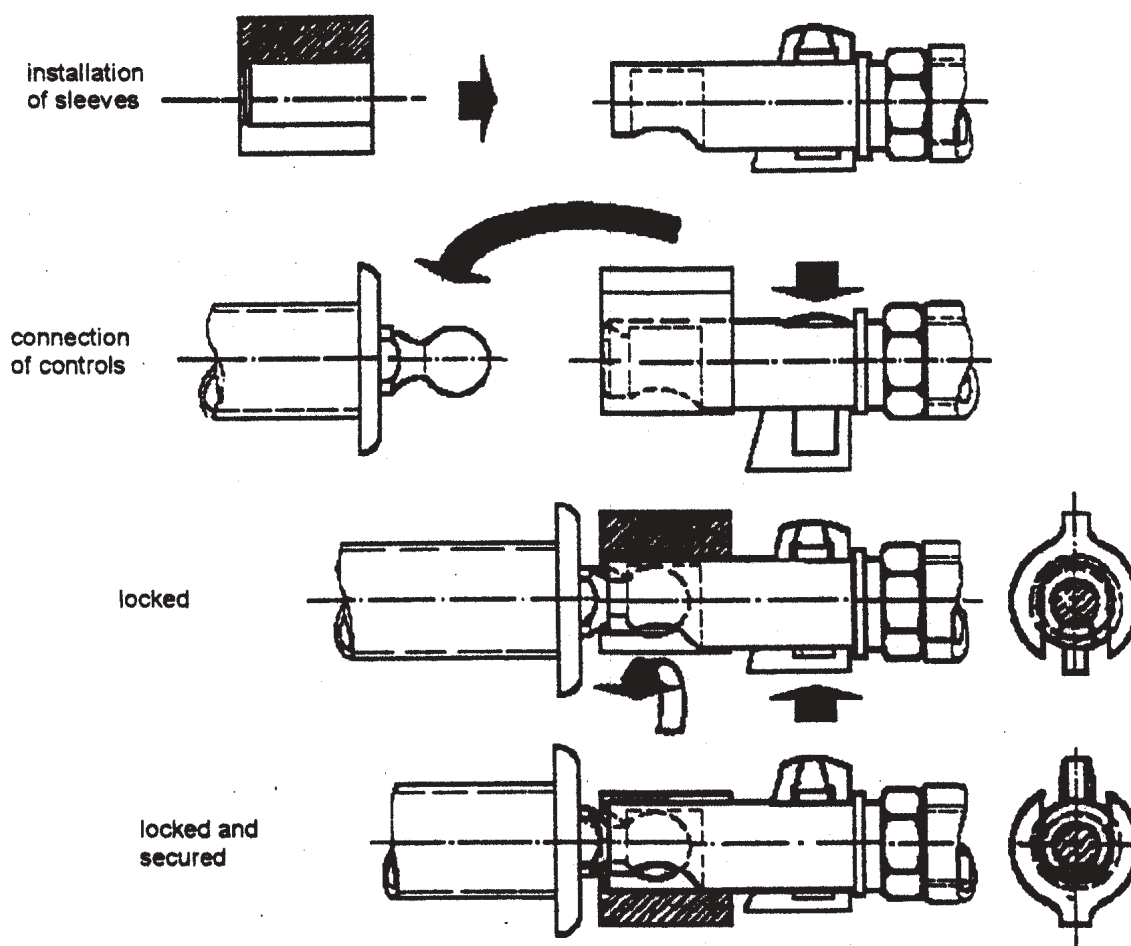
They may by no means be clipped radially onto the l'Hotellier ball and socket connector. Radial clipping (excessive opening of the sleeve) may lead to cracks or ruptures due to oversteering so that the sleeve cannot function properly any more.

For installation, the sleeves have to be slid axially onto the l'Hotellier ball and socket connectors.

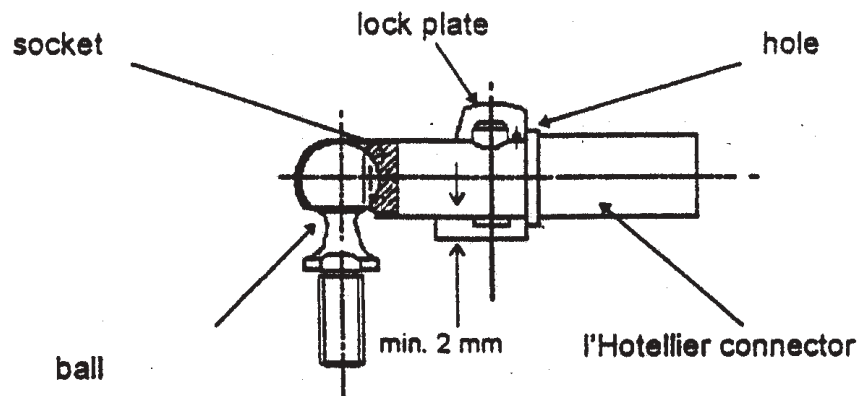
Unsecured ball and socket connectors may open automatically in flight.

The socket is to be slid completely over the ball with the lock plate pressed down. During locking the lock plate moves back slightly so that in a correct connection the hole on the narrow edge of the lock plate becomes visible.

The safety pin is to be inserted in this hole thus securing the ball and socket connector.

By loading the connection full engagement of the ball is to be verified!
