AIRWORTHINESS ADVICE NOTICE

TYPE AFFECTED: Nimbus-3T / Nimbus-3DT / Nimbus-3DM

SUBJECT: Miscellaneous airworthiness information.

GFA AN 147	ISSUE: 1	12Dec2022	Page 2 of 2
-------------------	-----------------	------------------	--------------------

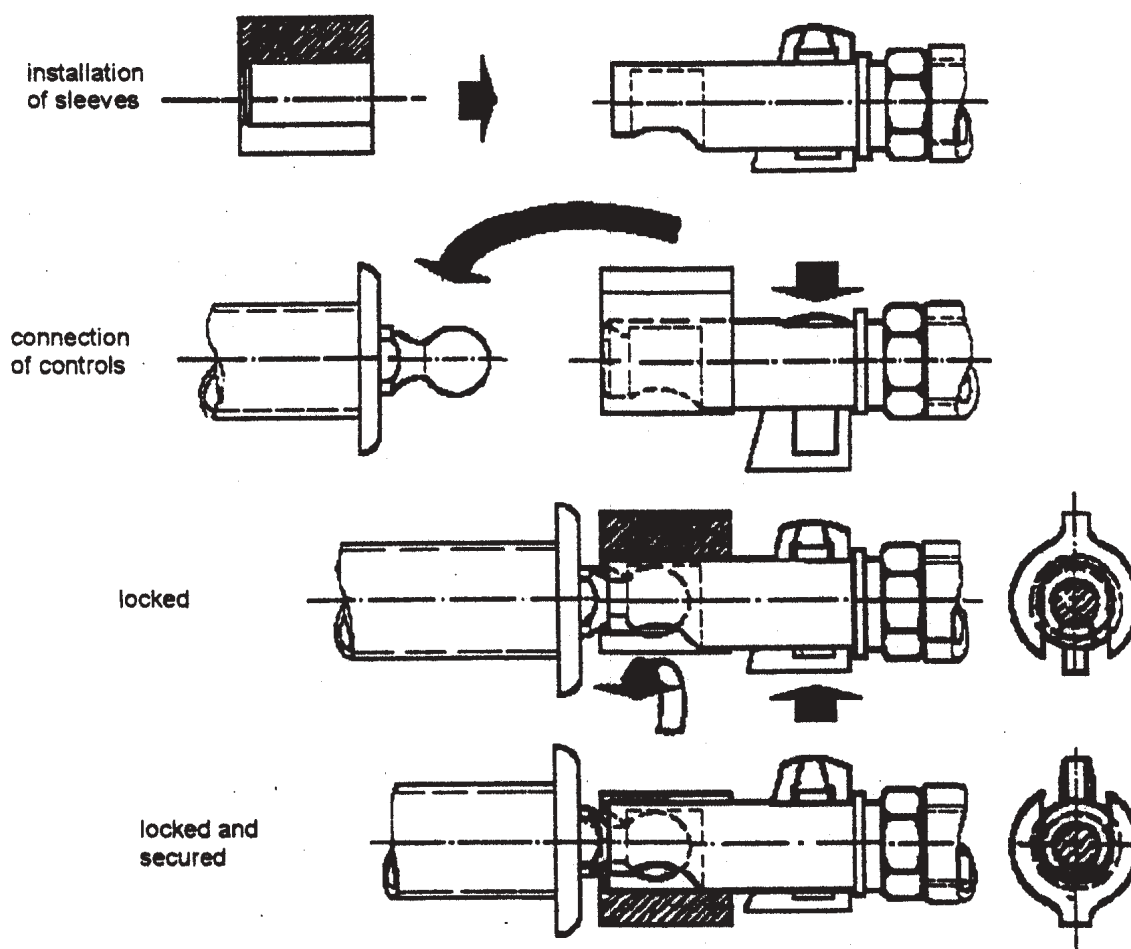
Section III

They may by no means be clipped radially onto the l'Hotellier ball and socket connector. Radial clipping (excessive opening of the sleeve) may lead to cracks or ruptures due to overstressing so that the sleeve cannot function properly any more.

For installation, the sleeves have to be slid axially onto the l'Hotellier ball and socket connectors.
