GFA AN 193

AIRWORTHINESS ADVICE NOTICE

TYPE AFFECTED: Arcus T

SUBJECT: Miscellaneous Airworthiness Information

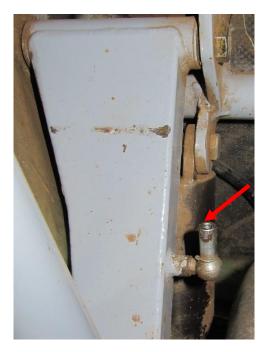
DEFECTS: 1. UNDERCARRIAGE GAS STRUT FAILURE ON DUO

DISCUS (Same undercarriage mechanism as Arcus): The gas strut bottom end is suspected to have unwound at the bottom end fitting from the barrel of the gas strut. After detaching, the top attachment ball failed during operations and the gas strut penetrated the parcel shelf behind the rear

cockpit.

Figure 1: View in the wheel wheel looking forward showing port undercarriage arm and disconnected gas strut connection

- 1. LUBRICATION: The ball ends of the undercarriage gas strut should be lubricated every annual inspection.
- 2. THREAD LOCKING: The threaded junctions on the undercarriage gas strut should be secured against unwinding by use of a thread locking compound (recommend Loctite 243).
- 3. BALL REPLACEMENT: The ball ends are subject to significant fatigue loads due to the high oscillatory loads on the rocker arm mechanism on the ground roll during take off and landing, and during towing. It is recommended to replace the ball ends whenever the gas strut is replaced.
- 4. GAS STRUT REPLACEMENT: Replace the gas strut when it becomes noticeable that the retraction effort has increased significantly. Pay attention that the gas strut force rating matches the mainwheel type installed. Refer maintenance manual.

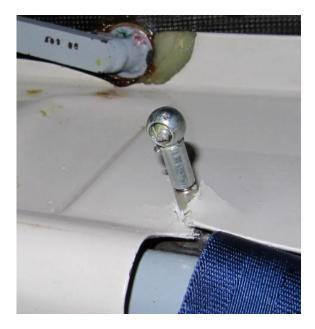
Figure 2: Gas strut end protruding through parcel shelf.

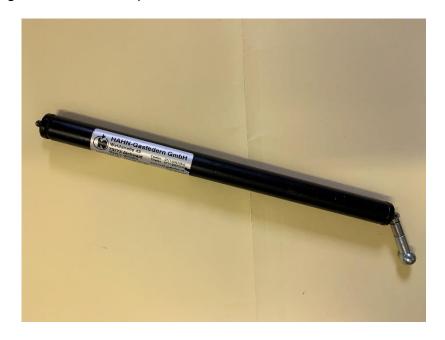
2. UNDERCARRIAGE GAS STRUT FAILURE ON DUO DISCUS: While preparing to put the fuselage in the trailer, the undercarriage gas strut was found disconnected from the lower and upper attachment points. The ball ends had sheared and the end attached to the top of the gas strut rod was bent. Reference defect 1 above, this was the second gas strut failure experienced on the same aircraft.

Figure 3: Failed gas with bent strut.
