AIRWORTHINESS DIRECTIVE - GLIDERS

GFA/AD 91 EIRIAVION OY 8

Types Affected: All PIK 20 Series.

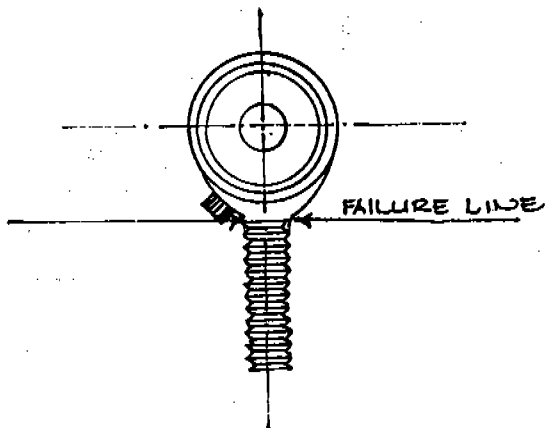
A Pik 20D currently under repair following a crash was found to have a cracked elevator rod ball end fitting that failed completely when the aircraft crashed.

The diagram below illustrates the fitting and the area where it failed.

Before further flight remove elevator and rudder fittings and subject them to an optical examination for cracks using a powerful magnifying glass. In particular check the upper extremity of the thread.

Should your aircraft be subject to a heavy landing this area must be checked thoroughly for evidence of failure.
