AIRWORTHINESS DIRECTIVE - GLIDERS

GFA/AD 92 START & FLUG 3

Type Affected: Salto H 101Background:

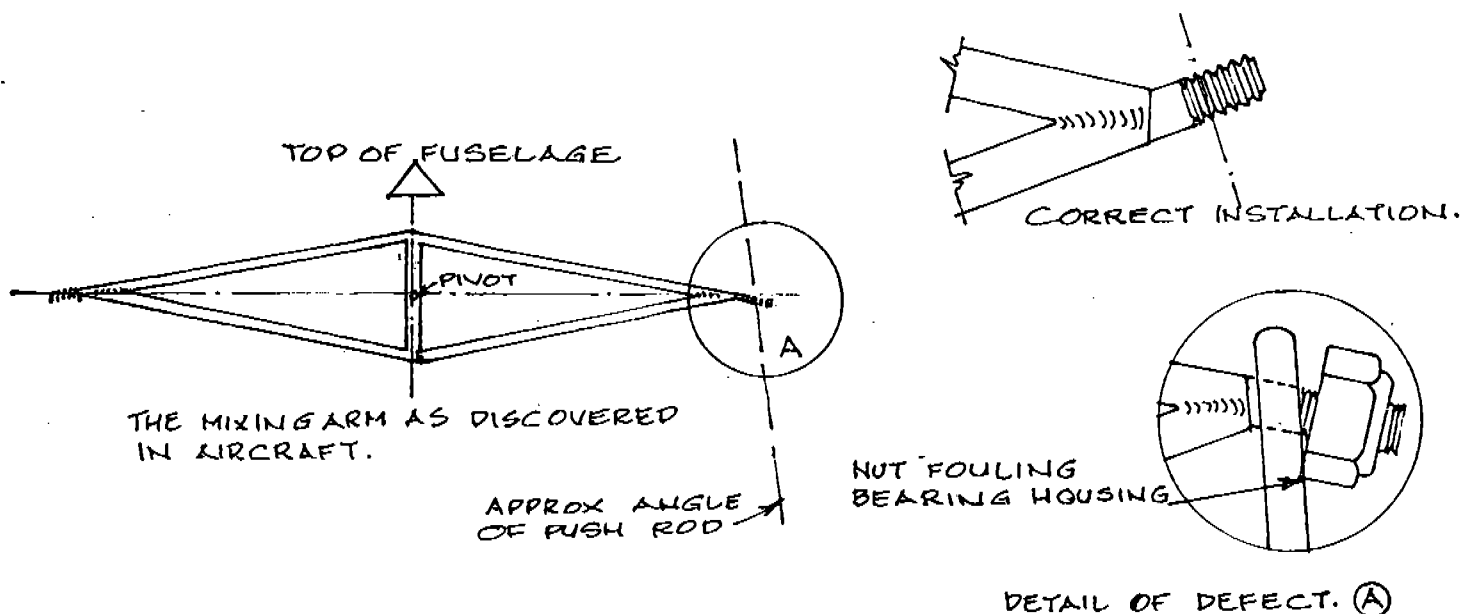
It has been discovered that it is possible to install the Ruddervator Mixing Arm upside down and it has been done.

The fitting is not symmetrical and if replaced inverted the push rod connections are not correctly aligned and foul the 10 mm lock tight nut when back stick and full rudder is applied.

The illustrations hereunder clearly indicate the malfunction.

Check your aircraft for the correct installation of the mixing arm.
