# AIRWORTHINESS DIRECTIVE

## GFA AD 114 Issue 2

Date: 09 February 2018

<b>Type Certificate Holder</b>	FFA Flugzeugwerke Altenrhein AG
<b>Manufacturer(s)</b>	Flug- und Fahrzeugwerke AG Altenrhein (FFA)
<b>Types/Models Affected</b>	Diamant 16.5 Diamant 18
<b>Serial Numbers</b>	Serial Numbers 11 to 80
<b>Subject</b>	Inspection of Spar Web Bonding
<b>Implementation</b>	Envelope restrictions are required by Action 1 and is <b>MANDATORY</b> . The envelope limitations can be lifted by completing Action 2 of this AD.
<b>Background</b>	<p>GFA issued AD 107 mandated immediate envelope restrictions after unsatisfactory bonding between the spar cap and shear web was found in a Diamant.</p> <p>GFA AD 114 Issue 1 superceded AD 107 and mandated visual inspections of the spar cap to shear web bonding IAW Service Bulletin 06. The envelope restrictions from AD 107 were retained.</p> <p>GFA AD's 130 and 131 mandated further inspection and repair IAW Service Bulletins 07 and 08. At the completion of <b>BOTH</b> AD 130 and AD 131, the envelope restrictions can be removed.</p> <p>Issue 2 of this AD clarifies that the envelope restrictions can be removed by completing both AD 130 and AD 131.</p>

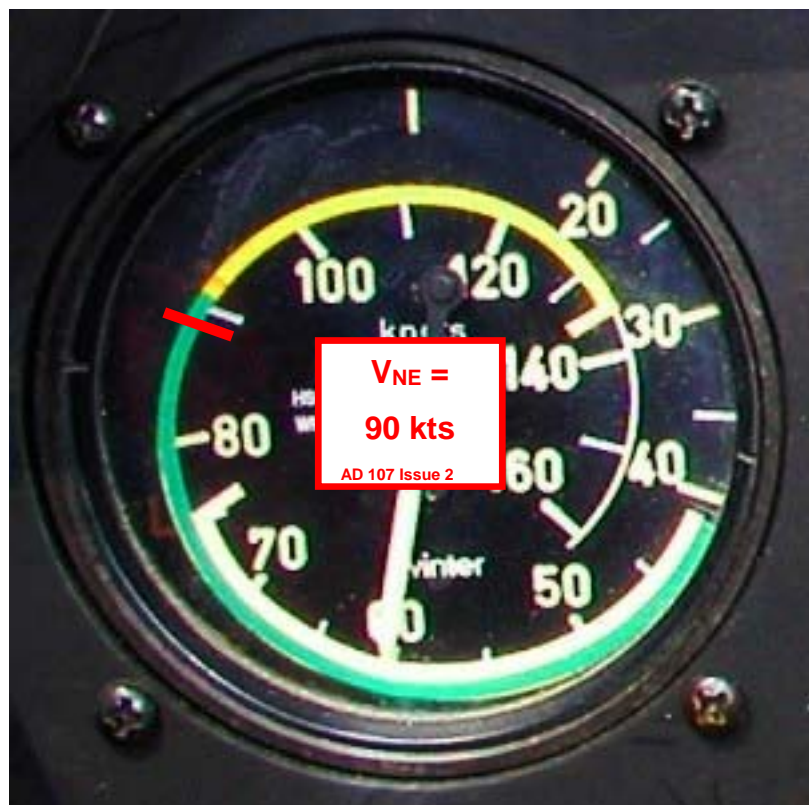
Apply a red mark on the airspeed indicator at 90 knots using instrument decal, marking tape or similar. Apply a red placard to the airspeed indicator as shown in Figure 1.

**Figure 1:** ASI Markings for Action 1

**2. Carry out the actions specified in GFA AD's 130 and 131. When this action is complete, the flight envelope may be restored to its original values and the restricted placard, ASI red mark and decal on the airspeed indicator can be removed.**
