AIRWORTHINESS DIRECTIVE GLIDERS

GFA AD/129 L.E.T. KUNOVICE 16

L-13 Blanik all serial numbers (Mandatory Bulletin No. L13/052 refers)

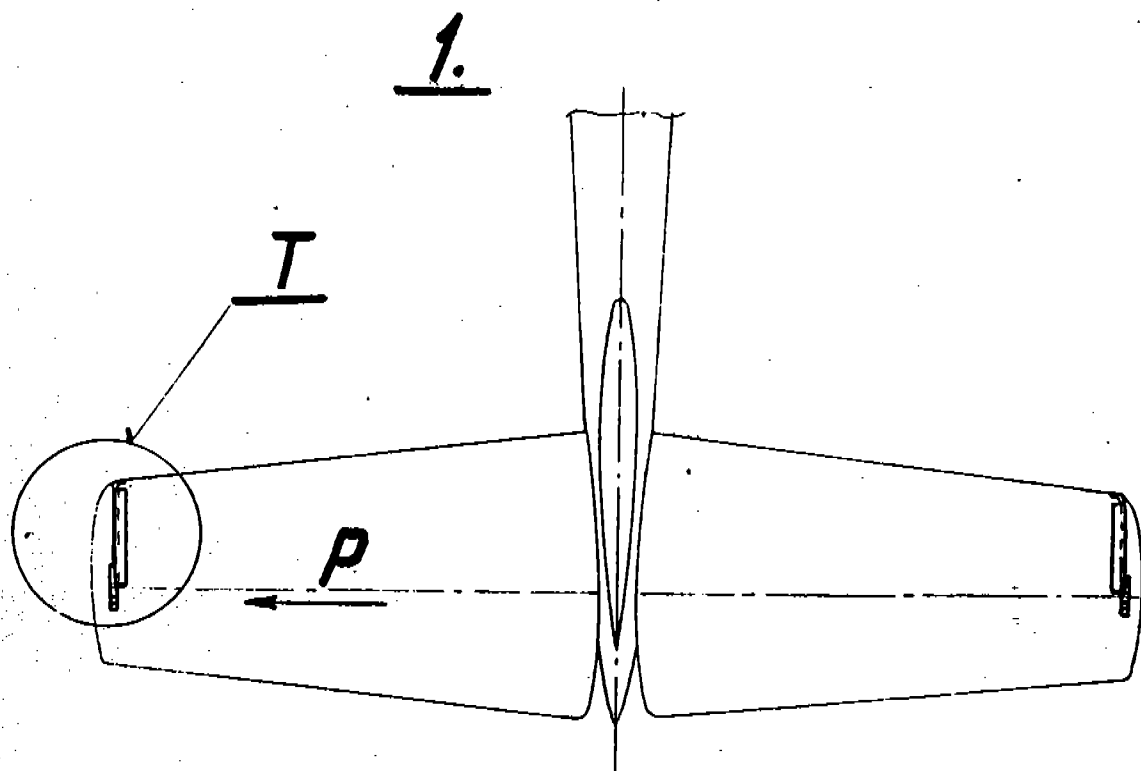
"P"

A number of L-13 Blaniks operated in U.S.A. have been reported to have developed cracks in the bend radii of tailplane end ribs at outer elevator hinge attachments. It is likely that this defect would occur in gliders subject to frequent trailering.

- 2) Carefully drill off original rivets pos. 3 and 5 using a 2.6 mm dia. drill and rivets pos. 4 and 6 using a 3 mm dia. drill. See Fig 1, view "P".
- 3) Drill holes at the ends of cracks using a 2 mm dia. drill and de-burr the holes carefully.

- 4) Locate angle pieces pos. 1 and 2 on the rib - see Fig. 1, view "P". Through original rivet holes mark-off and centre-punch holes on angle pieces. Drill holes dia 3.1 mm for rivets pos. 4, 5 and 6. Holes for rivets pos. 3 to be drilled using a 2.7 mm dia. drill and dimpled. Re-drill holes for rivets pos. 5 in the spar boom to the diameter of 3.1 mm.
