AIRWORTHINESS DIRECTIVE GLIDERS

GFA AD/130 FFA 4

GLIDER TYPES AFFECTED: Diamant 16.5 and 18 Serial Nos. 11 to 80

INSPECTION AND REPAIR OF BONDING IN WING

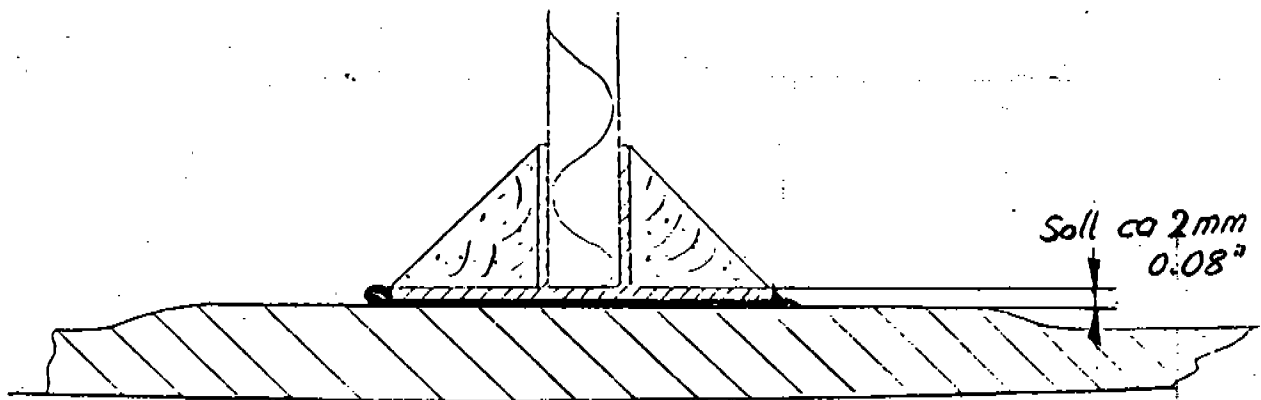
1. Lay wings on trestles the right way-up.
2. Remove covers in bottom wing panel
3. Insert strip lamp through holes in root rib.
Inspect forward facing bonding seams up to tank rib,
rearward seams up to 9 ft from root rib.
Inspect bonding seams directly or by means of the angled mirror
through the access holes in the root rib using the following criteria:
 - 3.1 The bonding may be considered to be satisfactory, if the resin has oozed, often in drops, out of the bonded joint. The height of the hat section flange should be less than 0,08" above the skin panel surface to ensure a thin bonded joint.

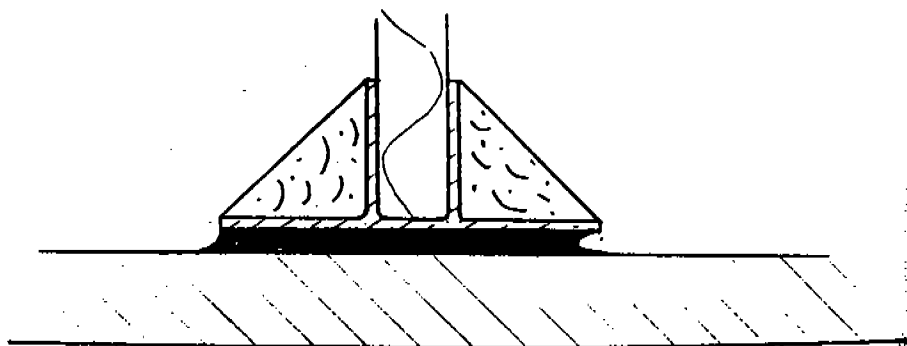
- 3.2 Overthick bonded joints may well include entrapped air bubbles, if the resin had not been properly squeezed out. Receding glue line must be viewed with suspicion. In both these cases a repair according to Appendix II must be carried out. The extent of the fault will be determined by means of probe drillings. Probe drillings shall be carried out within the suspected area, starting from inboard, in accordance with para. 4.

3.3 If receding glue line is detected, estimate depth of same with probe hook and mark spanwise position on opposite wing surface. Repair according to Appendix II of this Service Bulletin.

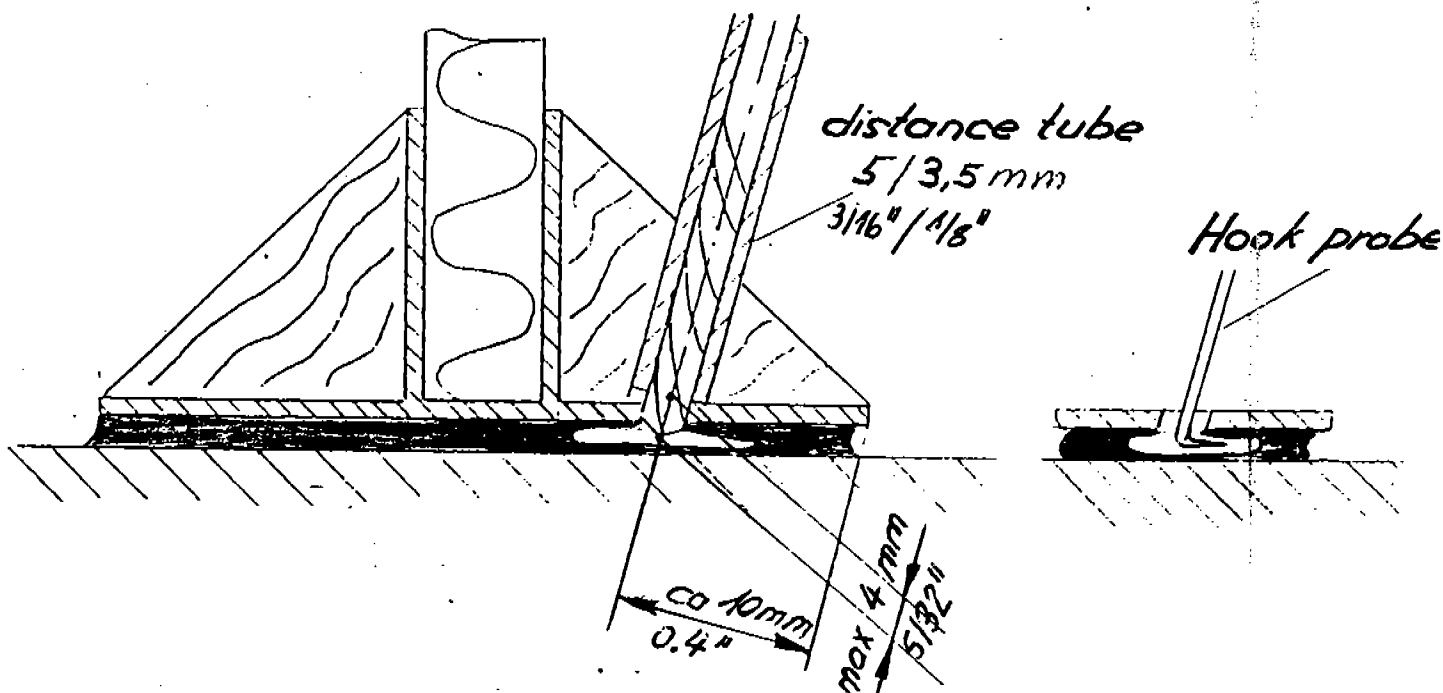
4.4 Drill 1/8" dia. hole into foam corner fillet of hat section, through hat section flange and into thick joint according to figure below. Cavity will be felt when drilling. If not, introduce "short" probe hook and see if cavity can be felt.

- 4.5 Repeat probe drillings cca. 1 in inboard and outboard of the first hole using the same hole in the upper wing skin.
- 4.6 Repeat steps 4.2 through 4.6 using a new hole drilled 3" outboard of the first hole in the top surface, to be repeated until the range of the suspected joint defect has been covered.
5. Where no cavities have been found, the holes may be filled in after completion of operations of Appendix III.
6. If cavities have been found, repairs according to Appendix II of this Service Bulletin must be carried out.
