GFA AIRWORTHINESS DIRECTIVE

- TYPE AFFECTED:** SZD-9 bis Bocian 1D and 1E.
- SUBJECT:** Periodic Inspection requirements.
- BACKGROUND:** Issue 1 of this AD required the periodic inspection of the fuselage carry through and the wing root fittings.

GFA AD 158	ISSUE: 2	7 April, 1998	Page 4 of 4
-------------------	-----------------	----------------------	--------------------

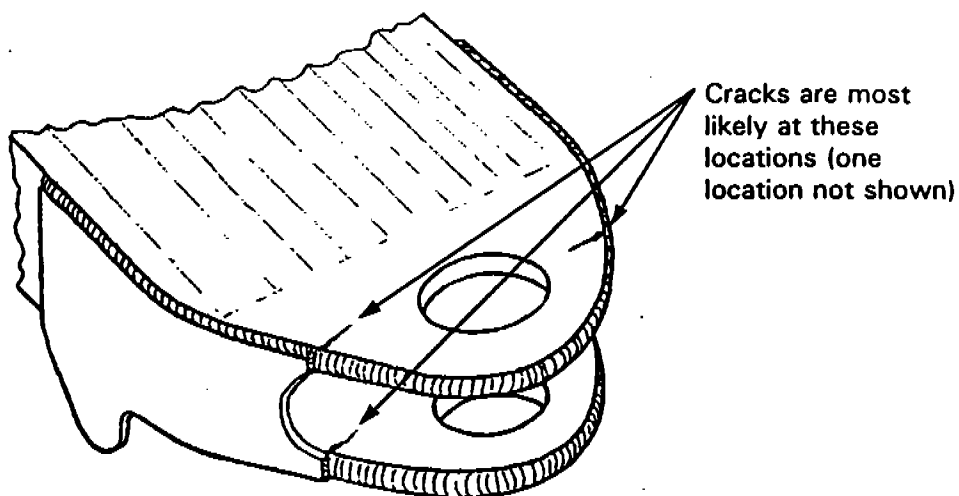
**FIGURE 1**

1. The wing main fittings must be inspected. The areas shown in Figure 1 are the most likely positions for cracks and damage.

Any cracks found must be repaired before further flight.

PZL Bielsko have prepared bulletin BE-27/86 Bocian which set down the maximum crack length and position which may be repaired. If cracks are found outside these dimensions then the part must be replaced.

The correct materials and technique for welding is contained in "Procedure of local cracks of main fittings repair" except that only TIG welding is permitted. Copies of these documents are available from the GFA Secretariat.

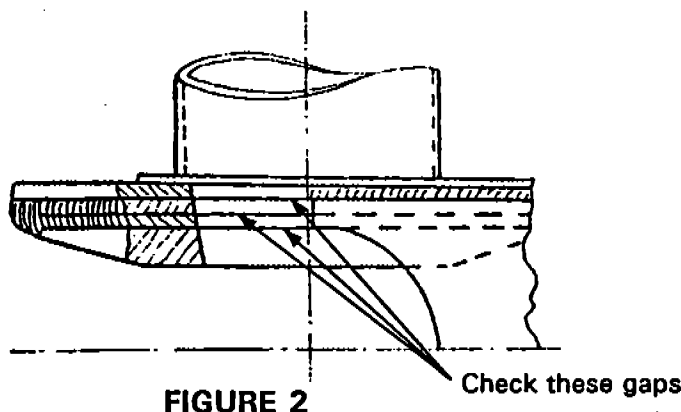
**FIGURE 2**

2. Check that the laminations of the main wing fittings are not separating. The maximum gap allowed is 0.4 mm. Any slipping movement between the laminations is not permitted.

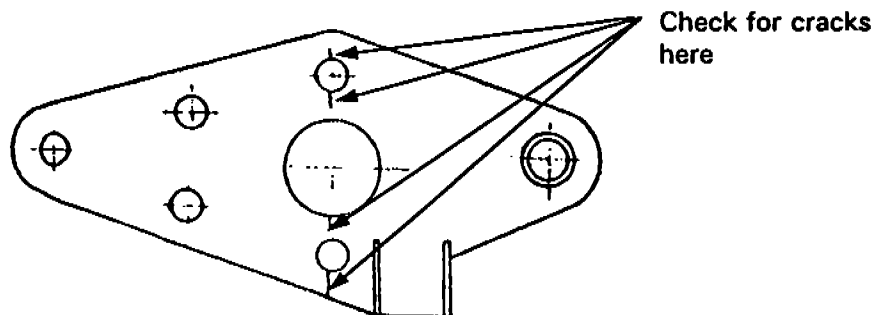
**FIGURE 3**

3. Conical wing pins. In addition to a normal visual inspection the contact area between the conical pins and the wing fittings, measured using Prussian Blue or similar must be at least 70% of the total area.
4. Rear spar fitting. The rear spar fitting must be inspected for cracks. Special attention must be given to the areas indicated in Figure 3.

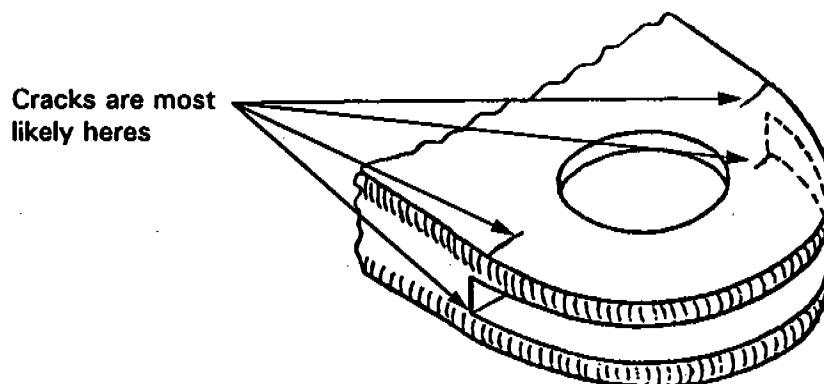
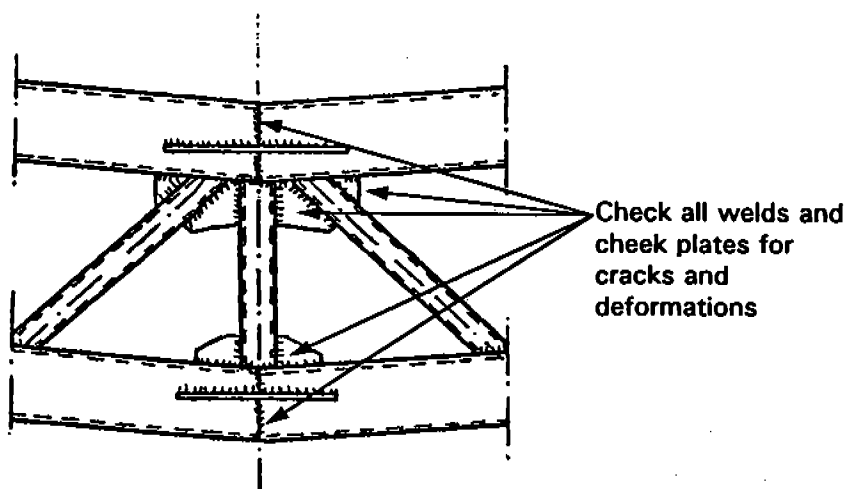
5. The main fuselage carry through must be inspected for cracks taking special care to inspect the places shown in Figure 4 and Figure 5.

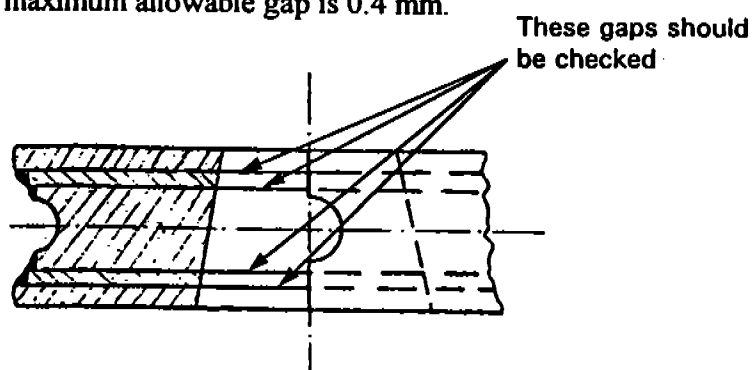
FIGURE 6

6. As for the wing fittings check for separation of the laminates in the fuselage carry through as per Figure 6. The maximum allowable gap is 0.4 mm.
