AIRWORTHINESS DIRECTIVE

SUBJECT: Inspection, replacement and maintenance of l'Hotellier couplings.

TYPE AFFECTED: All gliders, powered sailplanes and power assisted sailplanes fitted with l'Hotellier type ball joint quick disconnects in flight control systems.

For and on behalf of:		
CHIEF TECHNICAL OFFICER AIRWORTHINESS	THE GLIDING FEDERATION OF AUSTRALIA		
GFA AD 177	ISSUE: 7	9 May 2001	Page 1 of 9

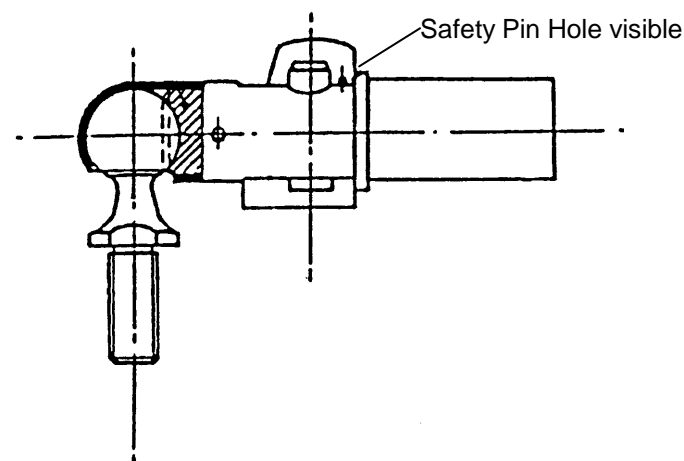
FIGURE 1. CORRECTLY ASSEMBLED COUPLING

The correct and incorrect assembly of the couplings must be pointed out by Daily Inspector Examiners and understood by Daily Inspectors and is shown in figure 1.

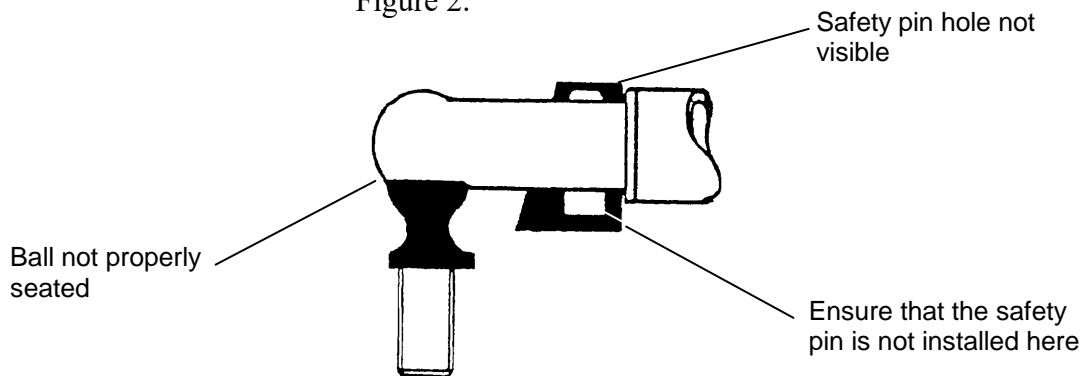
FIGURE 2. INCORRECTLY ASSEMBLED COUPLING

Daily inspectors should be aware that it is possible to connect these couplings incorrectly. The ball may not be fully home as shown in Figure 2.

After a coupling has been connected and the safety pin has been installed the slide should be pushed to ensure it is impossible to undo the coupling.

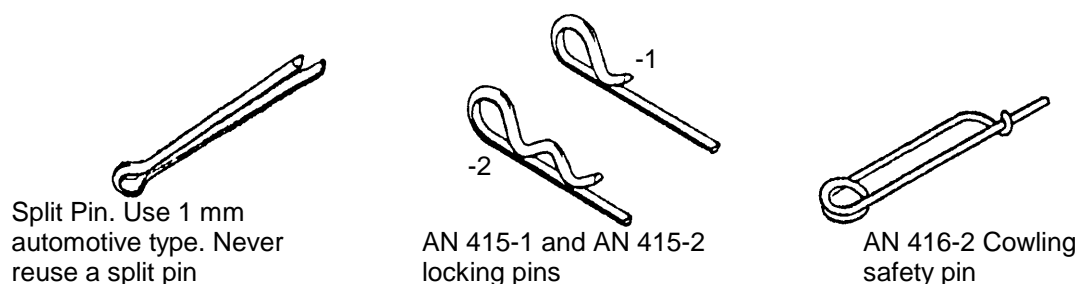
FIGURE 3. ACCEPTABLE LOCKING PINS

Acceptable methods of safety locking includes installing the pin types shown in Figure 3 and using of safety wire. Other methods of locking the couplings include Wedekind Safety Sleeves, Uerling type sleeves and the LS Sleeve as used on the LS 4. Because these other types of locking mechanism are significantly bulkier than the safety pins or wires shown in Figure 3 each type must be specifically approved for use in a particular aircraft type. If an aircraft type is approved for the use of other locking methods then it will be shown in the Flight and or Maintenance Manual or in the specific GFA AN for the type.

It is recommended that each safety pin be tied to part of the fitting by thin nylon chord or similar to avoid loss.

Each safety pin installation must be checked for clearance from the surrounding structure and control systems through the full travel of each control system.

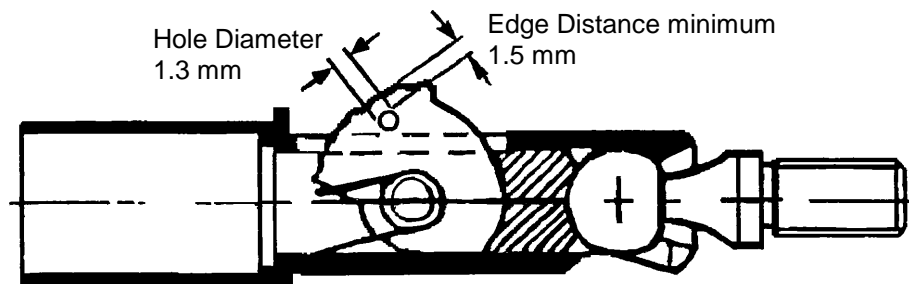
FIGURE 4. DRILLING THE LOCKING HOLE

Before 31 July, 1998 all cam style l'Hotellier couplings which do not have a hole for the safety pin must be modified by drilling a hole as shown in Figure 4 using the following procedures:

- a) Remove the connector from the aircraft.
- b) Fit a coupling ball so that the coupling is in the connected state.
- c) Drill a 1.3 mm \varnothing hole as show in Figure 4. Clean the coupling and ensure no swarf remains.
- d) Reinstall the couplings. Ensure that the lock nuts are secured.
- e) Check the control surface deflections and freeplays of all control circuits which have been disturbed.

Once the holes have been drilled safety pins as per Figure 3 or lock wire must be fitted. When fitting the pins for the first time clearance around the fitting must be checked as some designs do not permit the installation of the safety pins due to fouling with the adjacent structure and in these instances locking wire must be used.

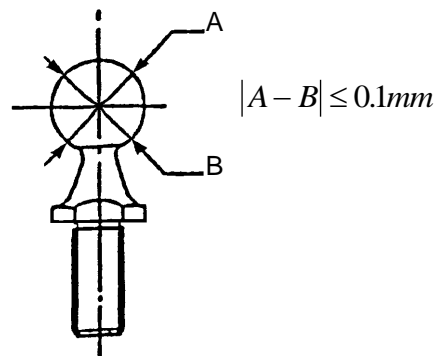
FIGURE 5. BALL WEAR MEASUREMENTS

All balls must be checked for wear, as per Figure 5, at 500 hour intervals and during Annual Inspections, whichever comes first. The maximum out of round $A - B$ or $B - A$ is 0.1 mm

It is recommended that the fit of the ball in the fitting be checked by unbolting the ball from the control system and installing it in the coupling and attempting to rotate it. Any variation in the torque needed to rotate the ball is an indication of wear and ball replacement should be considered.

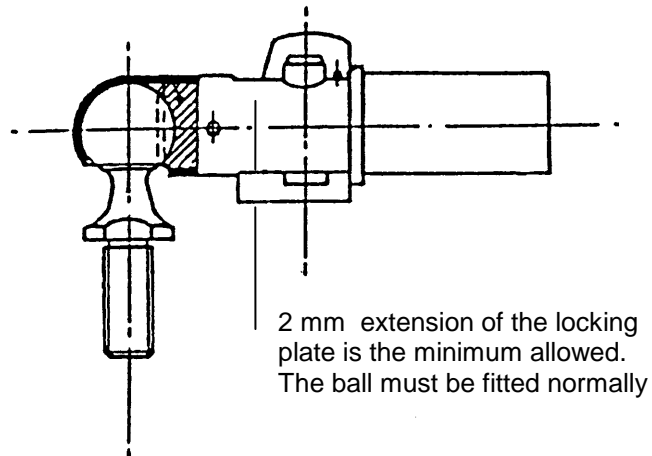
FIGURE 6. LOCKING PLATE EXTENSION

At each annual inspection the projection of the locking plate must be checked as per Figure 6. This measurement is an indication of the combined wear of the ball and coupling. If replacing the ball does not bring the extension back into tolerance then the coupling is excessively worn and must be replaced.

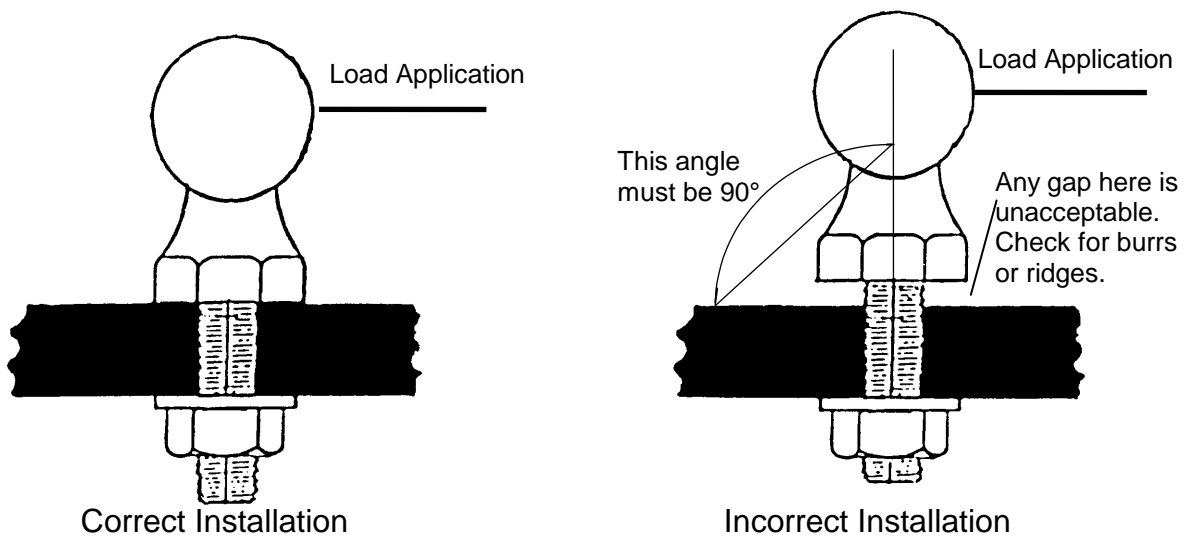
FIGURE 7. BALL INSTALLATION

Daily and Form 2 Inspectors must look for looseness of balls, ie. loose nuts, broken tab washers, worn threads etc. Any of these defects will allow them to wind out or loosen. Any looseness can cause bending failure and cracking of the shank at the underside of the flange .

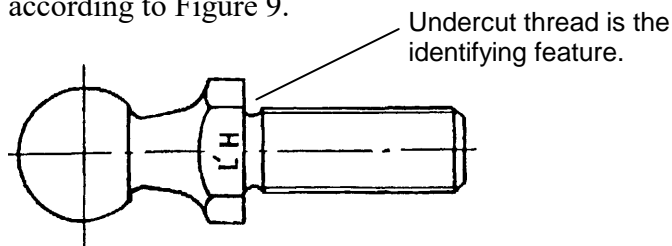
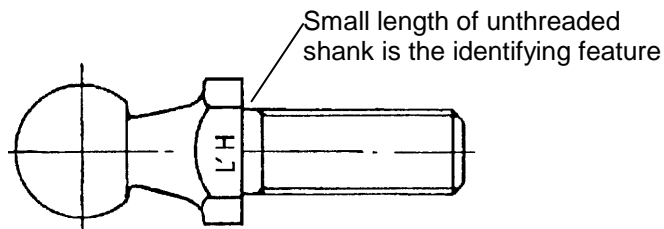
Since the last issue of this AD l'Hotellier have redesigned some of the balls to remove the undercut thread and introduce a small length of shank. The original design is shown in Figure 8. Balls with redesigned threads are identified as 961S-150-150.L3 according to Figure 9.

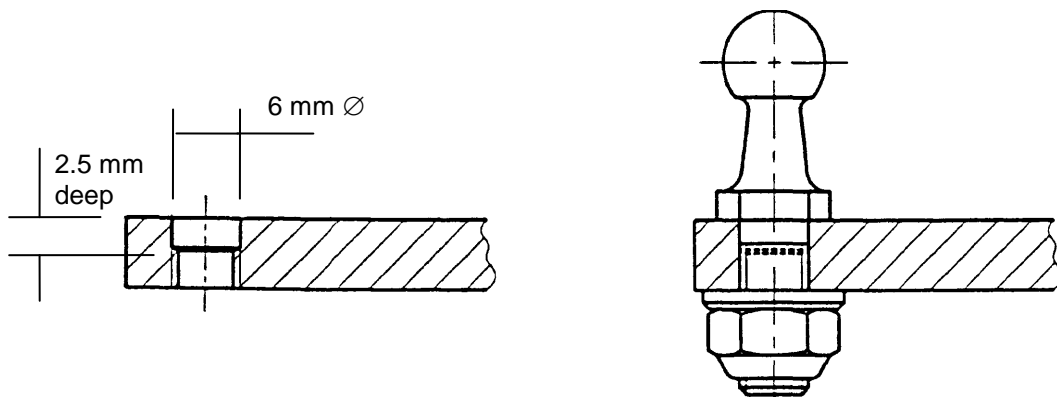
FIGURE 10 MODIFIED MOUNTING FOR 961S-150-150.L3 BALL

Because of the redesigned thread the mounting brackets must be modified to accept the new thread. Where the ball is mounted at

90° as shown in Figure 10 and there is a nut on the ball then the plate may be drilled out to accept the 961S ball.

The ball may be installed in end fittings by installing 2.5 mm of washers under the ball flange. Because this changes the geometry of the control system the control deflections or dive brake locking forces must be checked and adjusted to bring them back into tolerance.
