CANCELLED
AIRWORTHINESS DIRECTIVE GLIDERS

REF. NO. GFA/AD/178 GENERAL 4.

GLIDER TYPES AFFECTED.

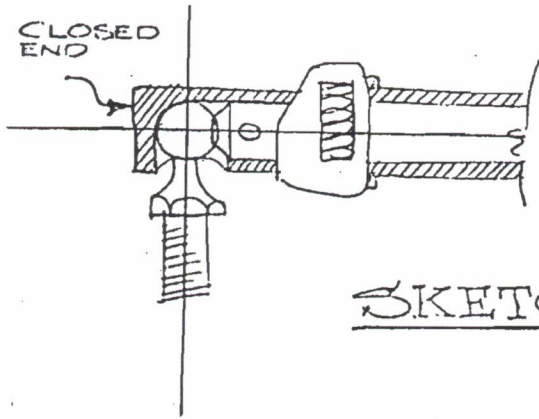
SKETCH 1

The female part of the coupling of the first mentioned type has a closed end and it cannot be used as an in line coupling.

All gliders fitted with ball joint couplings with side connections are to be inspected before further flight, to ensure the correct type of female connection is fitted. If an open ended type female coupling is fitted it is to be replaced with a closed end type. If any discernable wear marking is evident on the mating ball component, the ball and female part of the coupling are both to be replaced before further flight.

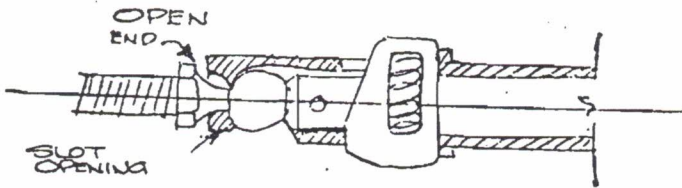
SKETCH 2.

The female part of the coupling of the second mentioned type has an open end and it is possible to use this type of coupling as an in line or as a side connection type, however when used as a side connection coupling the ball part of the coupling is subjected to more rapid wear due to the reduced bearing surface at the open end of the female part of the coupling. The resulting wear pattern can lead to the female part of the coupling obtaining a clamping grip on the ball part of the coupling and any rotary movement can lead to failure of the ball shank.

Tests have shown that approximately two degrees of twist between the ball and its shank can cause failure.

Alternatively the ball part only may be replaced but the female part of the coupling must be replaced within twenty five further hours in service.
