GLIDING FEDERATION OF AUSTRALIA

AIRWORTHINESS DIRECTIVE GLIDERS:

Ref. No. GFA/AD 187 Glasflugel 11

Glasflugel H201 and H201B to serial No. 476  
and H301 and H301B, all serial numbers.

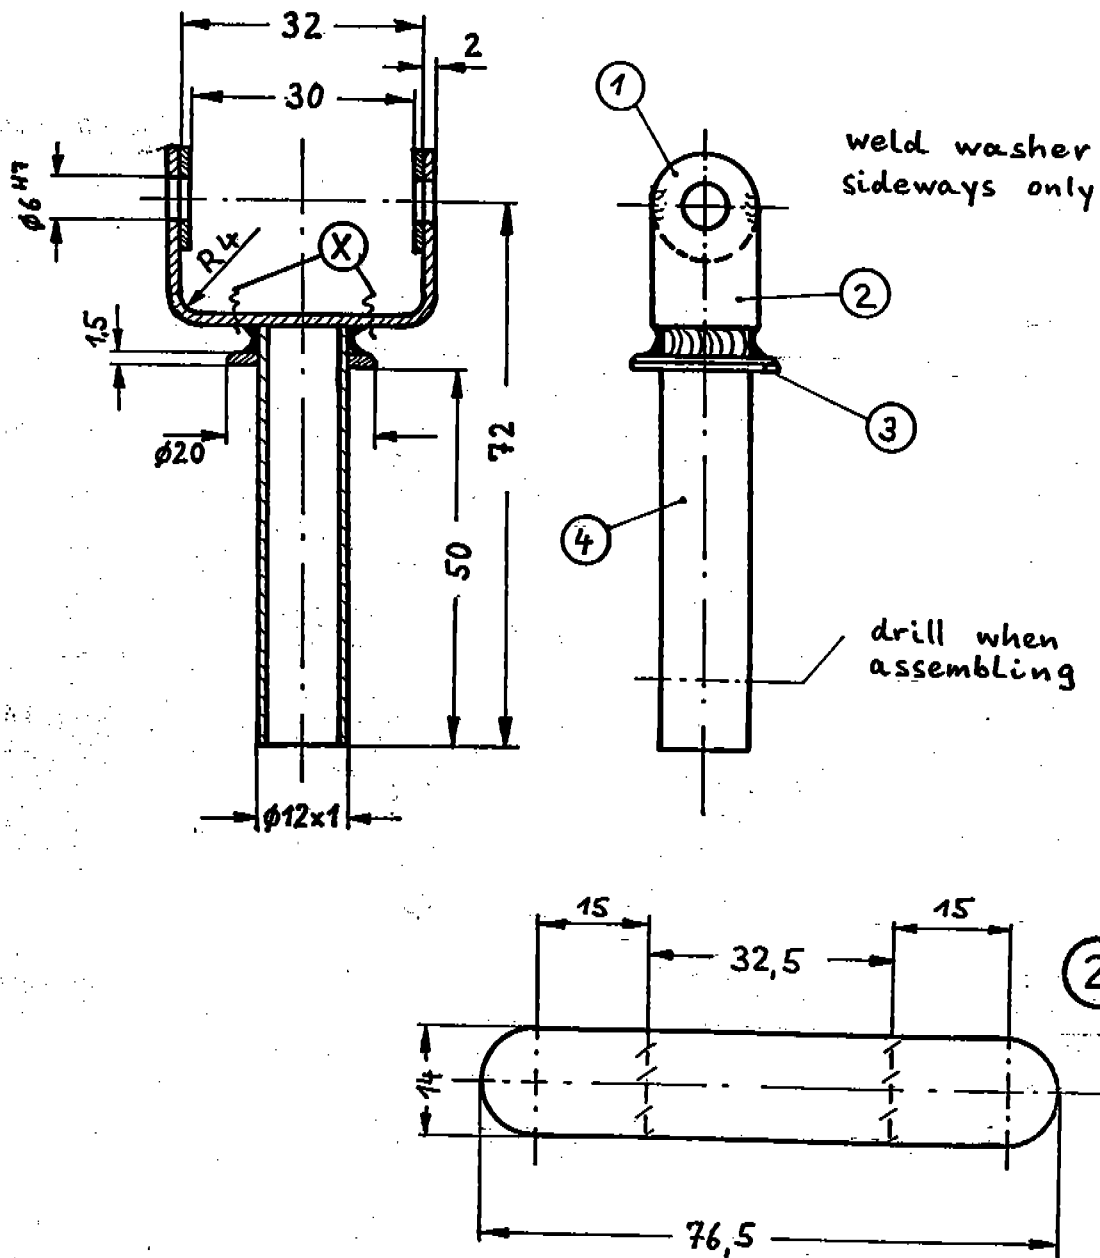
Failure of a component in the elevator control circuit at the base of the control column has occurred. The nature of the failure was such that it may be expected to occur in other gliders of the subject type.

(X) Position of possible cracks on original Elevator Linkage

1. Before further flight, the elevator linkage component (see illustration of modified component) is to be inspected. Inspection is to be carried out by a holder of a Glider Inspector's Certificate D.O.T 1109 endorsed for Certificate of Airworthiness Inspectors experienced in crack detection in metals. Inspection is to be carried out using a magnifying glass with at least 5 x magnification.

2. The modified elevator linkage component according to drawing No. 301-41-4/2 is available from Glasflugel, 7318 Lenningen 1, West Germany or Australian Agent,

heat-treatment after welding: Tempering in controlled atmosphere  
1 hour at 550°C
