GLIDING FEDERATION OF AUSTRALIA

AIRWORTHINESS DIRECTIVE GLIDERS:

REFERENCE No. GFA/AD 197 GROB 18

GLIDER TYPE AFFECTED: Grob Speed Astir 11 and 11B, from serial number 4001

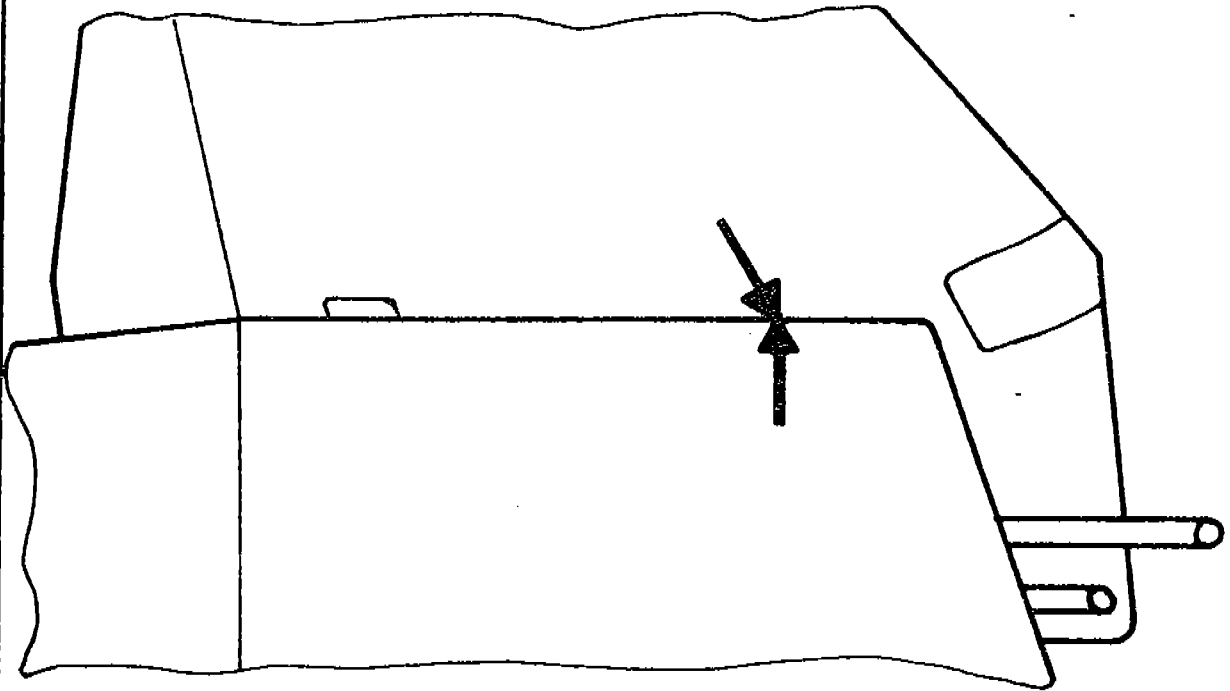
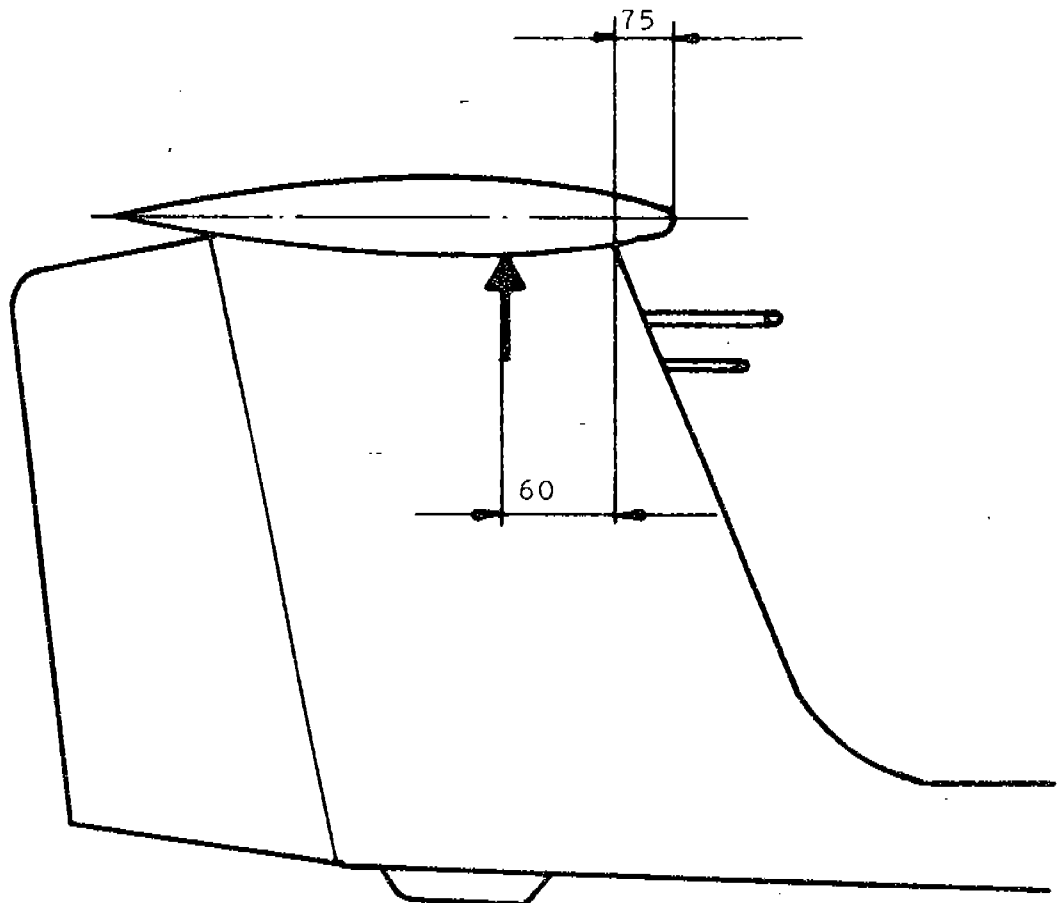
BACKGROUND: Marks on the tailplane and fin to indicate correct alignment of these components when rigging have been found to be insufficiently durable.

- (b) Provided the 4 markings at elevator and fin are still existing they must coincide after correct mounting. The former poorly adherent markings should be removed and replaced by new ones at the same position.

- (c) Provided the 4 markings at elevator and fin are missing completely or partially, the rest of the previous marks should be removed and replaced by new markings according to construction drawing. Before applying glue make sure the region is free of oil, grease or residue of former labels.

- (d) To attach the new marks, it is necessary to remove the paper cover before rubbing the arrow firmly with the transparent foil. Then the foil should be carefully removed and the mark again pressed. After 24 hours the adherence is sufficient to withstand application of sealing tape between stabilizer and rudder. There is no risk to remove the marking inadvertently when removing the tape.
