GLIDING FEDERATION OF AUSTRALIA.

AIRWORTHINESS DIRECTIVE GLIDERS

Ref. No. GFA/AD 206,  
ROLLADEN SCHNEIDER 17

Rolladen Schneider LS 4. Serial Nos. 4000-4004,  
4006-4013, 4015-4018, 4020-4028, 4031, 4033-4035,  
4037-4040, 4042-4045, 4047, 4048, 4050, 4053,  
4061-4063, 4068, 4075, 4077, 4081-4083, 4085, 4086,  
4088, 4099, 4106.

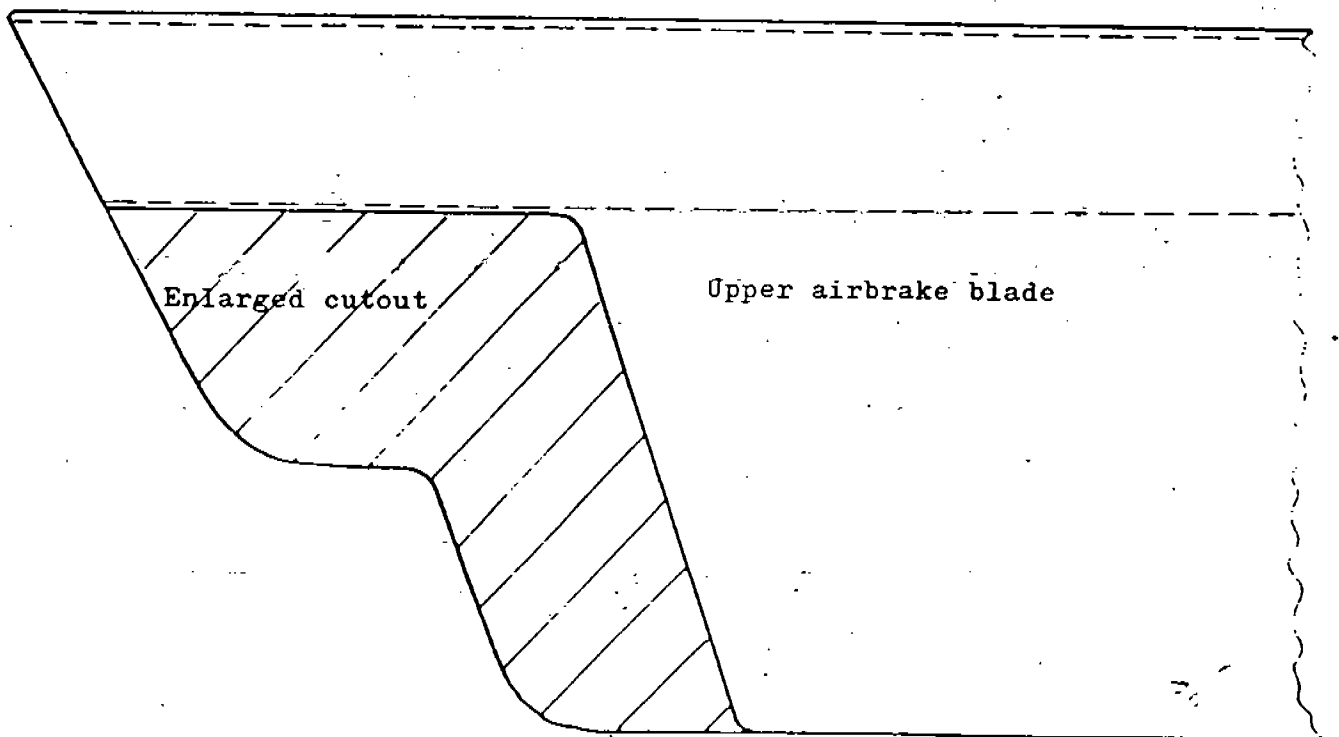
Left airbrake blade

Rolladen Schneider Technical Bulletin No. 4005 advises that there have been incidents where divebrakes on LS-4 gliders could not be closed at airspeeds above 125 knots due to the airbrake blade interfering with the head of the drive bolt as a result of manufacturing tolerances.

The cut out at the inboard end of the upper dive brake blade is to be enlarged to the profile as shown on the attached drawing.

According to the drawing below the contour of the cutout is marked by a lead pencil and is cut out by a metal saw. The cutting edges are smoothed by a file.
