**AIRWORTHINESS DIRECTIVE**

**TYPES AFFECTED:** Grob Astir CS gliders (All serial Nos.)

**SUBJECT:** Replacement of tailplane/fin locating pins.

GFA/AD 254	Issue 3
21/4/83	Sheet 2 of 3

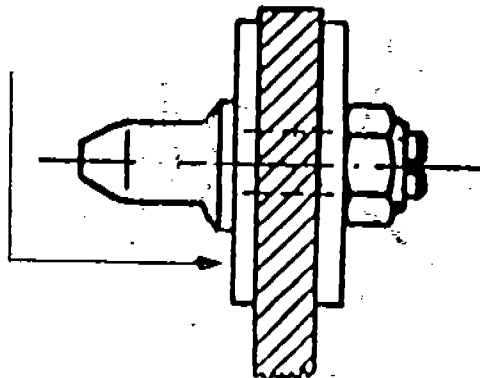
#### PIN INSTALLATION

Be very sure that this side of this washer is countersunk so that the edge of its hole does not bottom on the radius at the bottom of the flange.

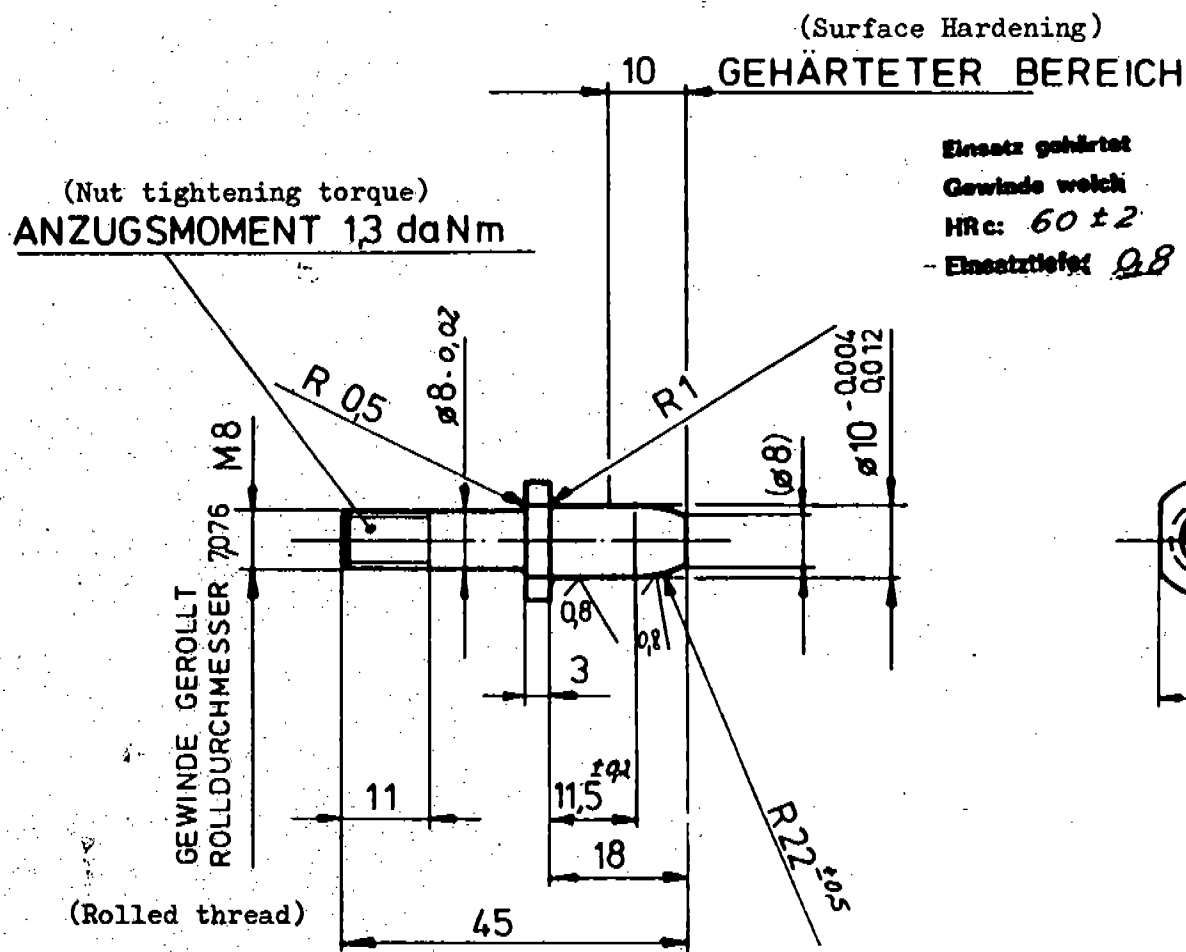
'New Style Pin'

To ensure that the correct pins are fitted at all times the Grob drawing is reproduced to show the "New style" pin identifying features which are:-

- (1) Flats on the flange
- (2) Rolled thread
- (3) Only first 10mm of pin nose Nitrided
- (4) Made to Grob drawing 102-2142-32

Einsatz gehärtet  
Gewinde weich  
HRc: 60 ± 2  
Einsatztiefe: 9,8

- ACTION REQUIRED:**
- (1) All Astir CS pins are to be dye checked at 25 hour intervals irrespective of pin time in service and immediately following any heavy landing or ground loop, until replaced with Grob "new style pins".
  - (2) On receipt of "new style" pins, the old pins are to be removed and destroyed.
  - (3) "new style" pins to be fitted observing the manufacturer's recommended torque specification.  
(Shown on Dwg 102-2142-32)

- (4) "New style" pins to be crack detected at each annual inspection or 200 hours flight time, whichever comes first.
- (5) "New style" pins to be crack detected after all heavy landings and ground loops.
- (6) Record of component replacement and all inspections to be entered into log book.
