GFA AIRWORTHINESS DIRECTIVE

SUBJECT: Cracking of flap drive. Issue 3 of this AD corrects an omission in Issue 2 by adding Ventus bT to the affected models. Otherwise the content of the AD and the attachments are unchanged.

**Airworthiness
Directive
2001-258**

SUBJECT: Flap drive inside the fuselage

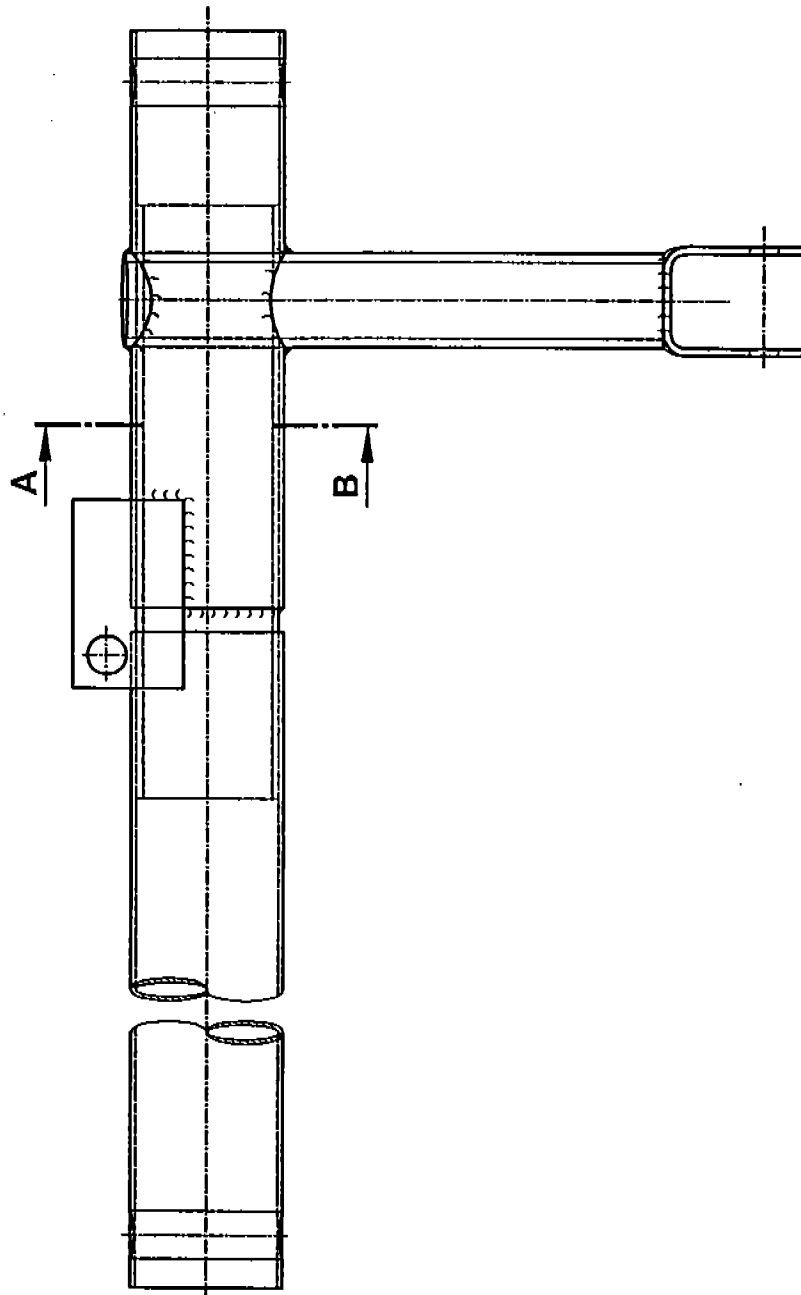
Schnitt A-B

BACKGROUND: Variations in flap setting were noticed on several sailplanes. Investigation revealed cracking around the weld between the flap drive lever and flap torque tube.

On several sailplanes a change in the setting of the flaps was noticed during rigging. Investigations revealed cracking around the weld between flap drive lever and flap torque tube.

- ACTIONS:
1. Sailplanes Ventus b and Ventus b/16.6 with a flap drive design according page 01 of the appendix to this technical Note are not affected of action 2.
 2. The reinforcement of the flap torsional drive must be done in accordance with the working instructions given in the appendix to this Technical Note and must comply with the following drawings:

Variant Ventus	Drawing No.	Nomenclature
a, a/16.6	HS8 – 10.084 modification a	Flap torsional drive
b, b/16.6	HS8 – 10.148/1	Reinforcement Flap torsional drive

a) The torque tube is disconnected by removing the rear lock nut (14 a) and loosening the clamping nut (14 b) – then the hexagonal bolt (10) must be turned out (with nut 14 b held fixed) until the two parts of the torque tube are apart.

b) Pull tube halve apart and remove port part.
3. Weld reinforcements to port torque tube as shown in drawing No. HS8-10.084 Modification “a” respective HS8-10.148/1.
4. Reverse steps to re-assemble flap drive.
5. With the sailplane rigged, adjust the starboard flap such that its setting corresponds with the marking previously applied (see 1. a)
