## AIRWORTHINESS DIRECTIVE

Mini-Nimbus B  
Mini-Nimbus C (up to Serial No. 110)  
Nimbus 2B  
Janus B

Elevator drive bracket - earlier type (Sketch 1 or 3)  
Later type (Sketch 2) is not affected.

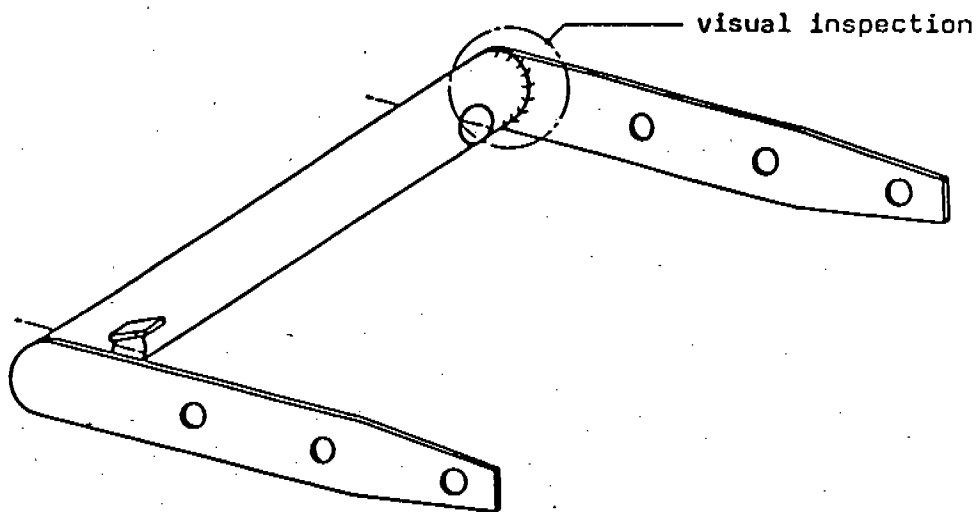
# SKETCH 1

Difficulties in the control of the sailplane were encountered when an earlier type elevator drive bracket broke on one side in flight. The schempp-Hirth factory have issued Technical Notes TN 386-24, TN 295-19 and TN 328-8.

On sailplanes having the earlier type elevator drive bracket according to sketch 1 or sketch 3, a visual inspection for possible cracks must be carried out while twisting the two elevator halves against each other.

## earlier type elevator drive bracket

The earlier type elevator drive bracket according to sketch 1 must either be replaced by a reinforced bracket (as shown in sketch 2) or be reinforced by means of welding metal strips according to sketch 4.

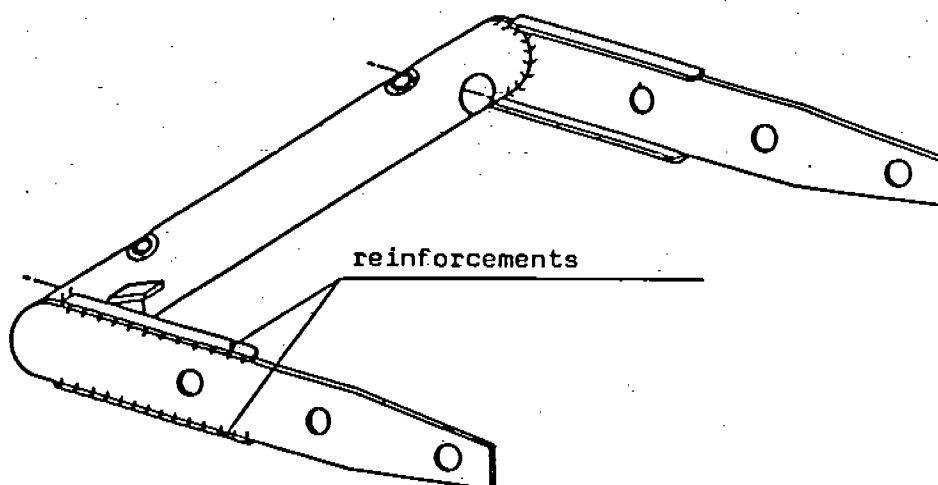
# SKETCH 2

## reinforced elevator drive bracket

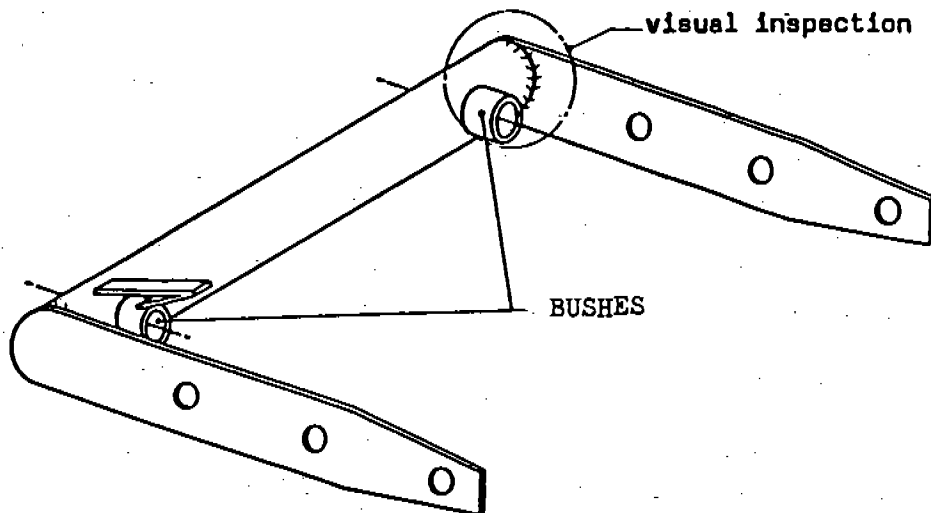
### SKETCH 3

#### earlier type elevator drive bracket

On sailplanes having an earlier type elevator drive bracket according to sketch 3 (bracket with bushings), a reinforcement by means of welding on metal strips according to sketch 4 is required.

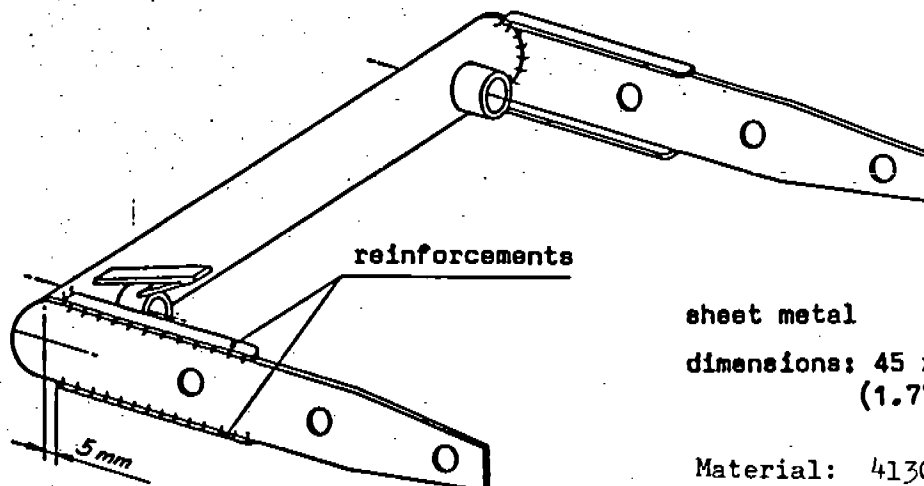
### SKETCH 4

#### reinforced elevator drive bracket

dimensions: 45 x 5 x 1.5 mm  
(1.77 x 0.20 x 0.06 in.)

Material: 4130 steel  
Weld with gas or T.I.G.
